## 37. FOOTBRIDGE 1931

### INTRODUCTION

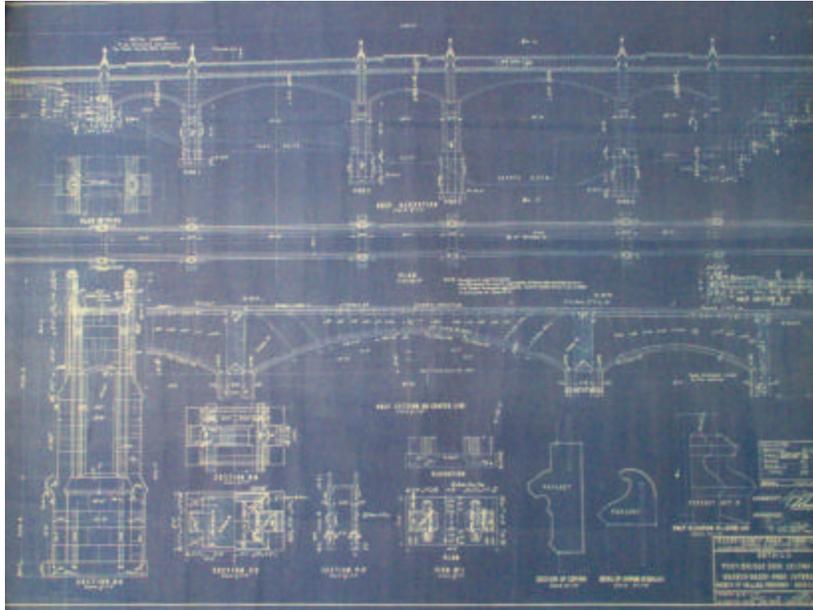
Original Drawing 27  
This blueprint from an original drawing displays the bridge in section, elevation and plan.

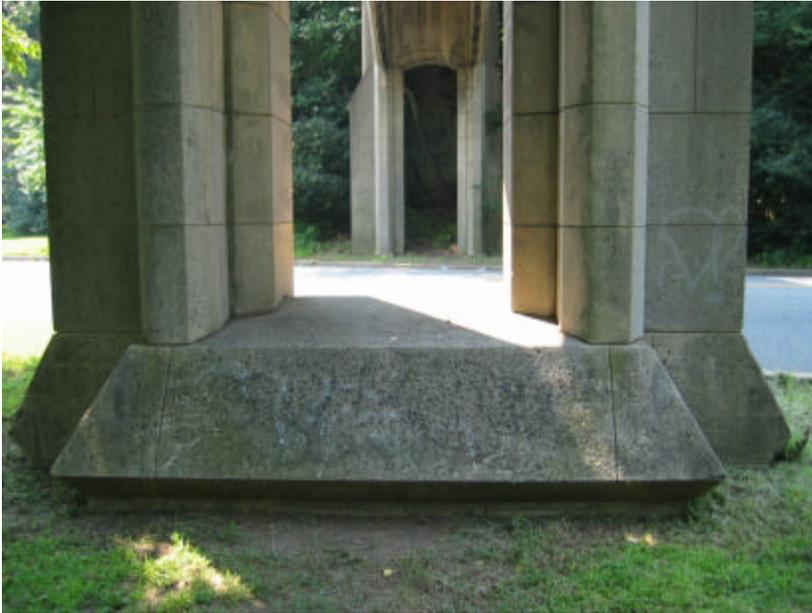
Photo 325  
The massive foundation caps and footings supporting the twin piers; note the graffiti and organic growth on the surfaces.

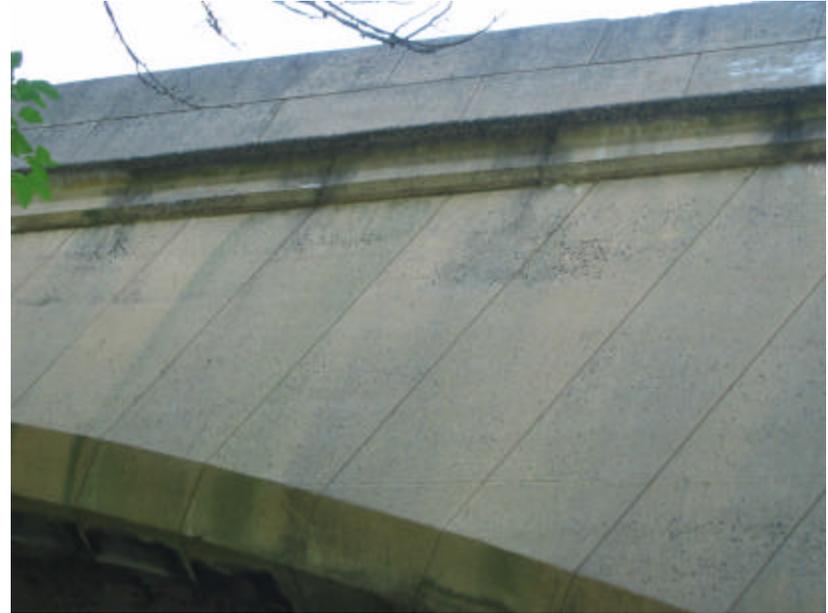
Photo 326  
The bridge's scored concrete surfaces simulating stonework; note that this section of the bridge is in fair condition.

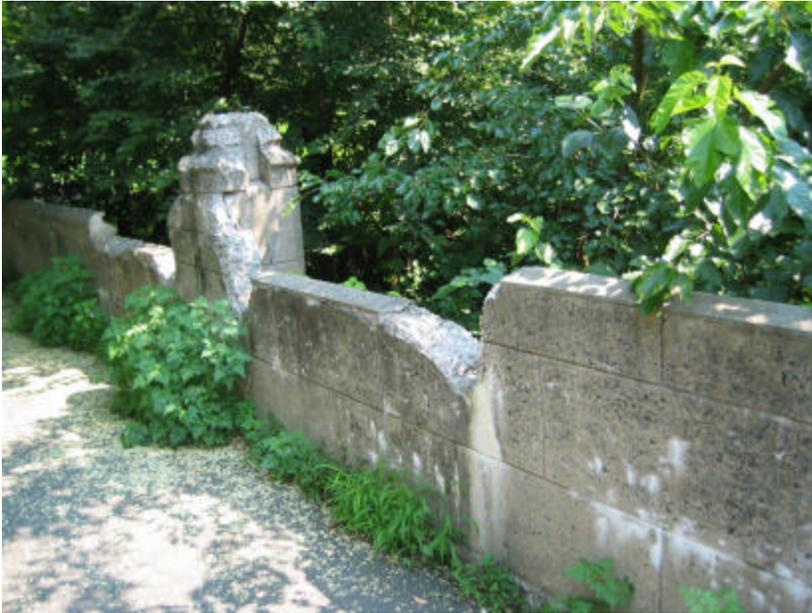
Photo 327  
The spalling and cracking parapet walls, copings, and pier caps;  
note the weeds in the gutter along the base of the wall.

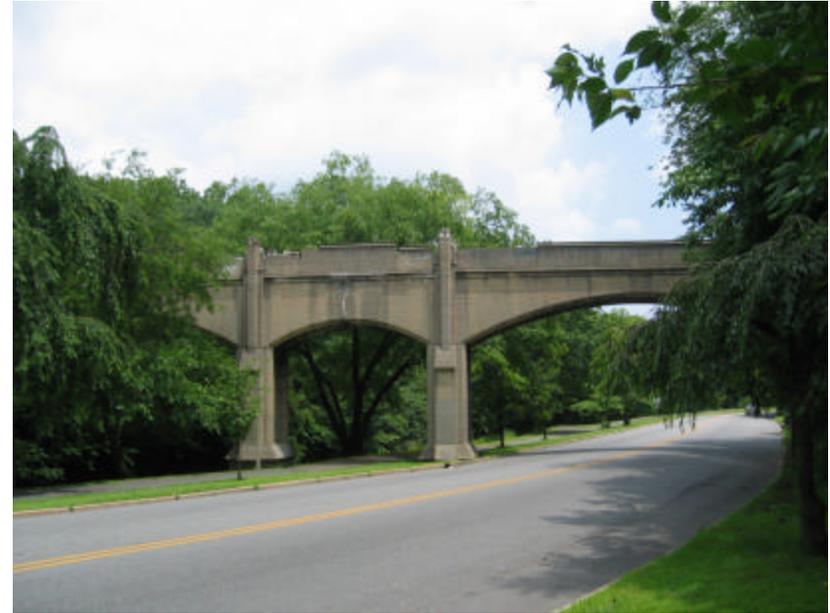
Photo 326  
View east towards the bridge; note the difference in the size of the  
arches and the overall condition of the parapet wall.

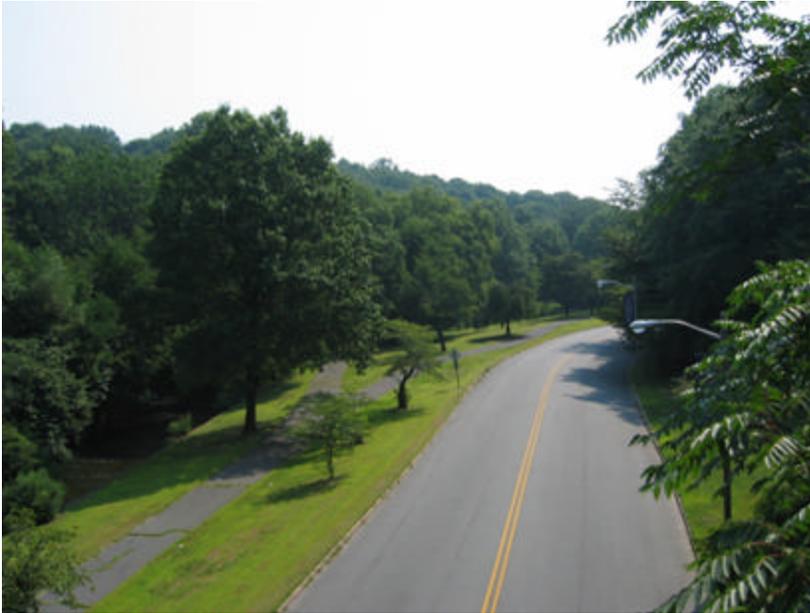
Photo 328  
View west from the bridge's deck; note that the site slopes gently towards the Second River.

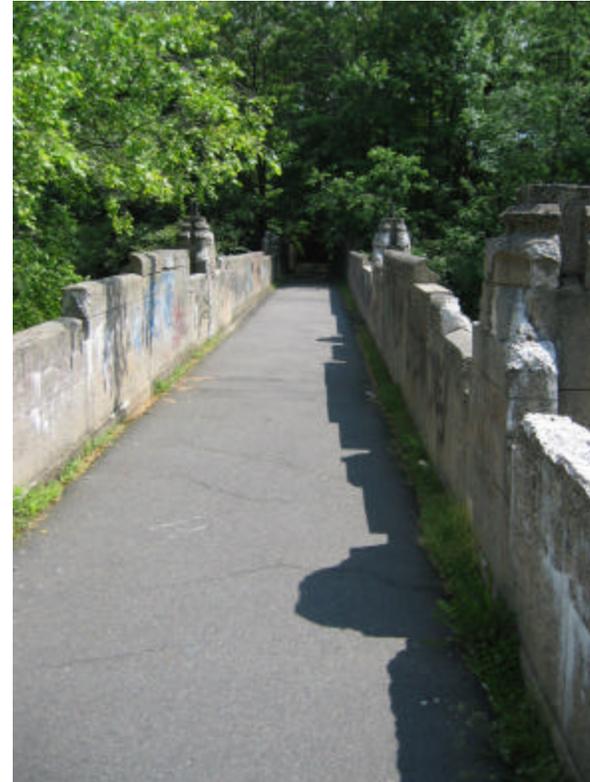
Photo 329  
The paved asphalt pathway over the bridge; note the extremely poor condition of the parapet walls, copings, pier caps and lantern bases. Also note that weeds and organic debris clog the gutters on both sides of the bridge.

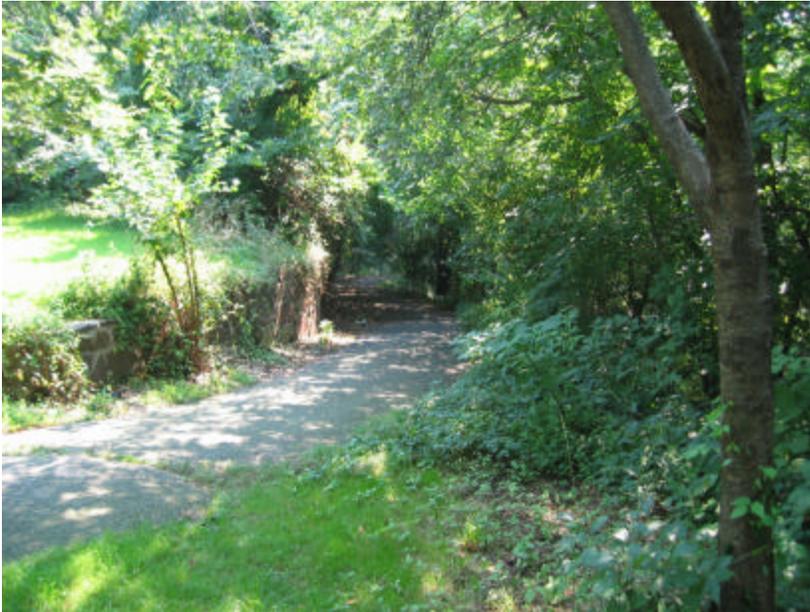
Photo 330  
The asphalt path leading from the north end of the bridge towards the path that runs under the bridge along the Second River.

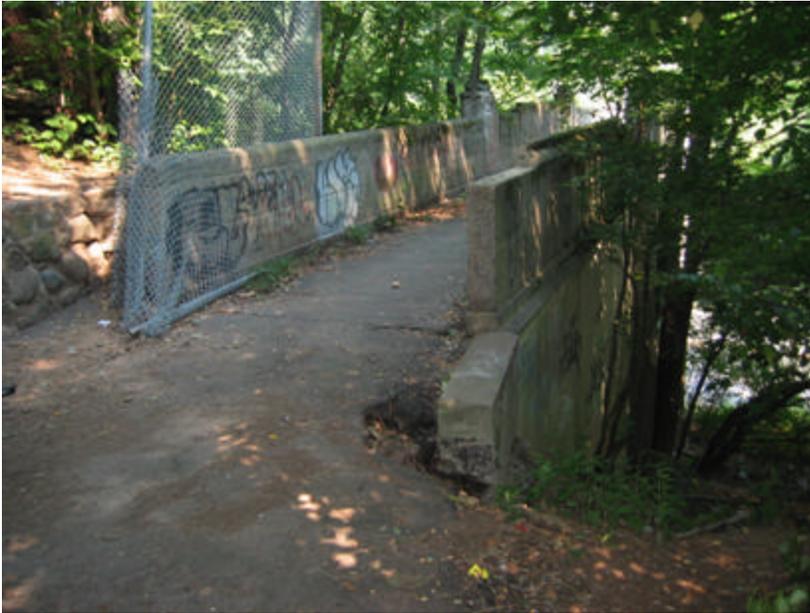
Photo 332  
View towards the south end of the bridge; note the severe erosion to the right of the photo evidencing damage by water runoff.

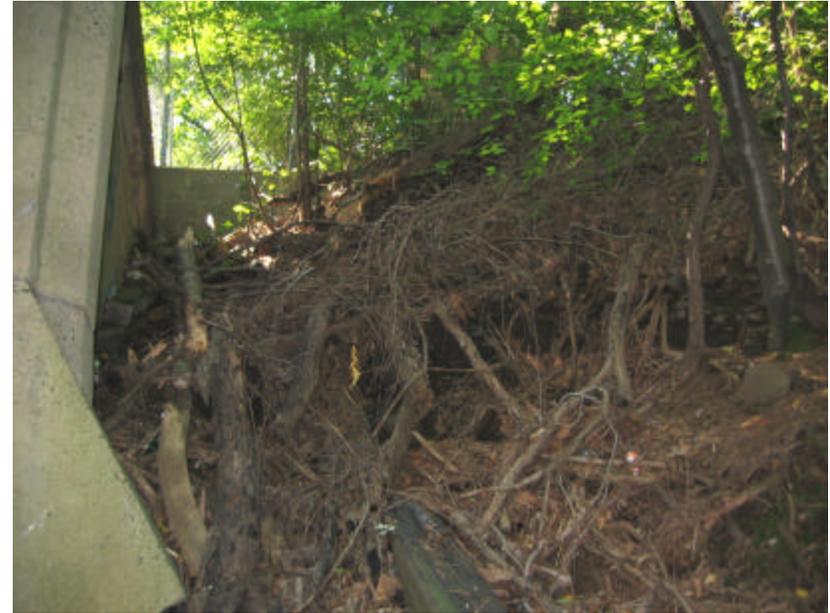
Photo 333  
Significant amount of debris including: fallen trees, branches, limbs, vines and roots.

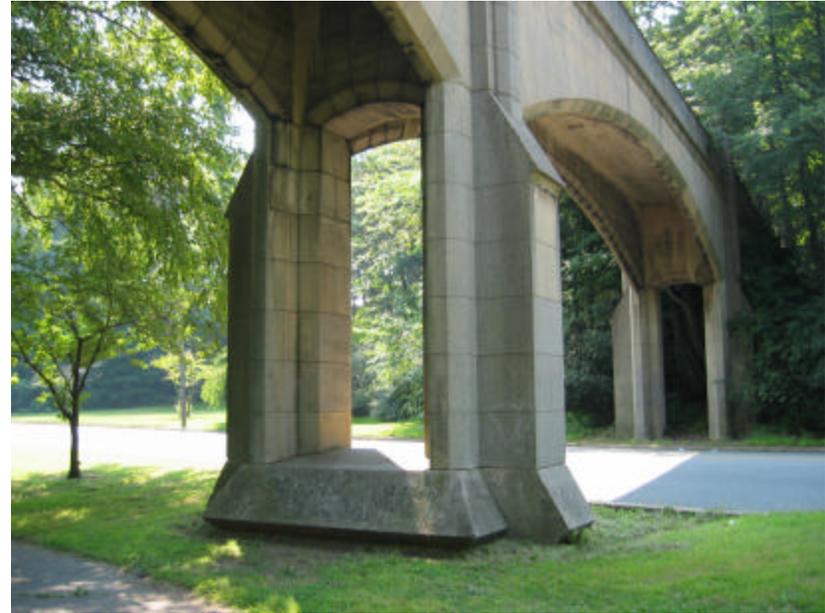
Photo 335  
Piers surmounting the foundations support the bridge; note that each pier is braced by a buttress.

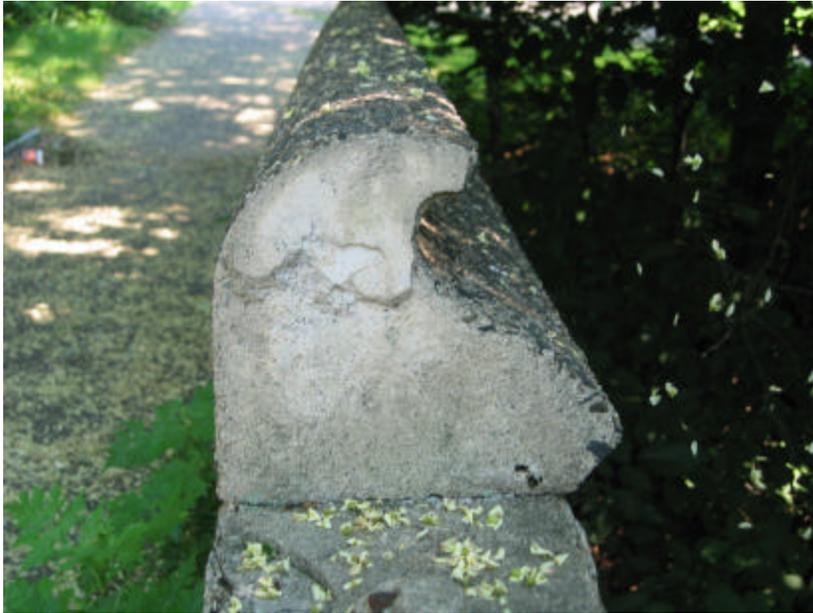
Photo 336  
An original piece of coping on top of the parapet wall; note the detailed design.

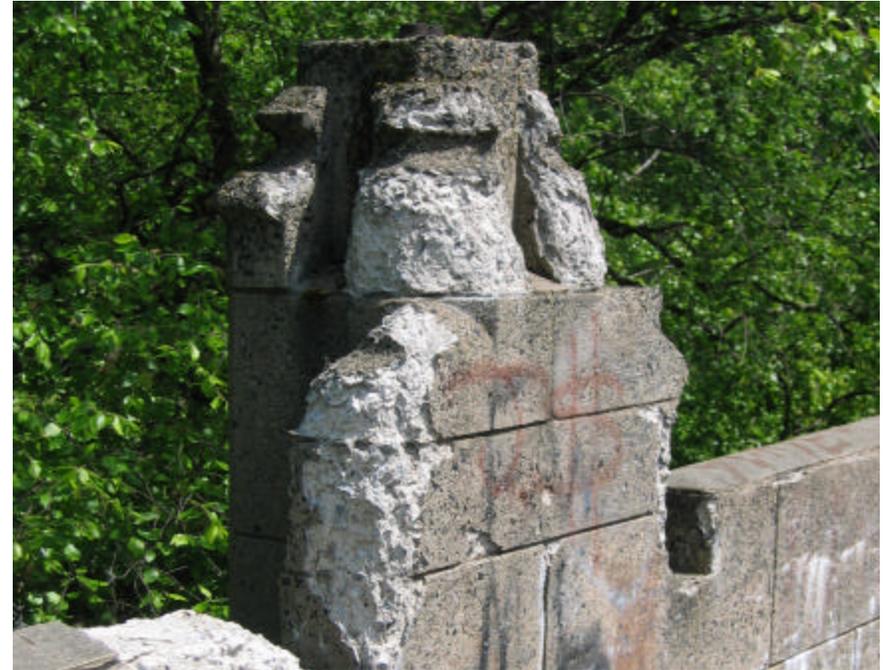
Photo 339  
The top of this pier has severely spalled; note the top of the wall has been patched with a thin layer of mortar.

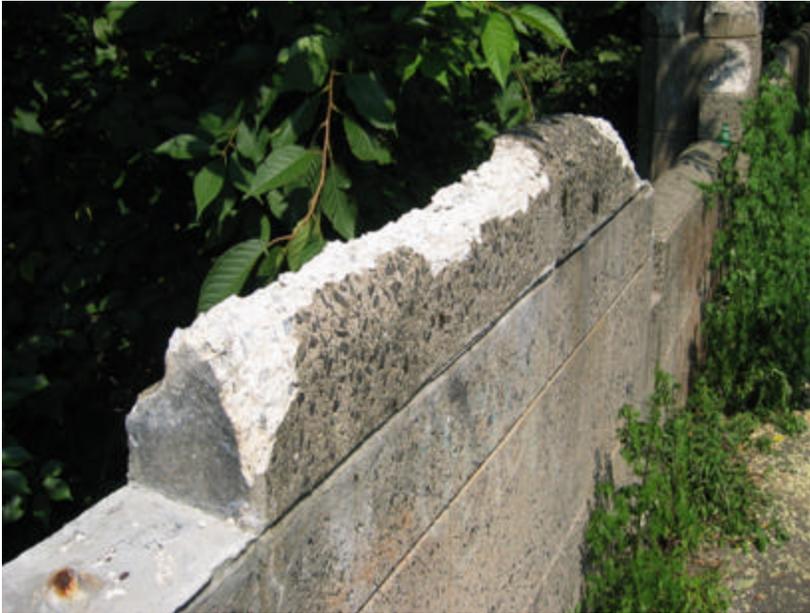
Photo 340  
Significant spalling of the concrete coping caused by water absorption and the adverse effects of freeze-thaw cycles.

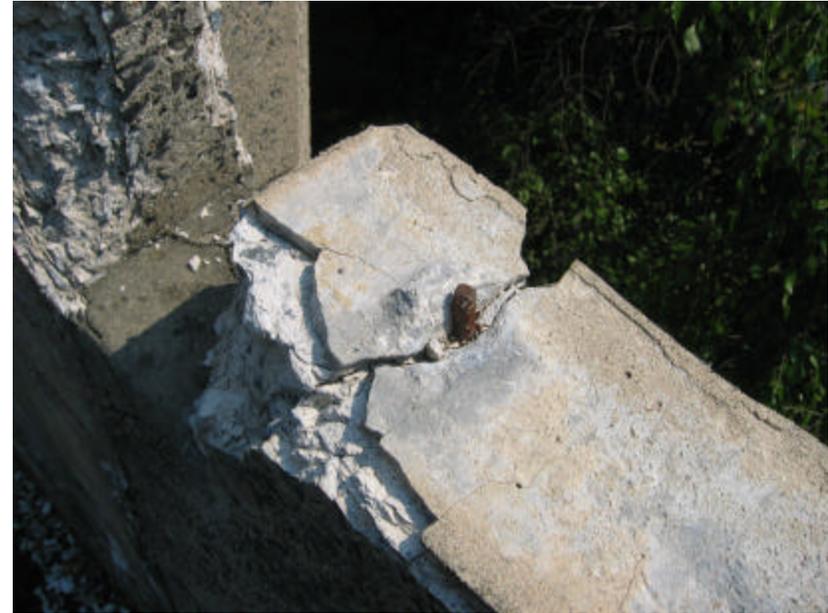
Photo 341  
Severe cracking and spalling around a piece of exposed, rusting steel reinforcing.

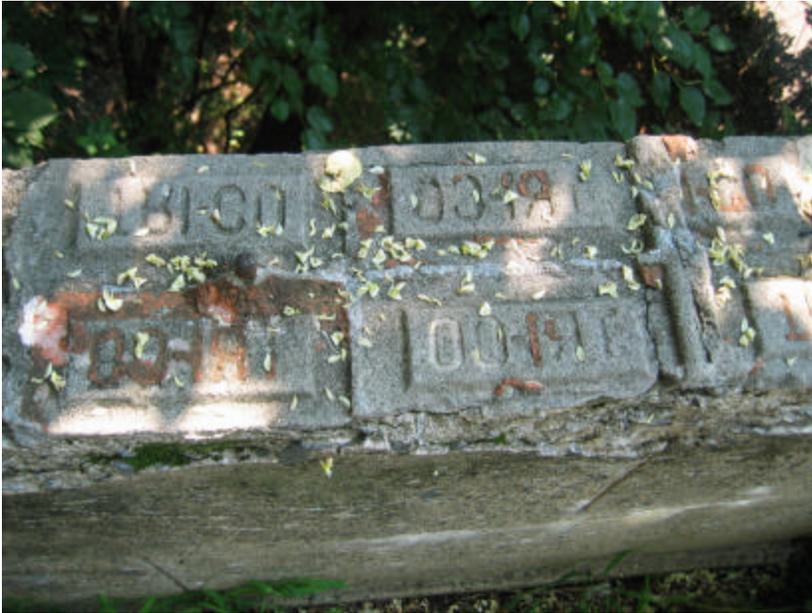
Photo 342  
Detail looking down at the top of a parapet wall, showing remedial patching by replacement bricks.

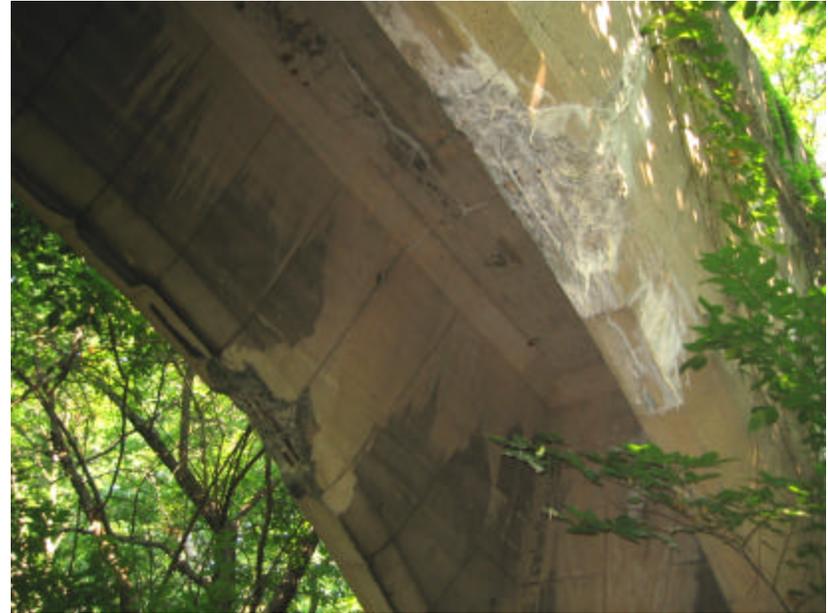
Photo 343  
An area of extreme spalling and cracking; note the exposed steel reinforcing, de-icing and other soluble salts and mineral deposits.

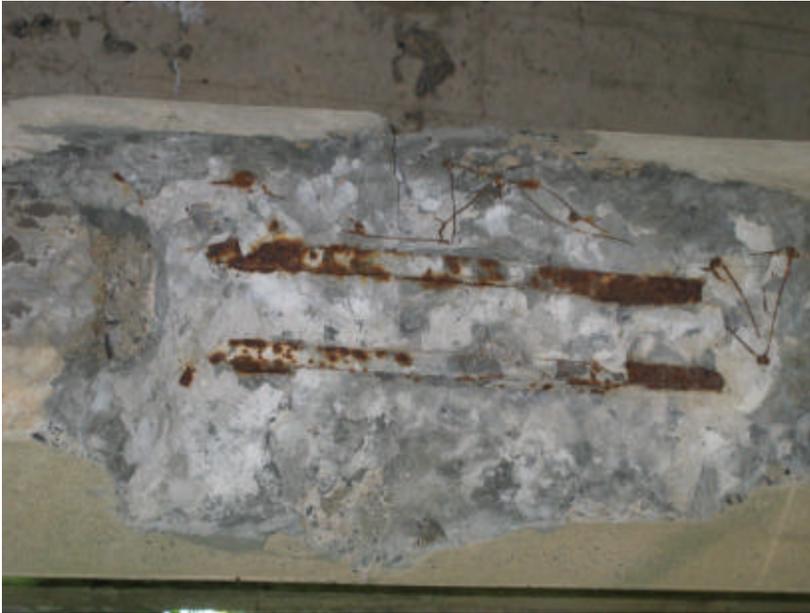
Photo 344  
Rusting steel reinforcing exposed by severe spalling underneath the concrete arch.

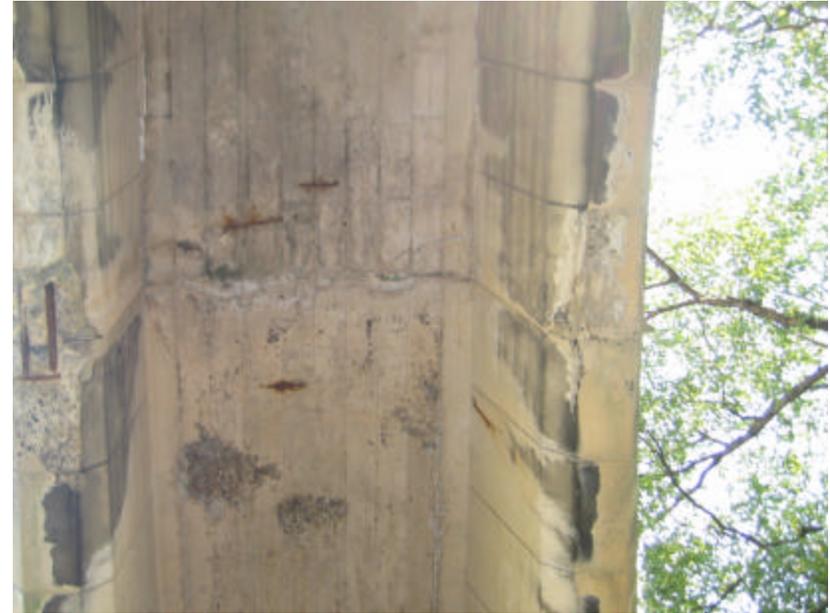
Photo 345  
This spalling and cracking extends underneath the entire bridge; note the areas of soiling, staining and exposed steel reinforcing.

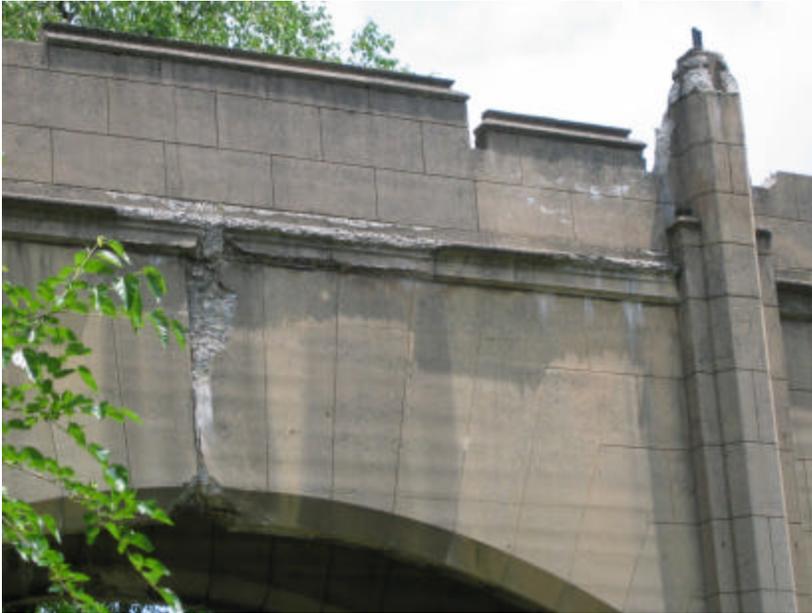
Photo 346  
Spalling and cracking on the side of the bridge. The severe spalling continues from the underside of the bridge through the cheek wall and along the stringcourse.

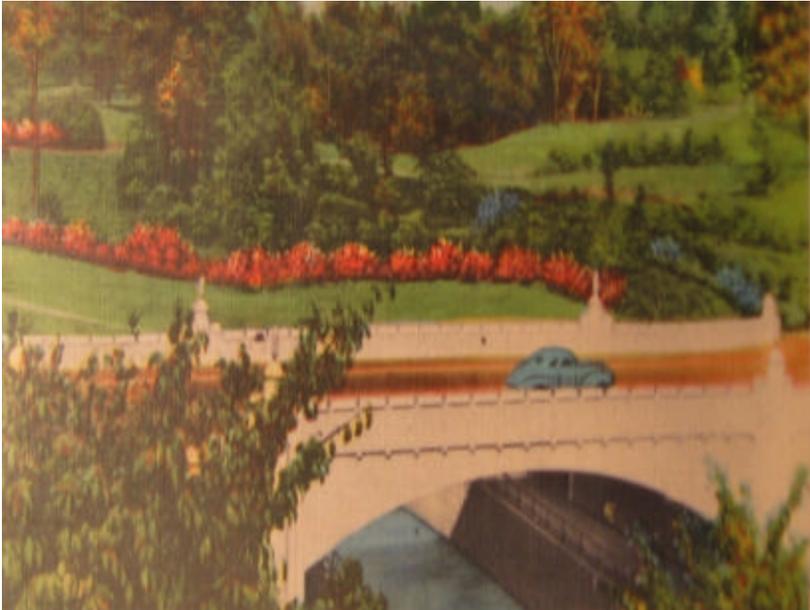
Historic Image 6  
A color post card from the 1930's, illustrating a bird's eye view of the bridge.

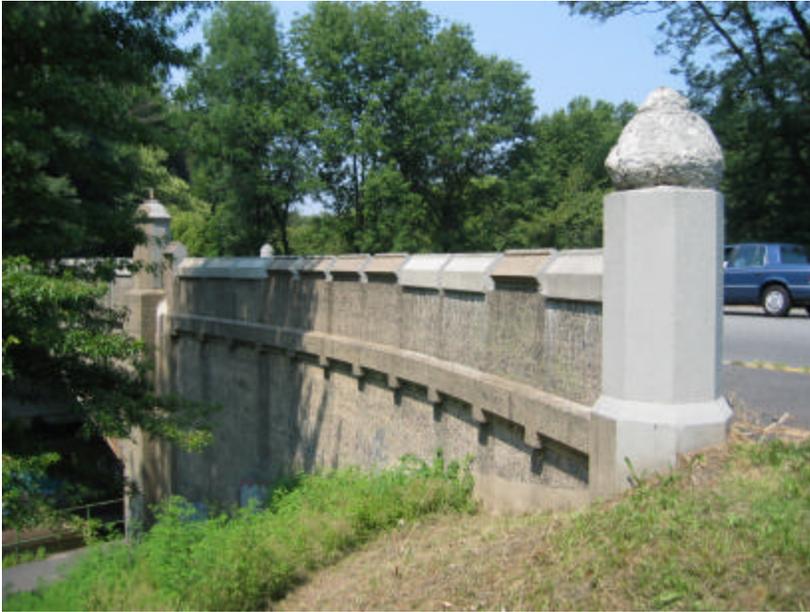
Photo 350  
The wing and parapet wall on the north side of the bridge; note that the top of the post has severely spalled and many of the battlements surmounting the parapet walls have been replaced.

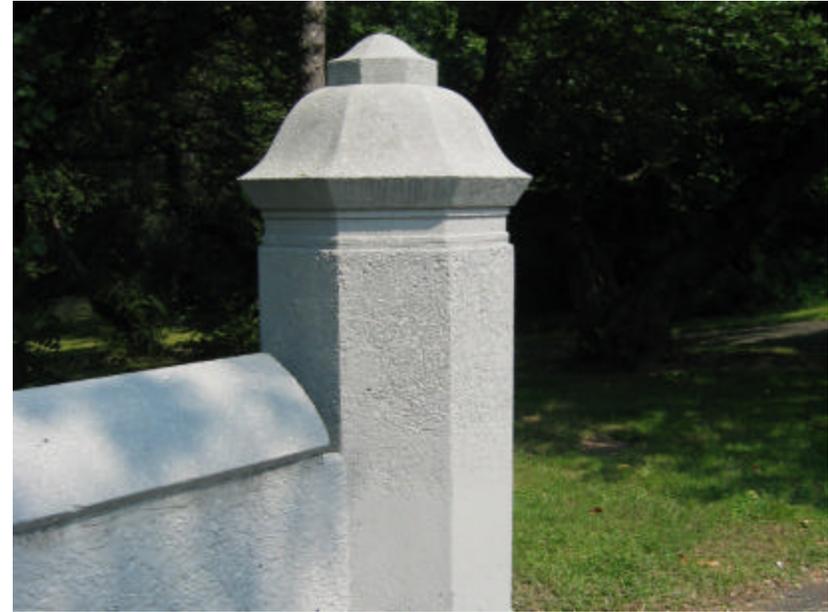
Photo 351  
One of the posts that terminate the parapet wall; note that this post is in good condition and has been painted along with the wall.

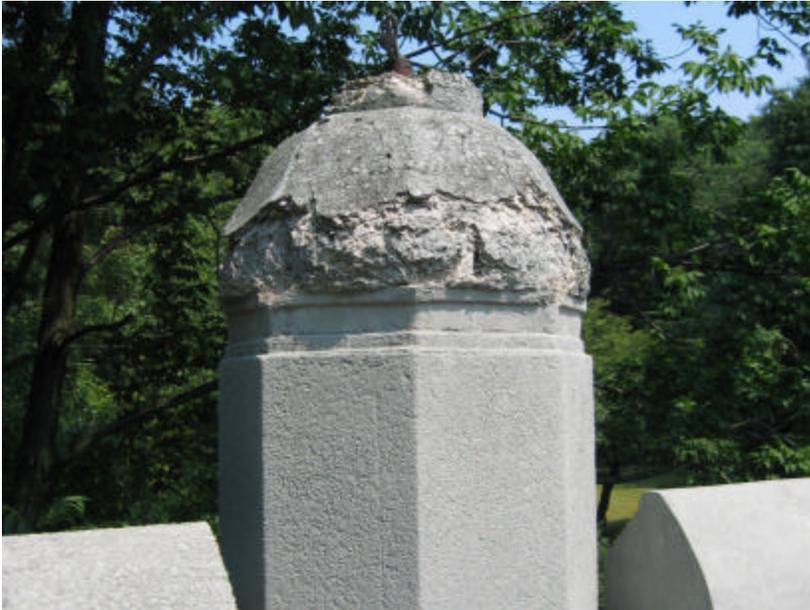
Photo 352  
A lantern base that surmounts one of the buttresses; note the severe spalling.

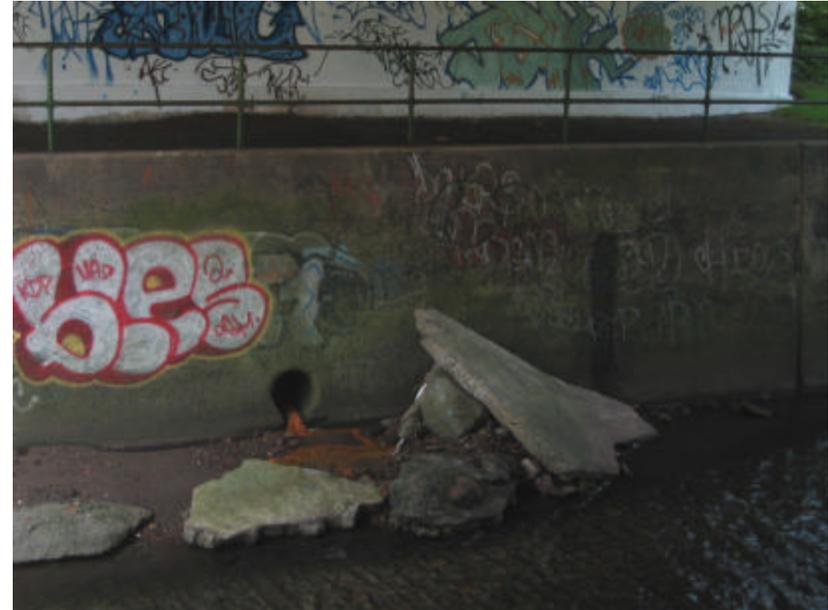
Photo 353  
Large sections of concrete in the river below the bridge; note the significant amount of graffiti covering both walls.

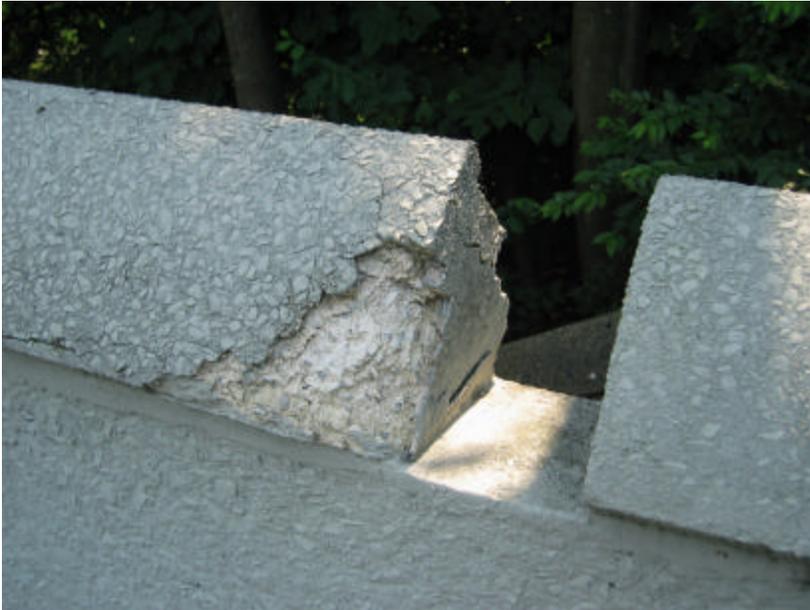
Photo 354  
Severely spalled surface of an original coping.

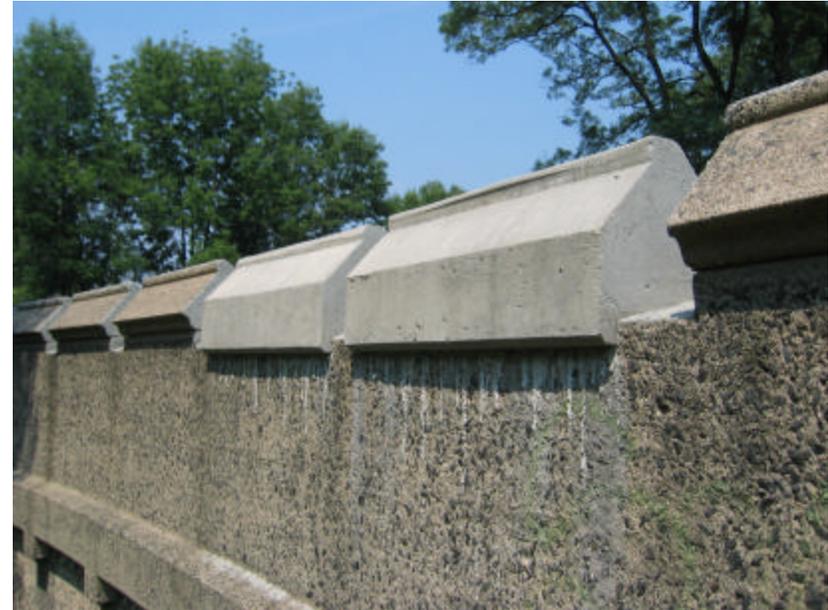
Photo 355  
Two new battlements on top of the parapet wall; note that the quality of workmanship and attention to detail is inferior in the newer battlements.

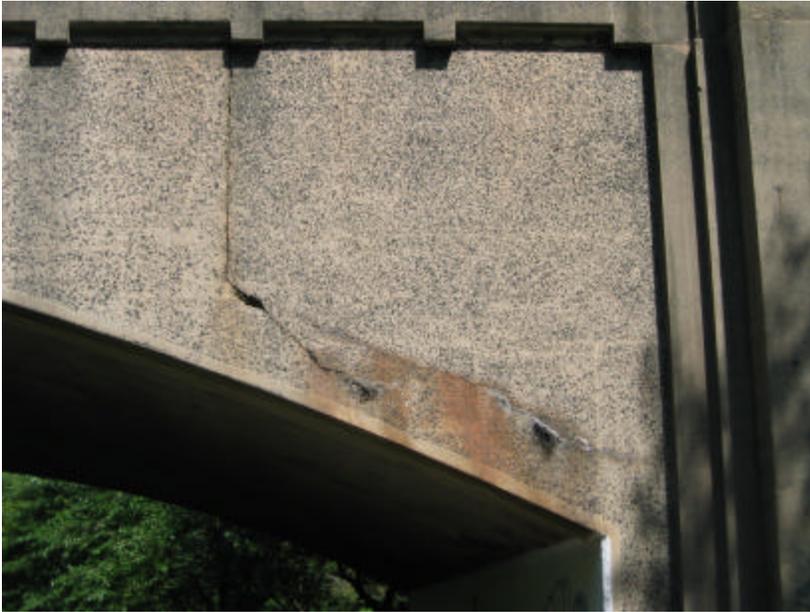
Photo 356  
Cracking along the cold joint in the parapet wall continues through the cheek wall; note the differences in the concrete finishes between the wall and the buttress.

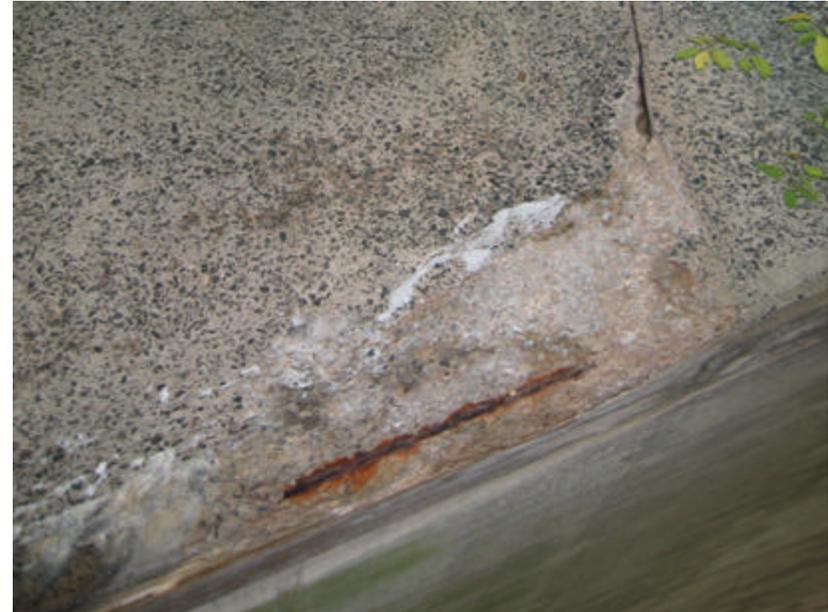
Photo 357  
Cracking and spalling where the arch meets the vertical face of the west cheek wall; note the exposed and rusting steel reinforcing.

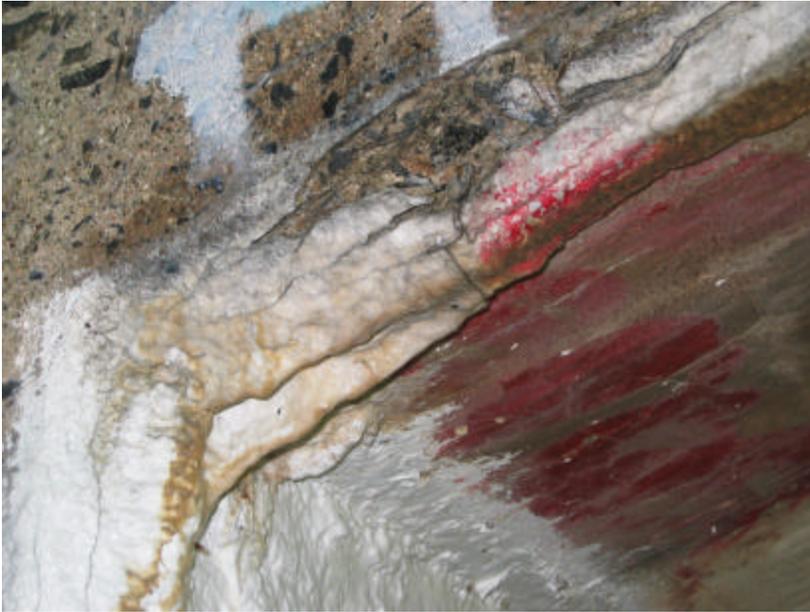
Photo 358  
Mineral deposits formed by de-icing and other soluble salts carried by water migration from the road and sidewalk surfaces.

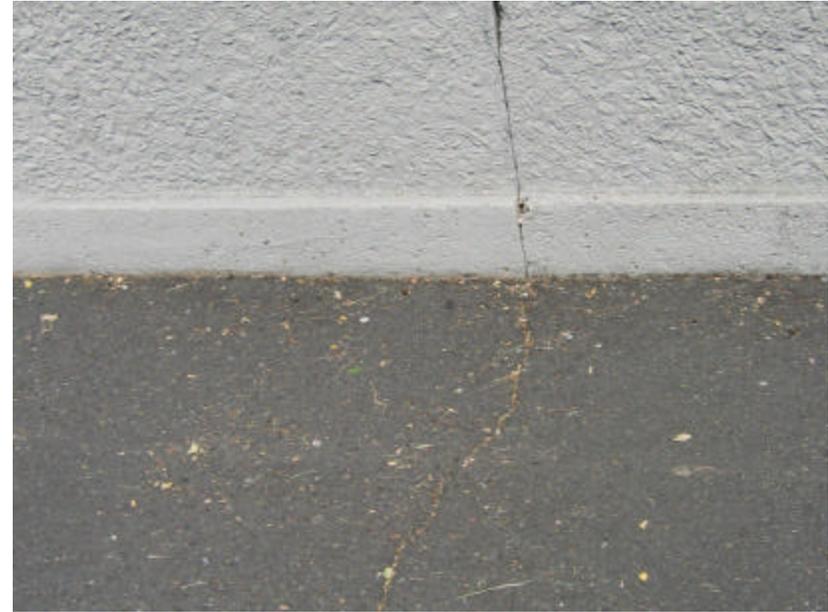
Photo 359  
This crack continues from the parapet wall to the sidewalk.

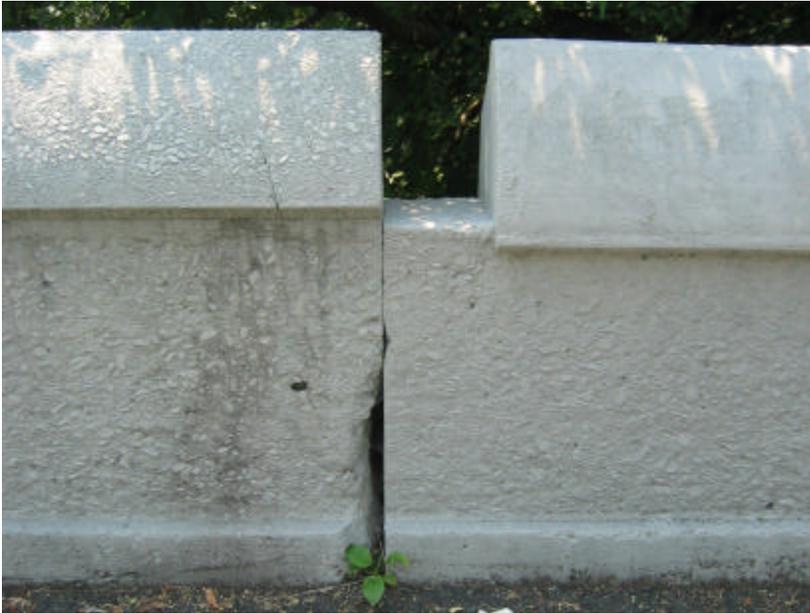
Photo 360  
This crack is directly across the street in the same location.

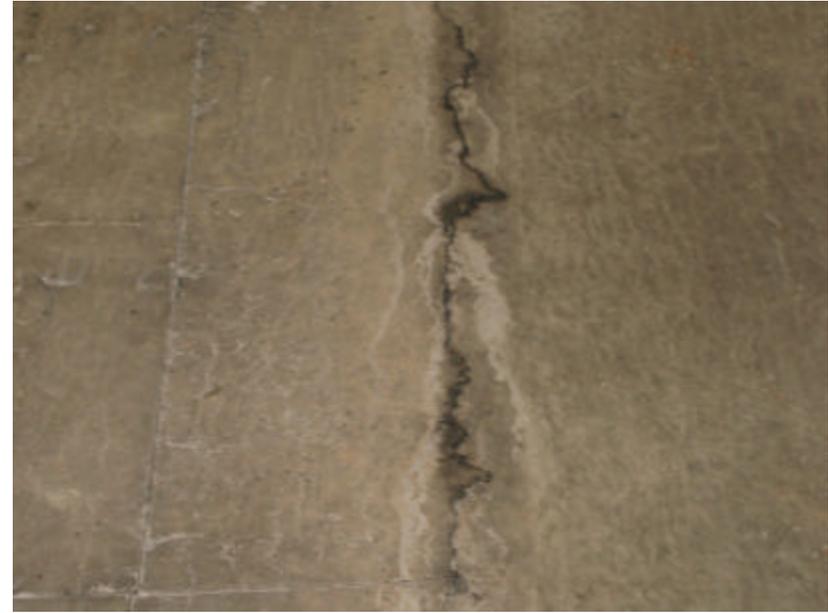
Photo 361  
Cracking on the surface of the arch; note the soiling and water staining.

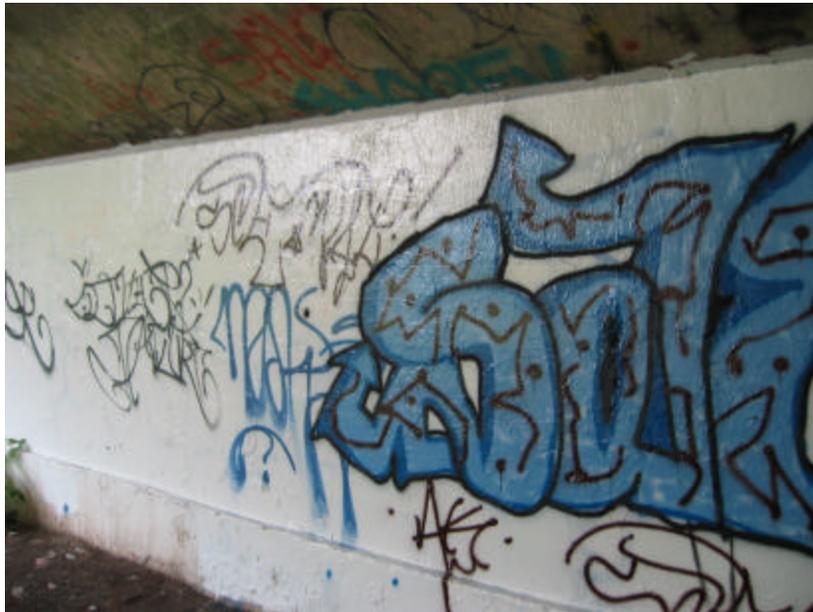
Photo 362  
A painted wall covered with graffiti on the south side of the bridge.

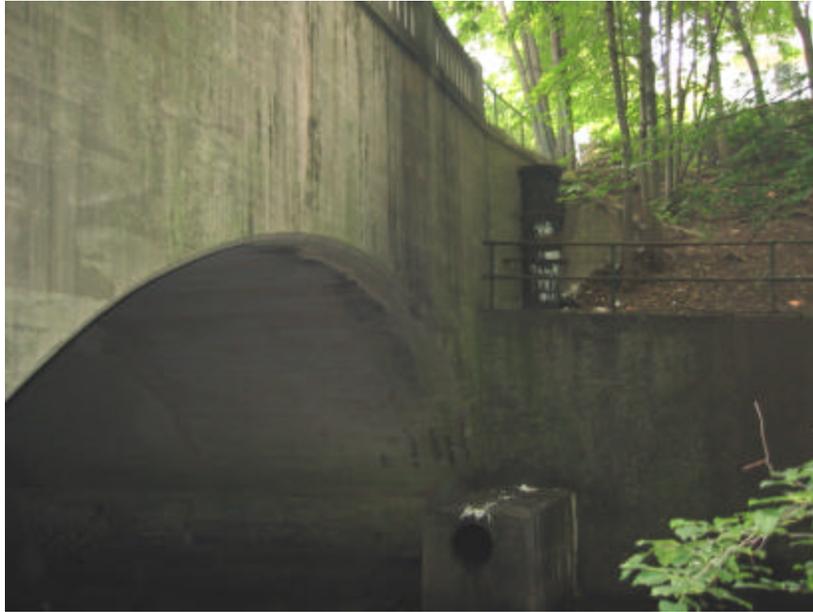
Photo 365  
View of the west cheek and wing wall; note the retaining wall, drain pipe and steel pipe railing.

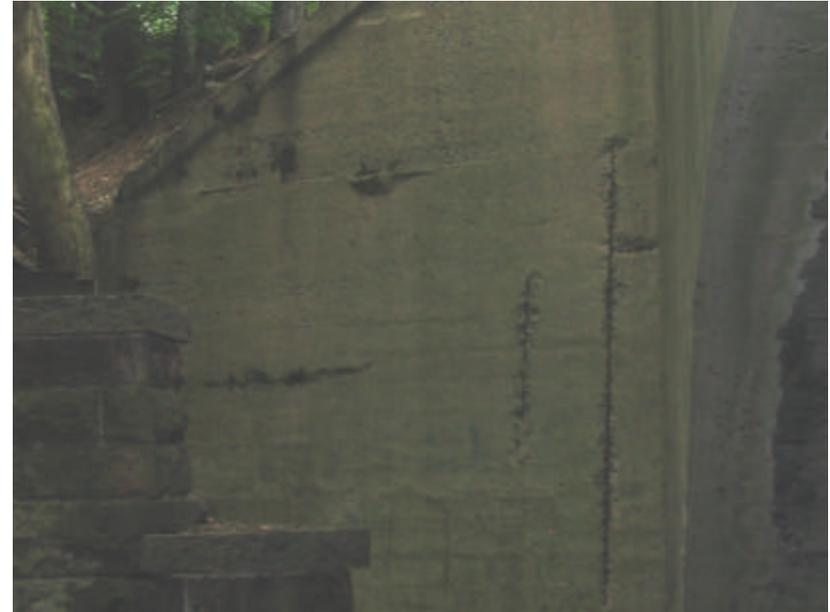
Photo 366  
Severe spalling on the southeast wing wall.

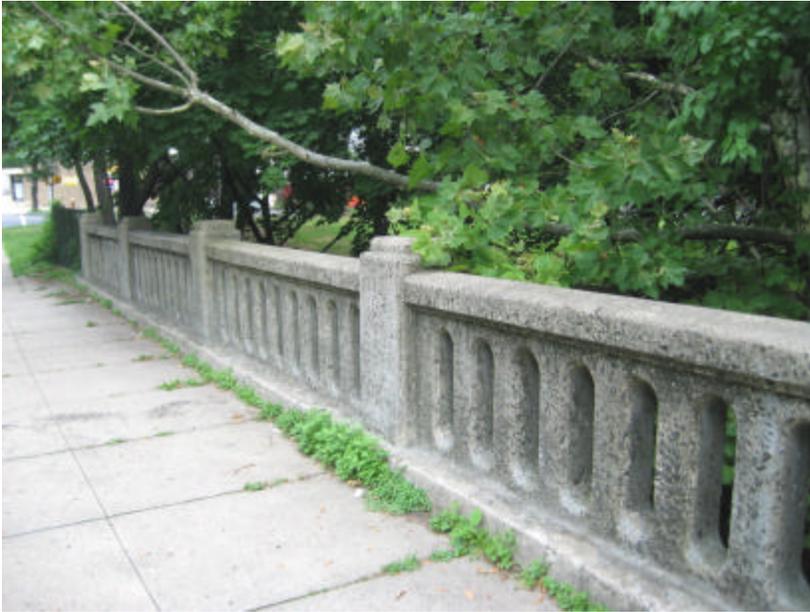
Photo 367  
The east parapet railing; note that it is in good condition overall but does have some areas of severe spalling and cracking.

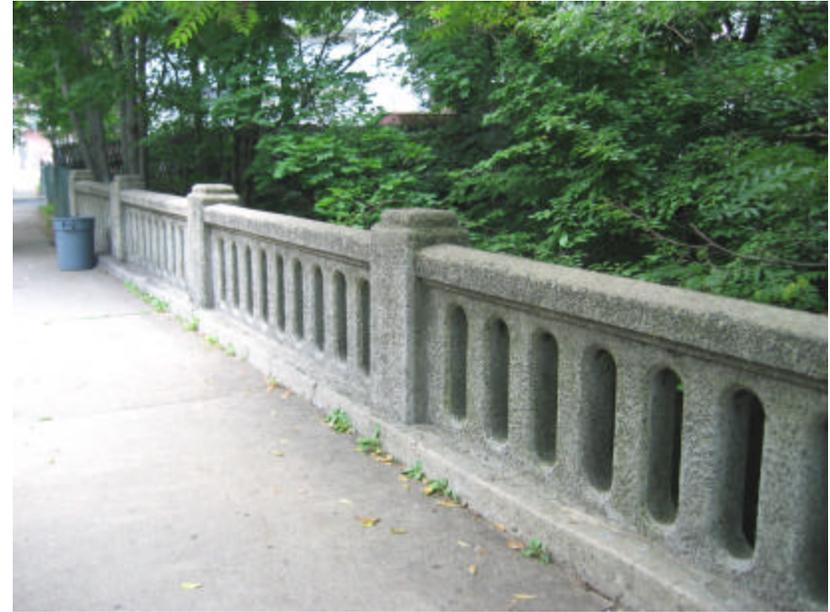
Photo 368  
The west parapet railing; note that it is in good condition overall but it has suffered weathering, which has exposed the concrete aggregate.

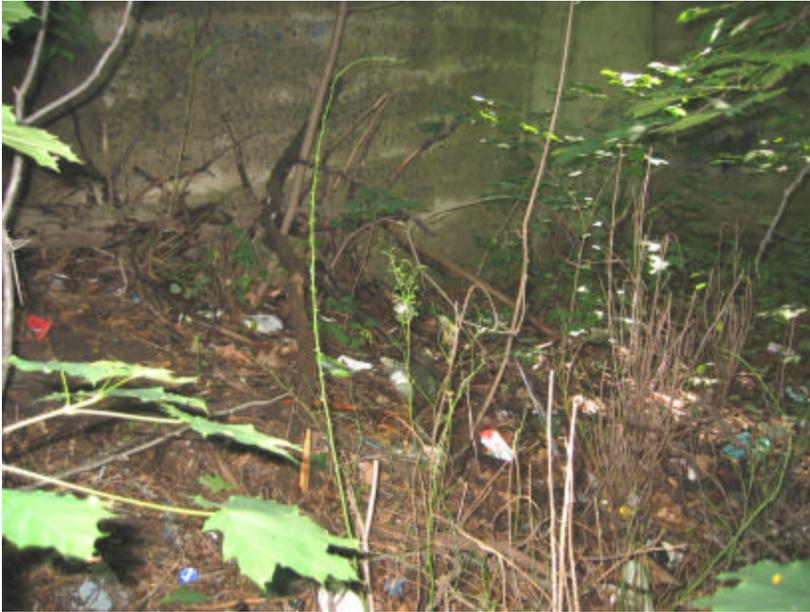
Photo 369  
Embankments on the northwest side of the bridge; note the weeds and debris that are typical on all sides of the bridge.

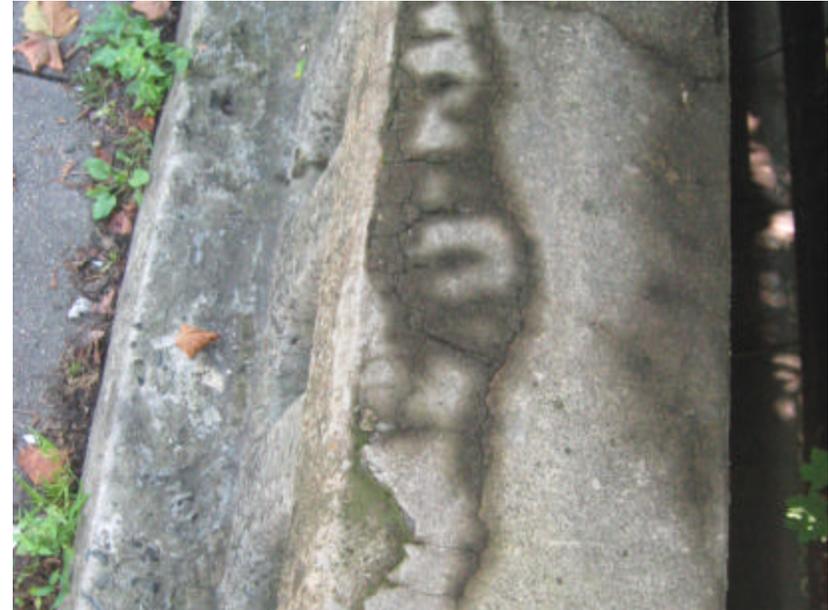
Photo 372  
View looking down at cracking and spalling concrete on top of the railing; note that the cracks have absorbed a significant amount of moisture.

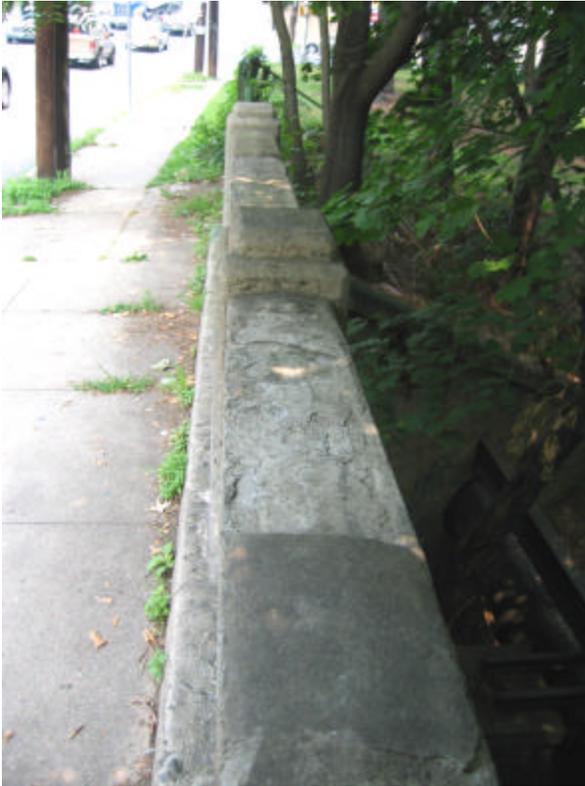
Photo 373  
An area of severe spalling and missing concrete on top of the east railing; note the grass and weeds growing from cracks in the sidewalk.

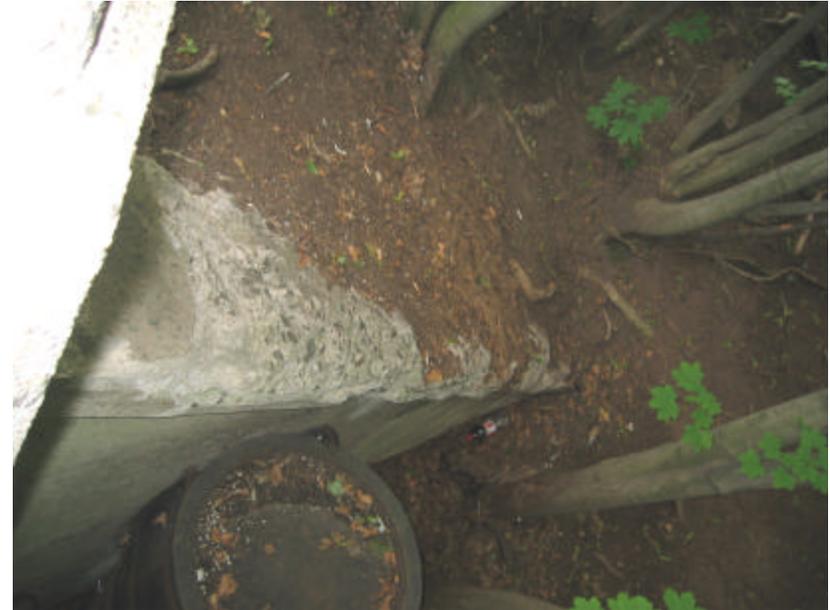
Photo 374  
Severe spalling on the southwest wing wall; note the erosion around the site and the steel barrels at the bottom of the photo.

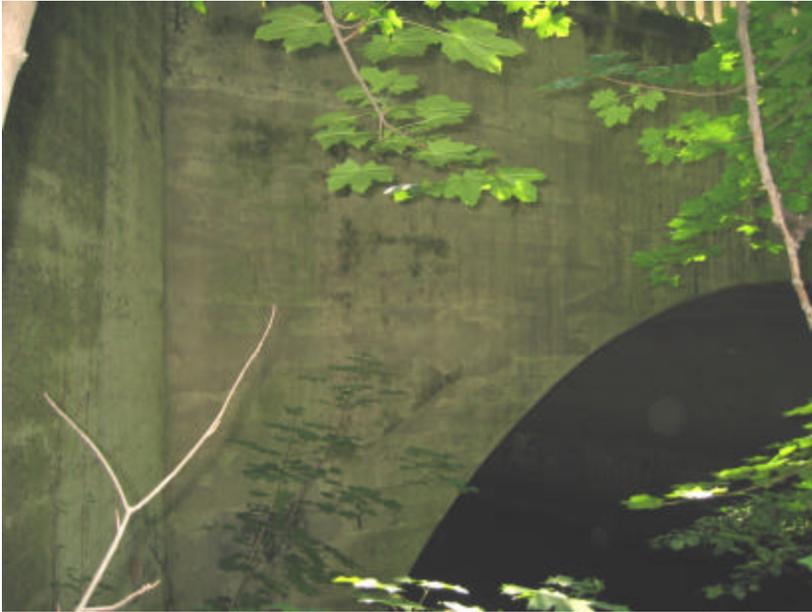
Photo 375  
The west cheek and wing walls are in good condition overall; note that there are areas of spalling and organic growth.
