## 37. FOOTBRIDGE 1931

### INTRODUCTION

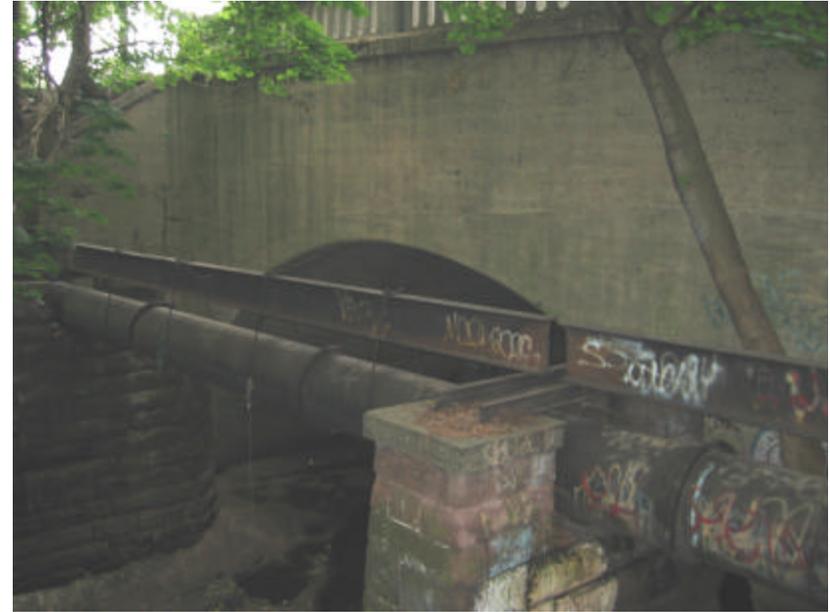
Photo 376  
The east cheek and wing walls are in good condition overall; note the pipe crossing the Second River directly east of the bridge.

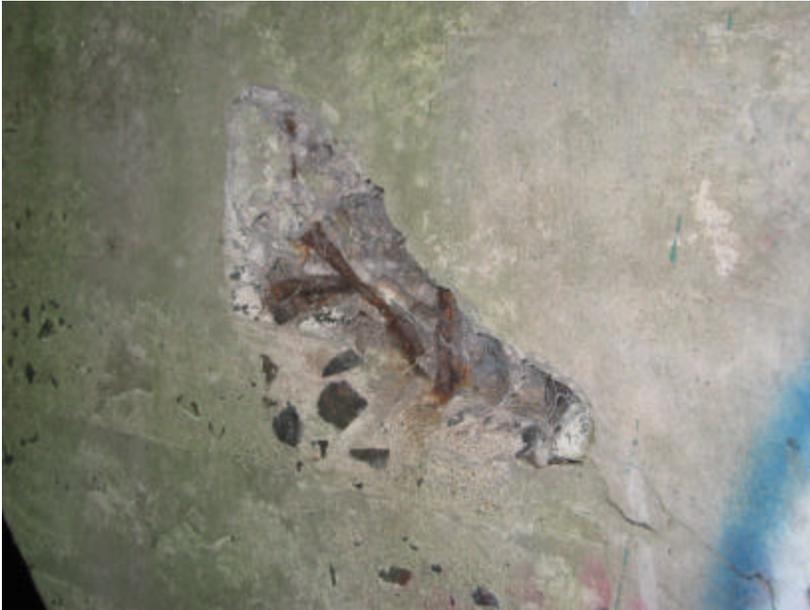
Photo 377  
An area of spalling and cracking on the northwest wing wall; note the exposed and rusting steel reinforcing.

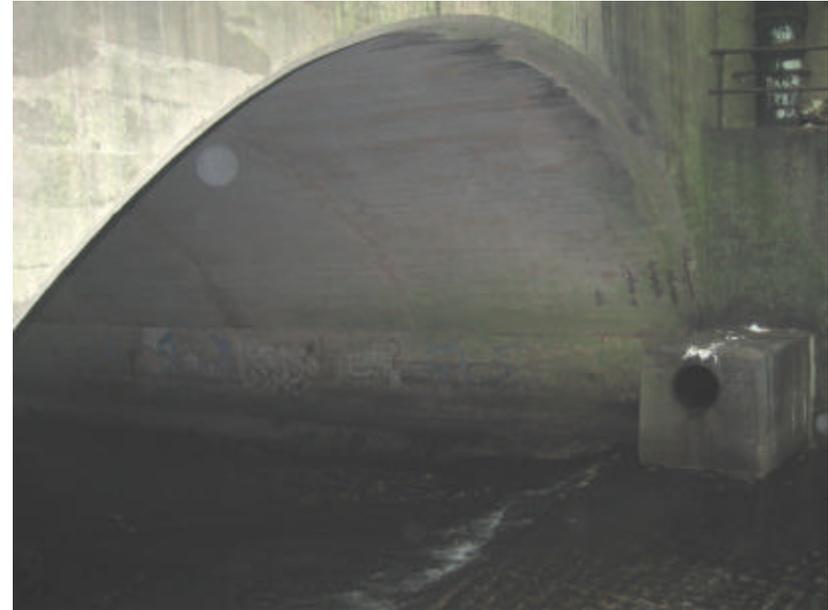
Photo 378  
View of the bridge's archway; note the soiling, graffiti and organic growth

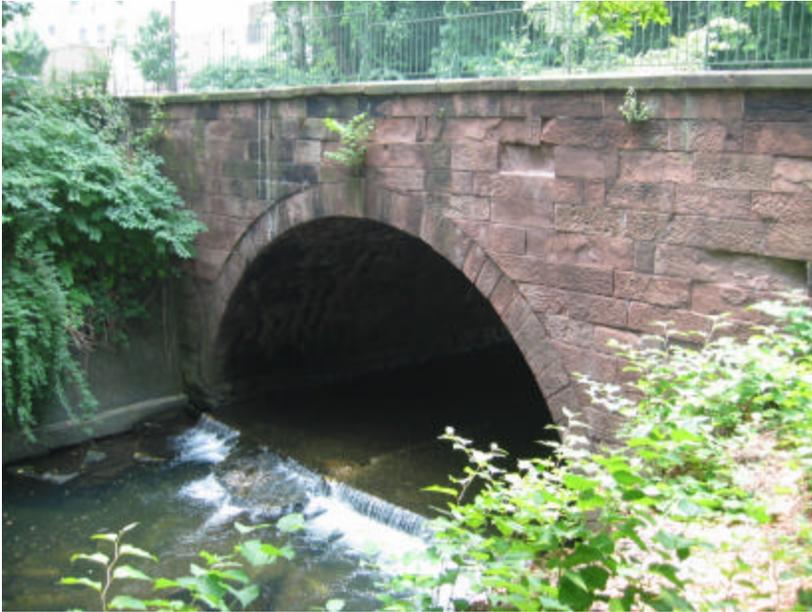
Photo 381  
View looking west towards the Summer Avenue Bridge; note the spalled and deteriorated surface of the brownstone.

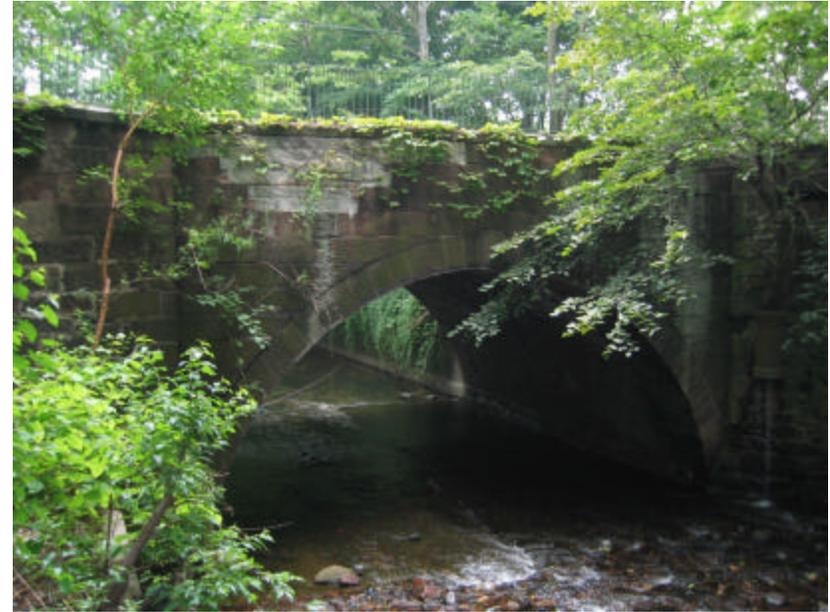
Photo 382  
View looking east towards the Summer Avenue Bridge; note the significant amount of plant growth and the area of brick patching covered with white mortar.

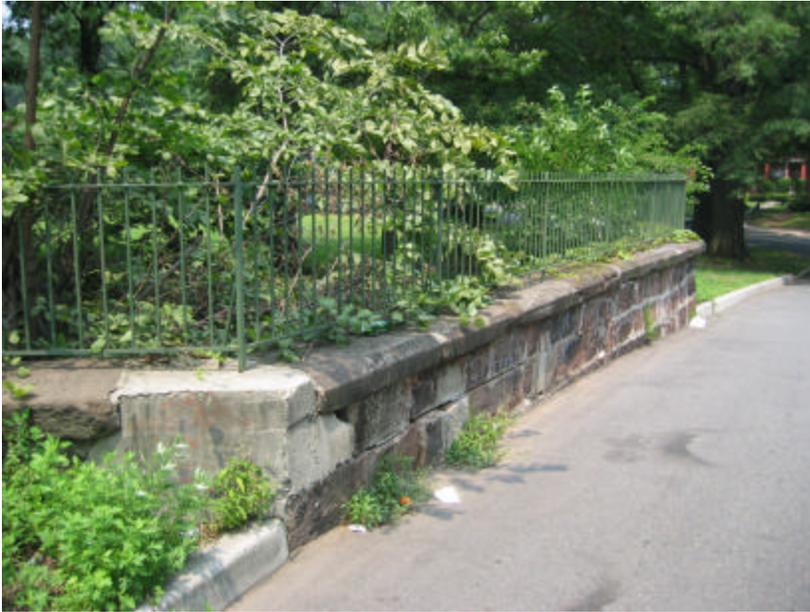
Photo 383  
The parapet wall and metal fence atop the cheek wall; note the poor condition of the brownstone and the section of concrete patching.

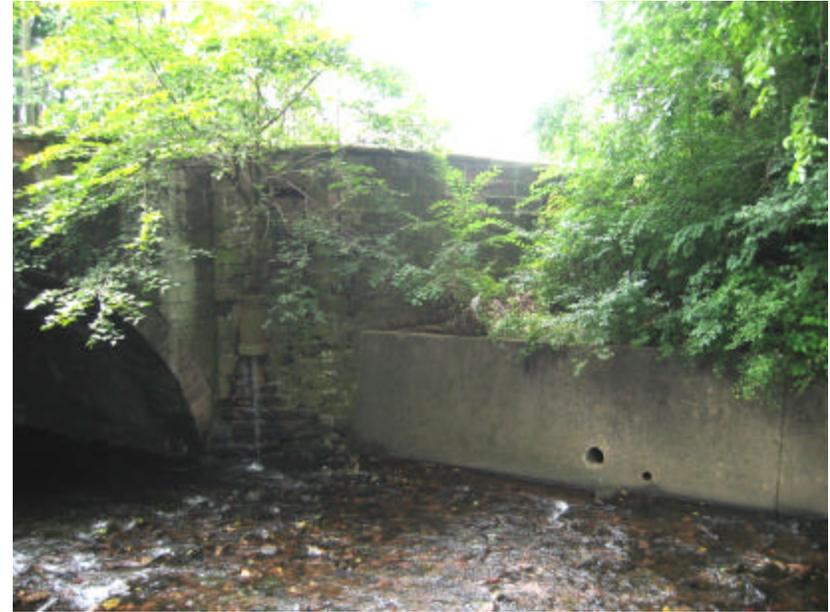
Photo 384  
View southeast towards the bridge; note the significant amount of plant growth, including a tree growing from the wing wall.

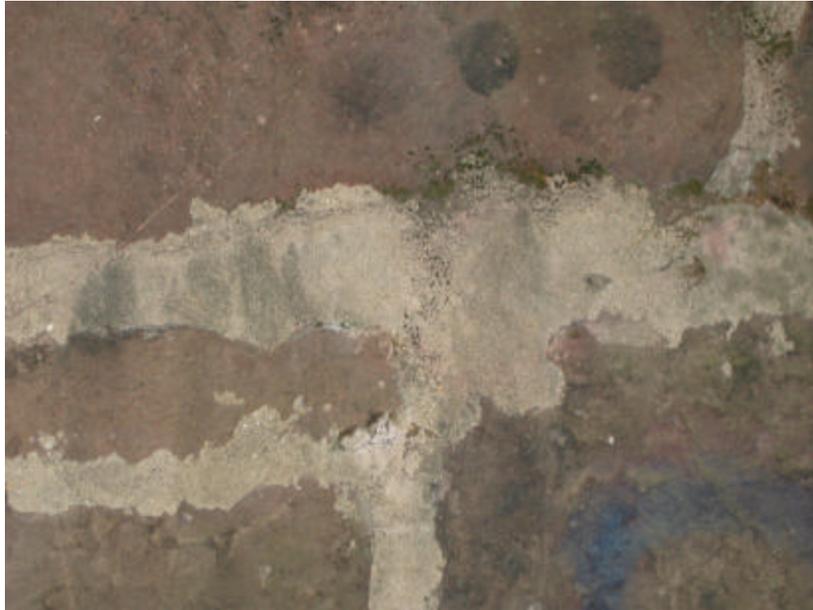
Photo 387  
Substantially widened mortar joints caused by remedial patching of masonry on the west cheek wall.

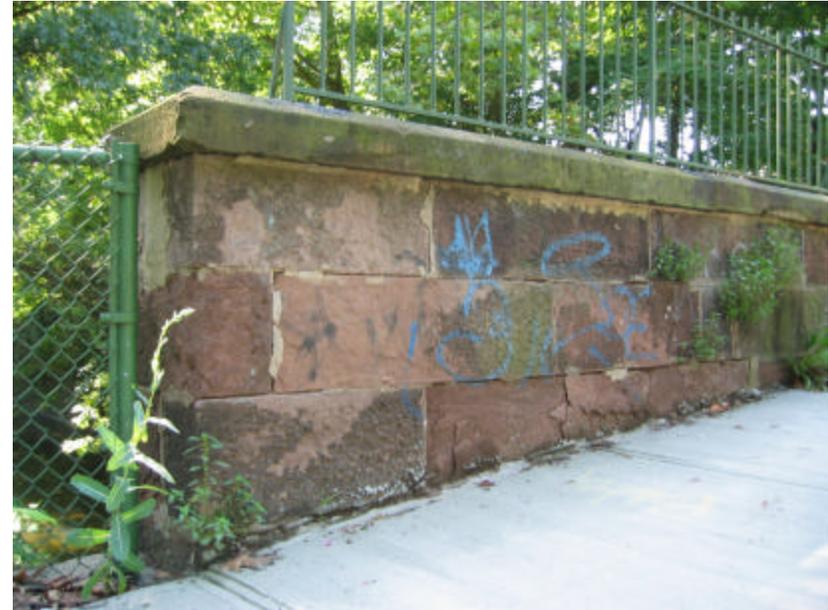
Photo 389  
The north end of the east parapet wall; note the change in grade from left to right. Also note the severely spalled brownstone surfaces and graffiti.

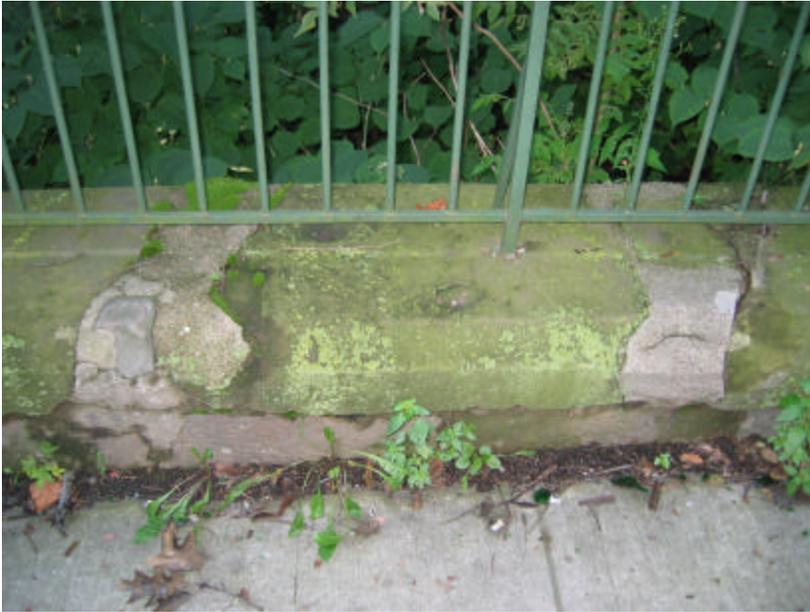
Photo 389  
Remedial patching of copingstones with concrete; note that organic growth has discolored the stone surface, turning it green.

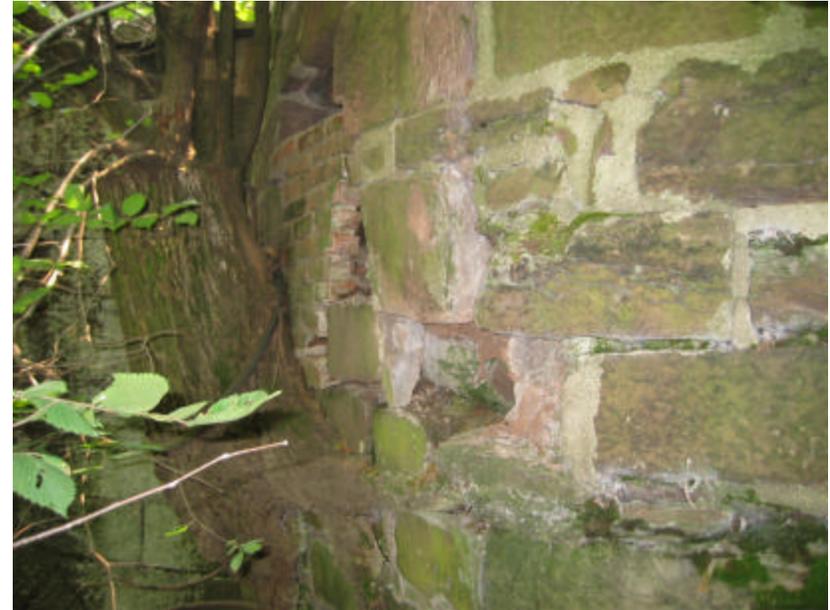
Photo 396  
The tree and its roots have caused significant damage to the wall; note the cracked and displaced masonry and the remedial brick patching.

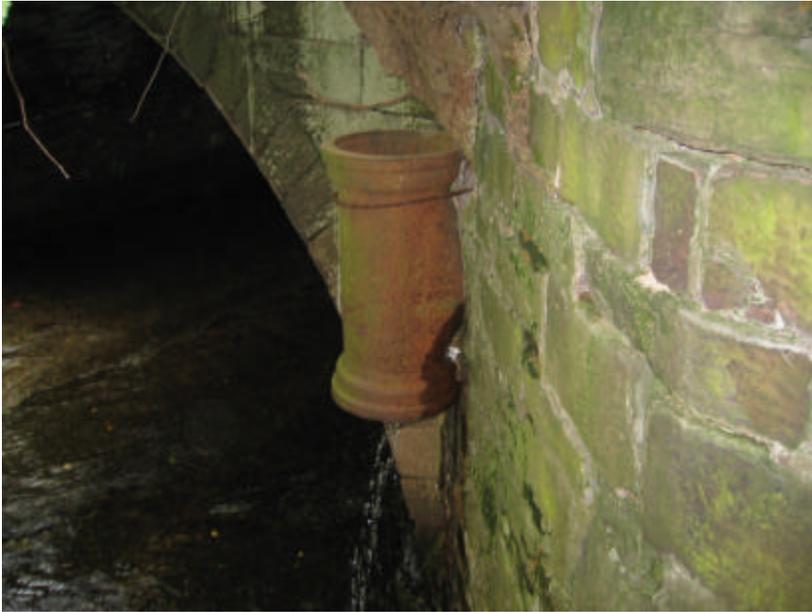
Photo 397  
The iron pipe in the wall; note the water coming out the bottom of the pipe.

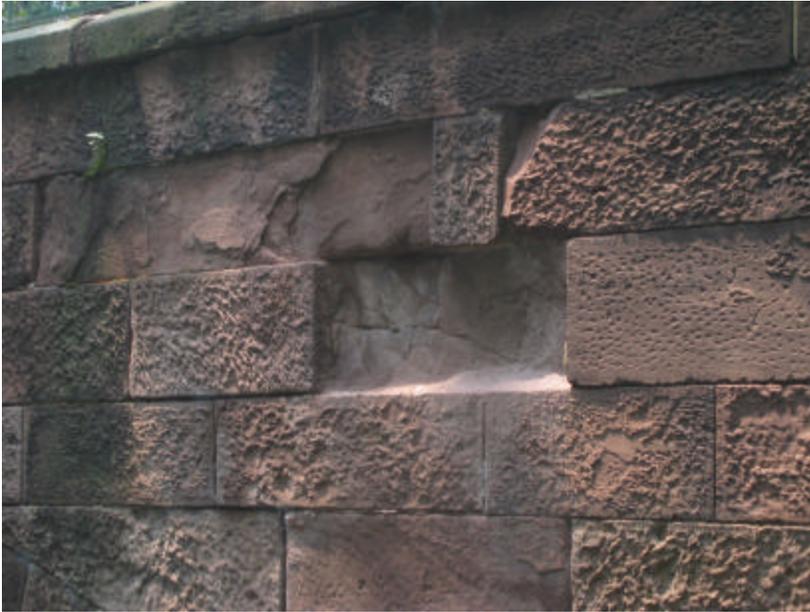
Photo 399  
Severely spalling and delaminating brownstone; note that the once well-dressed surface is now weathered and worn.

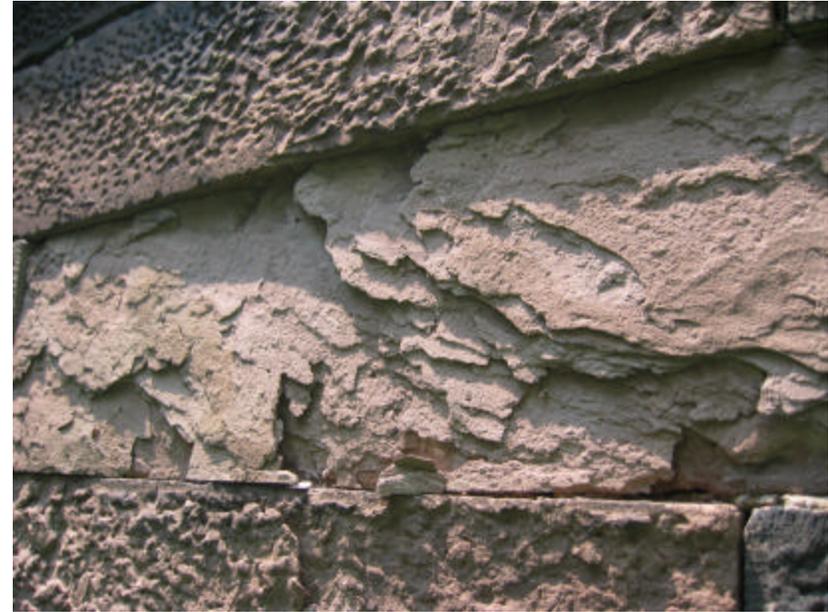
Photo 400  
Brownstone delaminating along the bedding plane; note that the mortar has completely eroded from the joints.

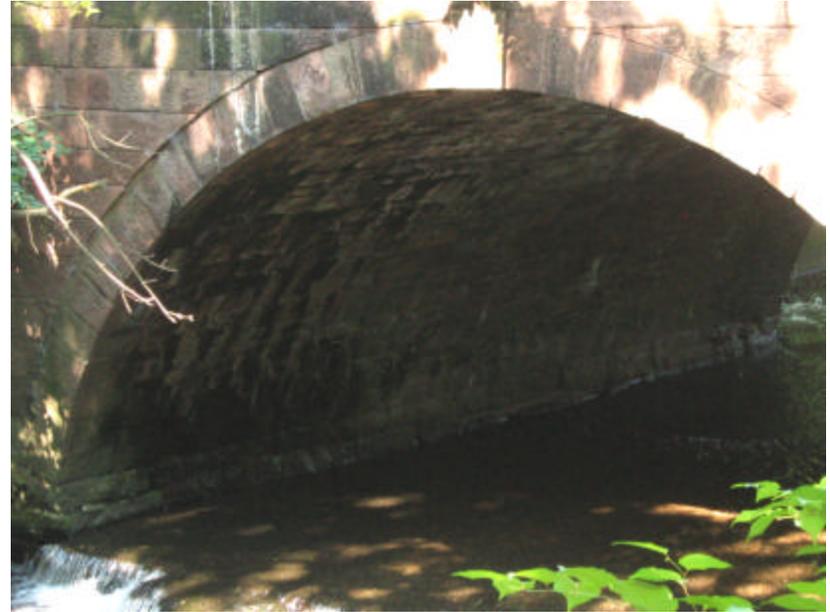
Photo 403  
Visible staining and soiling of the archway caused by organic growth and efflorescence from water penetration.

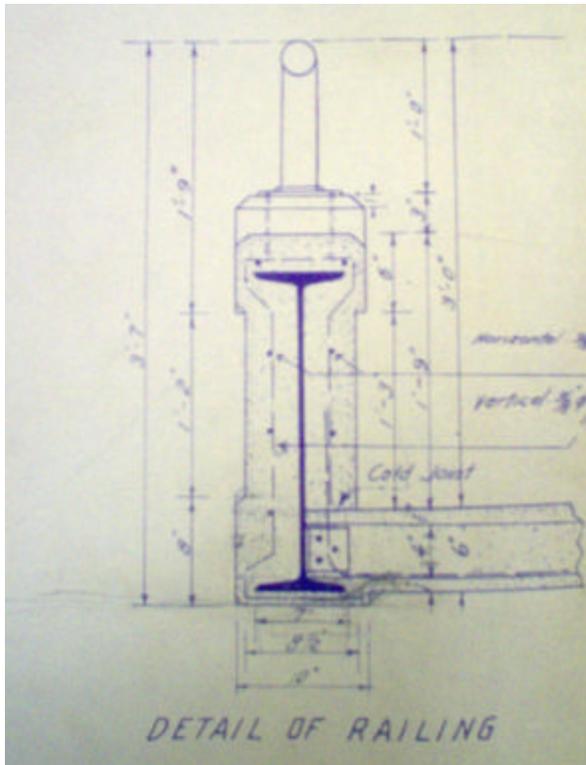
Original Drawing 33  
This blueprint from an original drawing illustrates a rail detail.

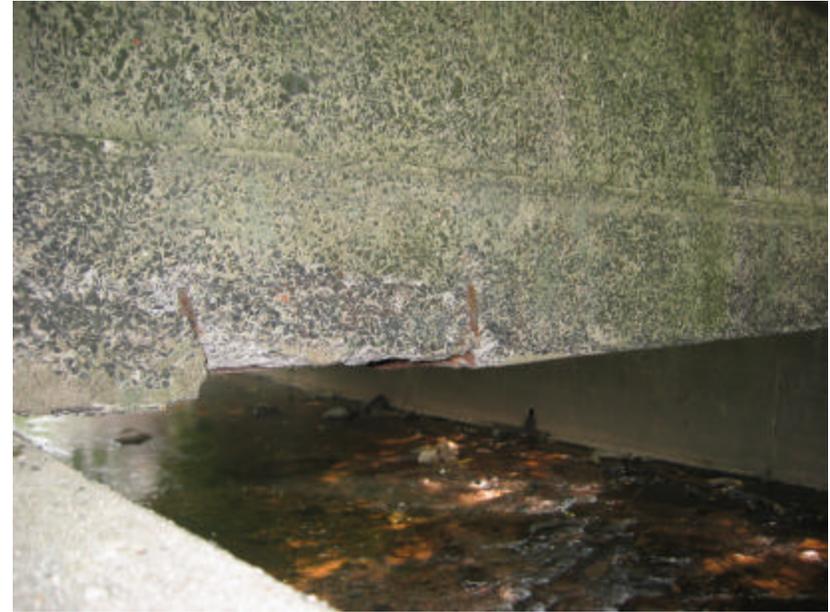
Photo 406  
An area of spalling on the base of the bridge.

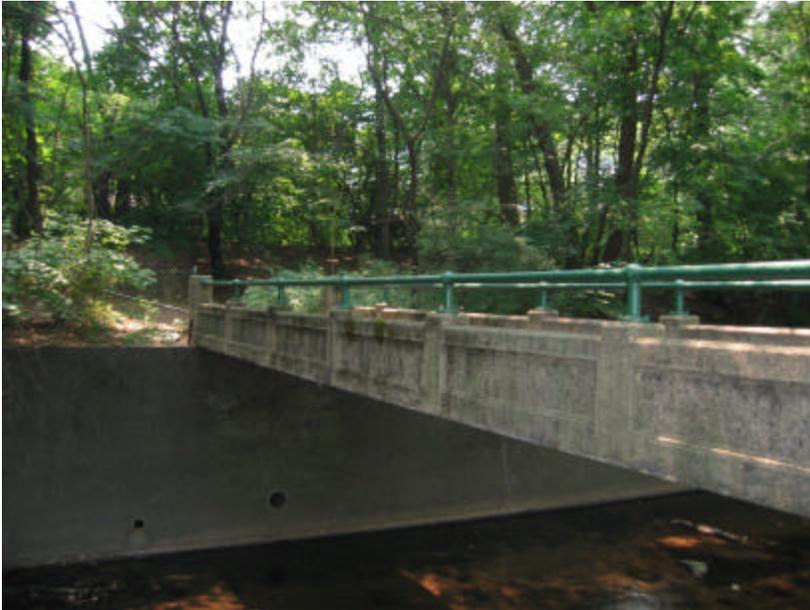
Photo 407  
View southwest over the footbridge; note the organic growth and staining on the surface of the bridge.

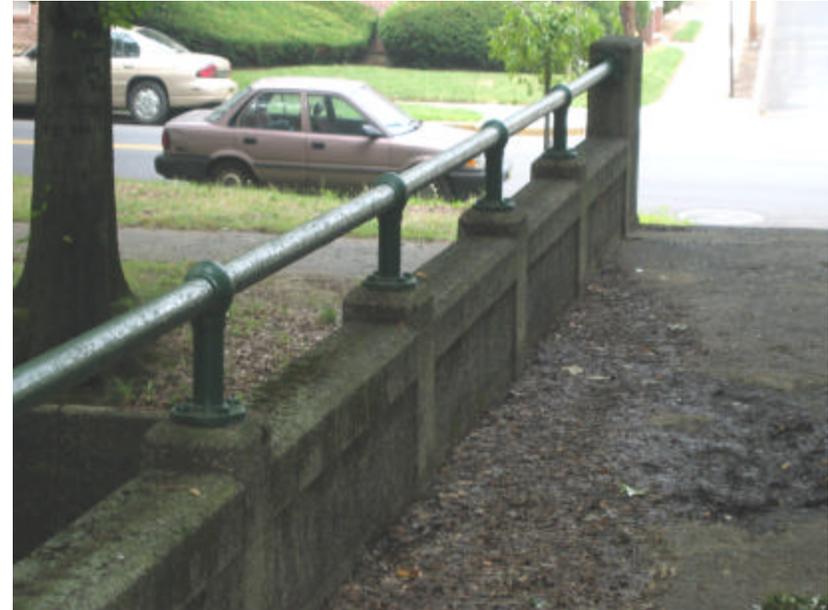
Photo 408  
View north towards Mill and Dow Streets, looking over the bridge's deck and railing; note the dirt, leaves and organic growth covering the bridge surfaces.

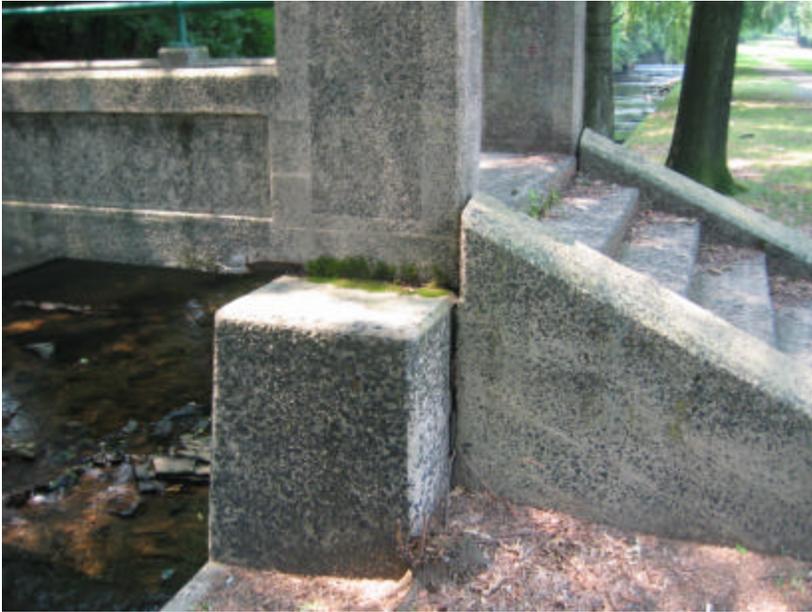
Photo 409  
Spalling and organic growth at the base of the bridge's deck directly below the post at the north end of the bridge.

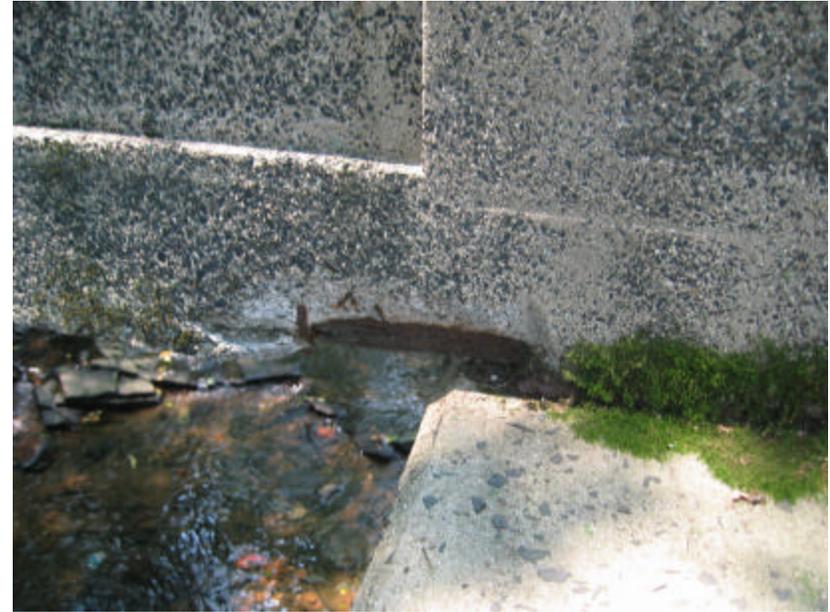
Photo 410  
A detail of the spalling and organic growth at the north end of the bridge.

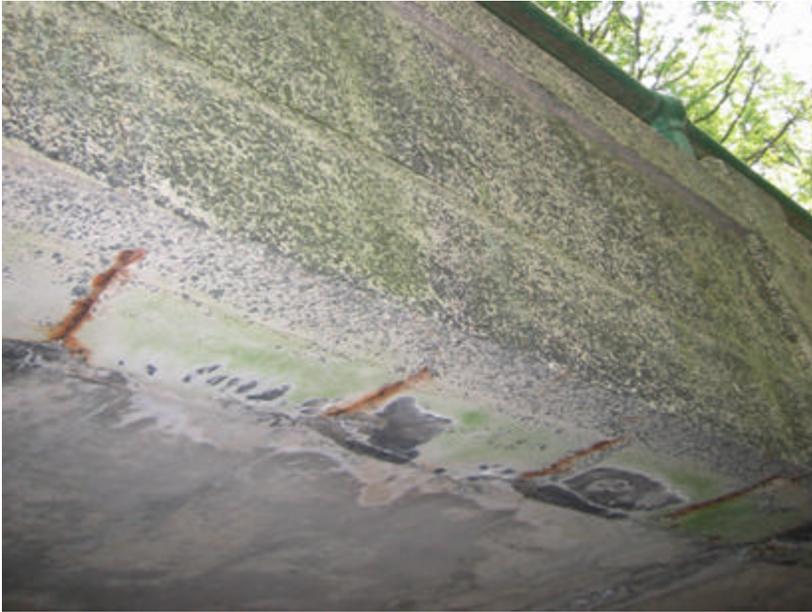
Photo 411  
View looking up at the bottom of the bridge; note the areas of rust and water staining.

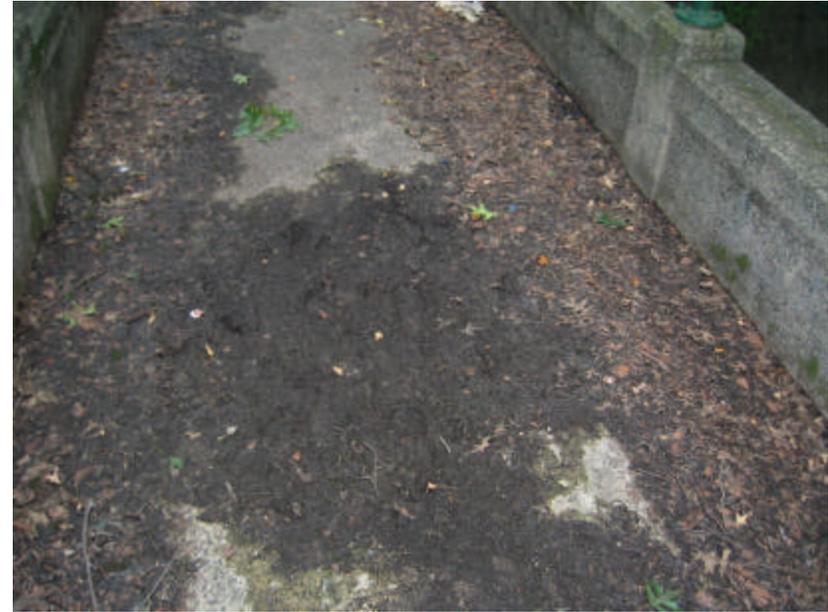
Photo 412  
Leaves and mud covering the bridge's deck; note that this debris covers a large area of spalling concrete.

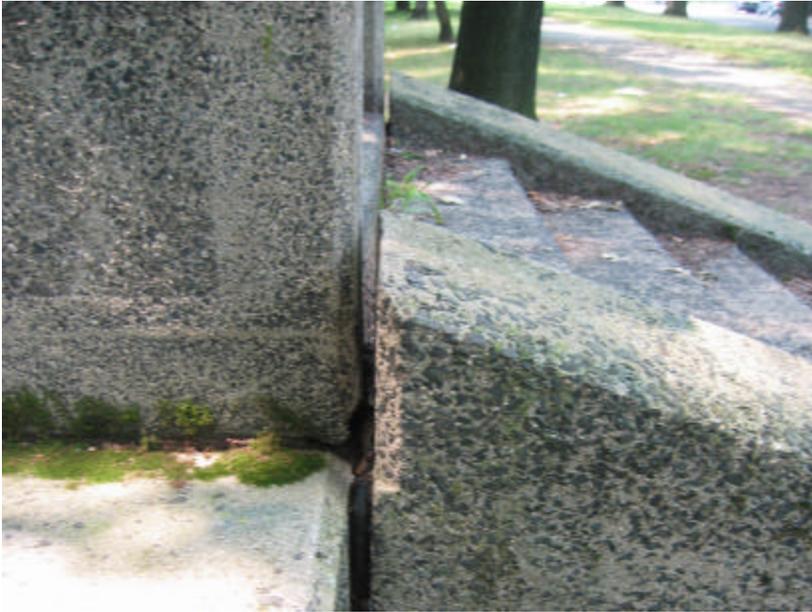
Photo 413  
Open and exposed joints at the north end of the bridge.

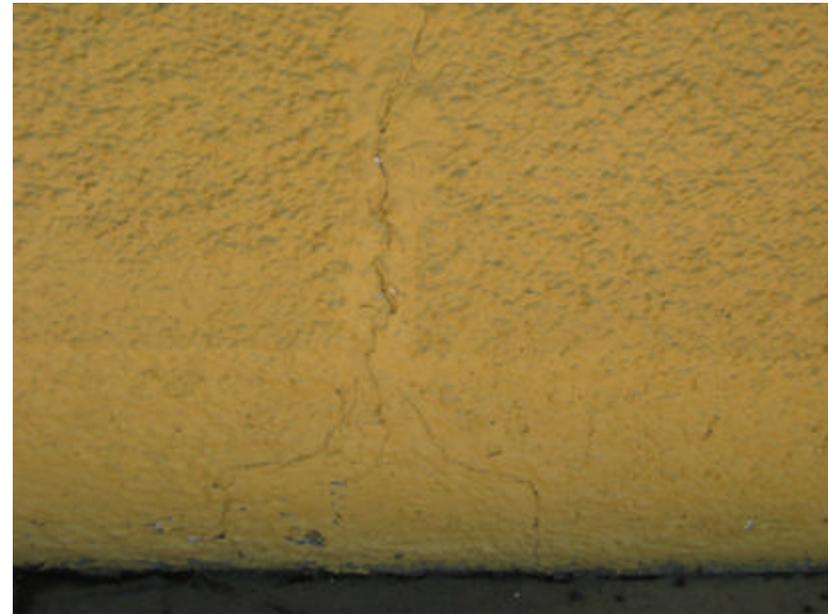
Photo 415  
Cracked stucco on the southwest wall; note that the crack has been patched and painted.

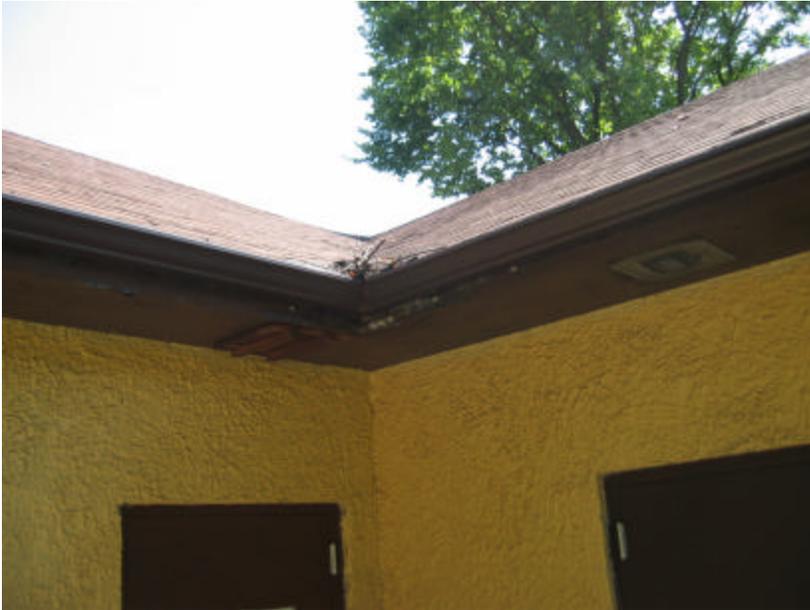
Photo 416  
Rotting and cracked plywood soffit caused by water damage because of debris collecting in the gutter.

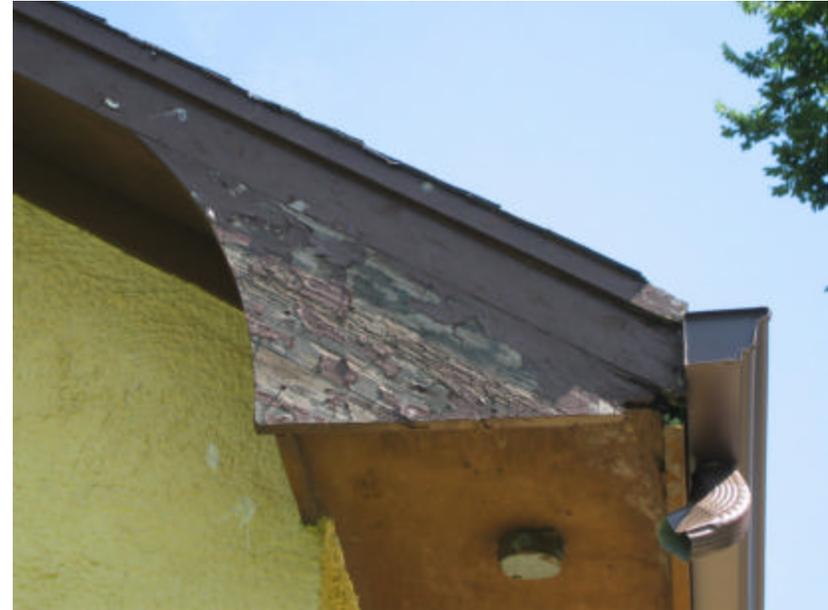
Photo 417  
Cracked and peeling paint on the rake and soffits of the roof; note that the gutter's downspout is missing.

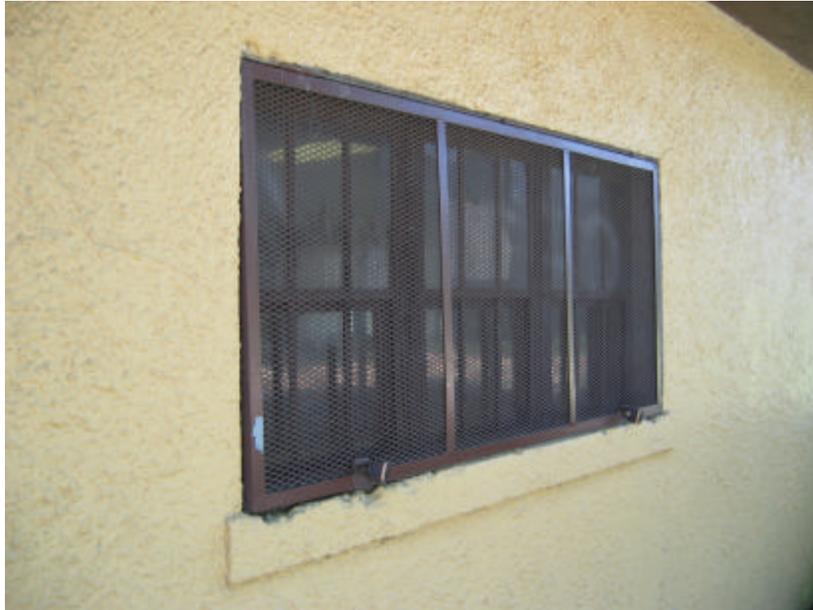
Photo 418  
One of the locked steel screens that covers a steel window.

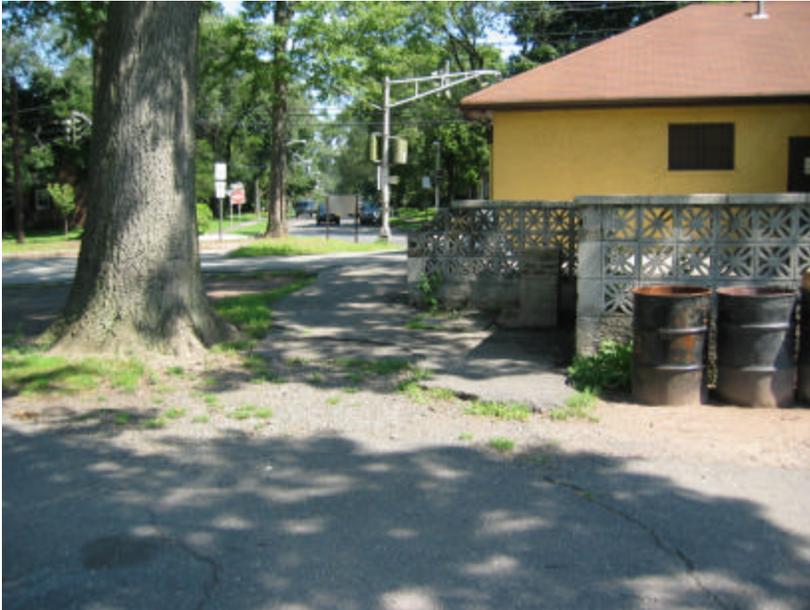
Photo 420  
View north towards Belleville Avenue; note the buckled and cracked asphalt paving.

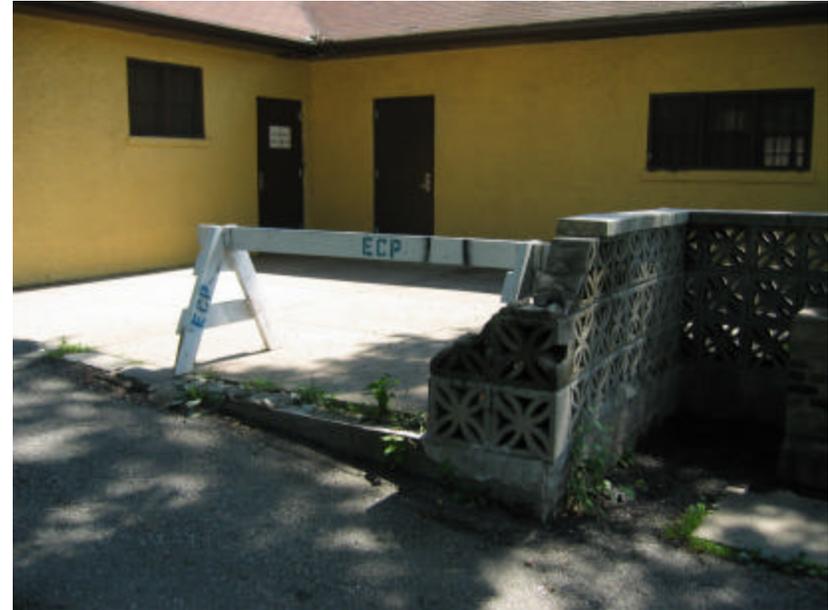
Photo 421  
Area of the damaged concrete block wall west of the building.

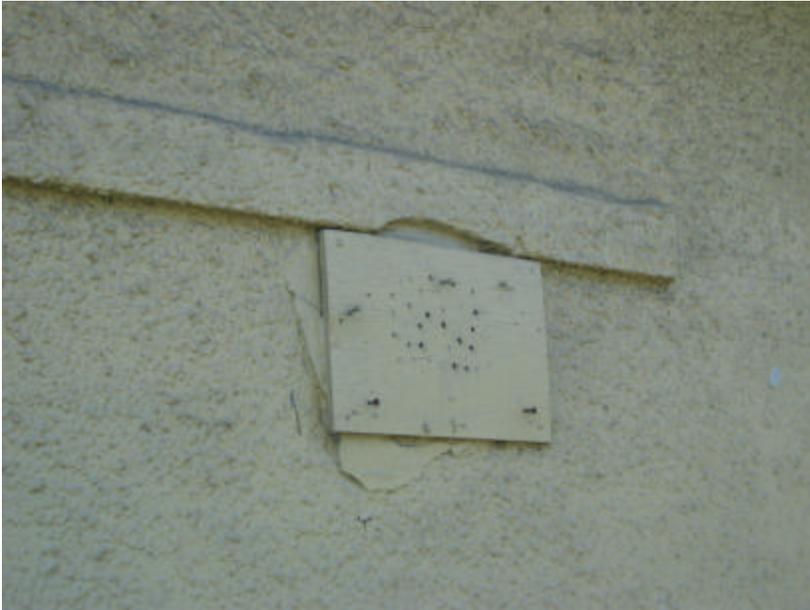
Photo 422  
Plywood covering a hole in the wall below one of the original windows.

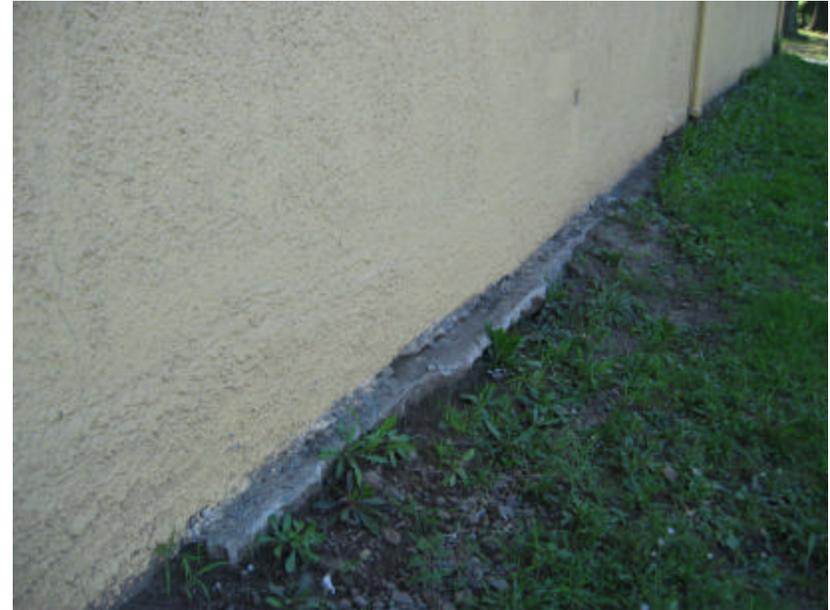
Photo 423  
A section of the exposed foundation on the building's north side; note the eroded soil.

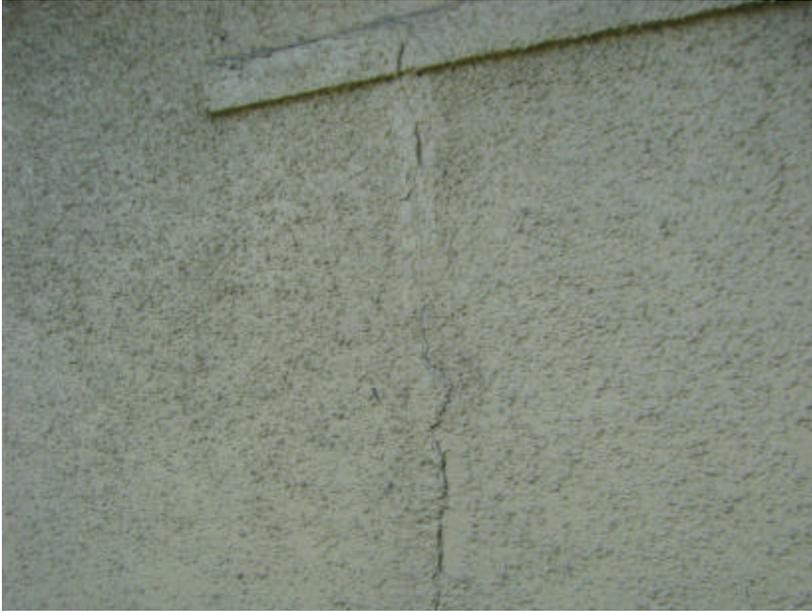
Photo 424  
Cracking on the north wall that has been poorly patched and painted.

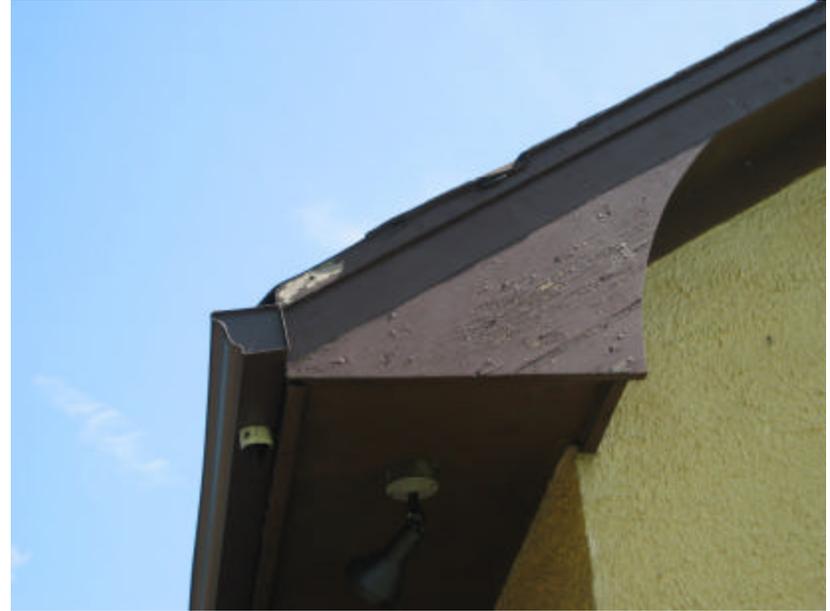
Photo 425  
Cracked and peeling paint along the rake of the roof and eaves.

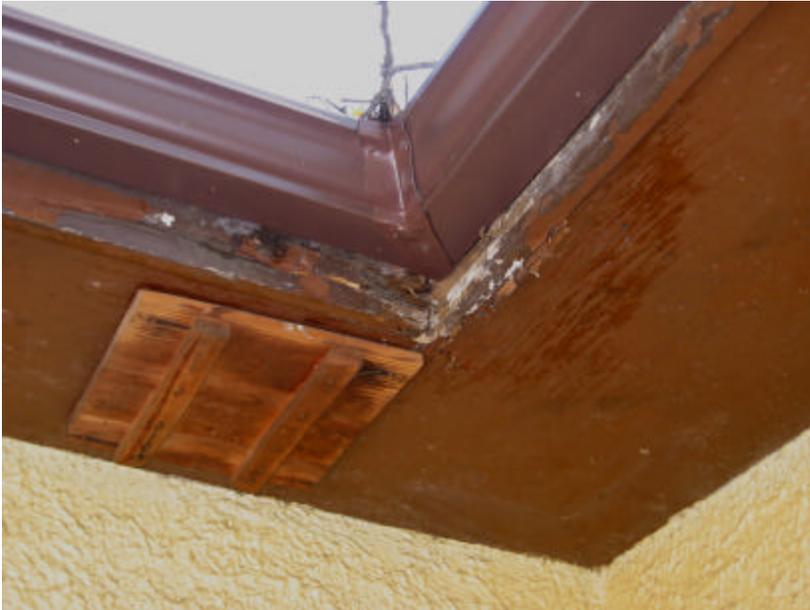
Photo 426  
Rotted wood and peeling paint on the eaves; note that a section of the soffit has been patched with plywood.

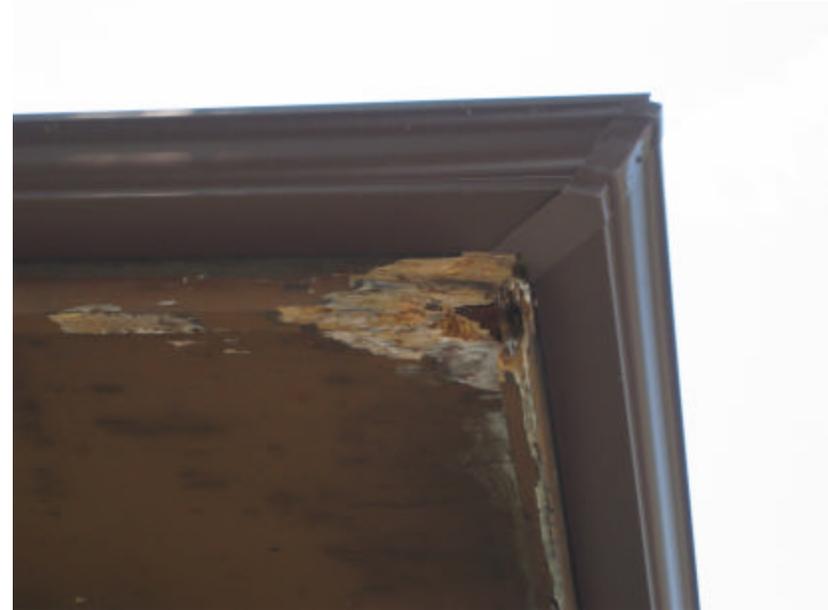
Photo 427  
Rotted wood and peeling paint on the soffit; note that the water damage on the soffits of this building usually occurs at the corners.

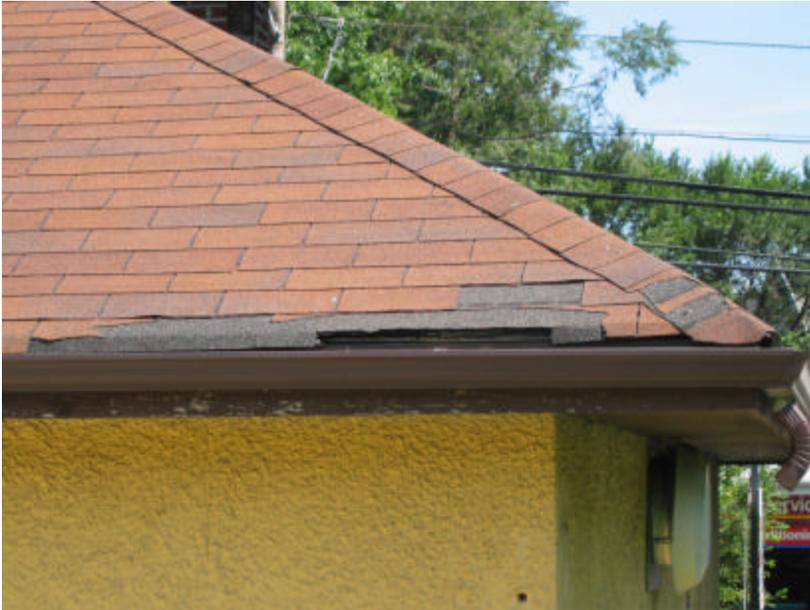
Photo 428  
Some missing asphalt shingles on the west side of the building; note that the shingles hang down into the gutter.

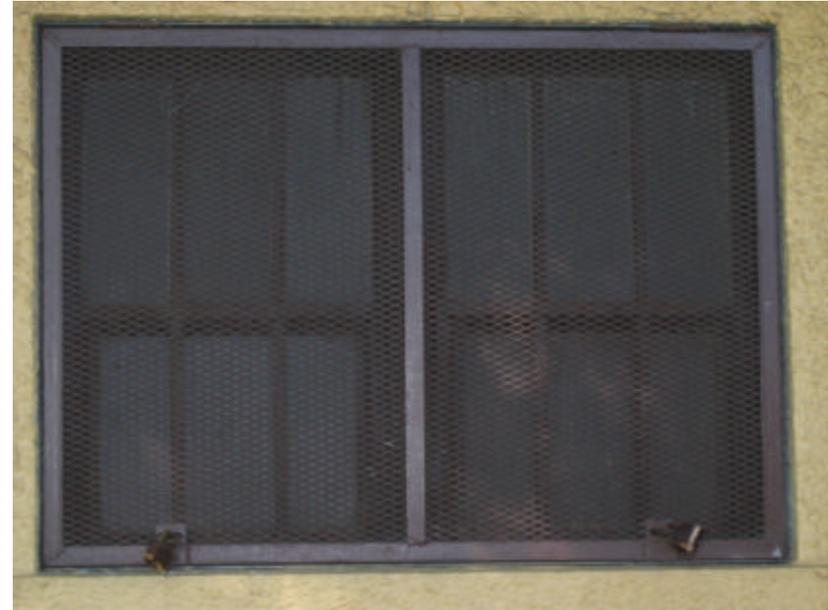
Photo 429  
One of the smaller steel windows; note that the stucco around this window is in good condition.

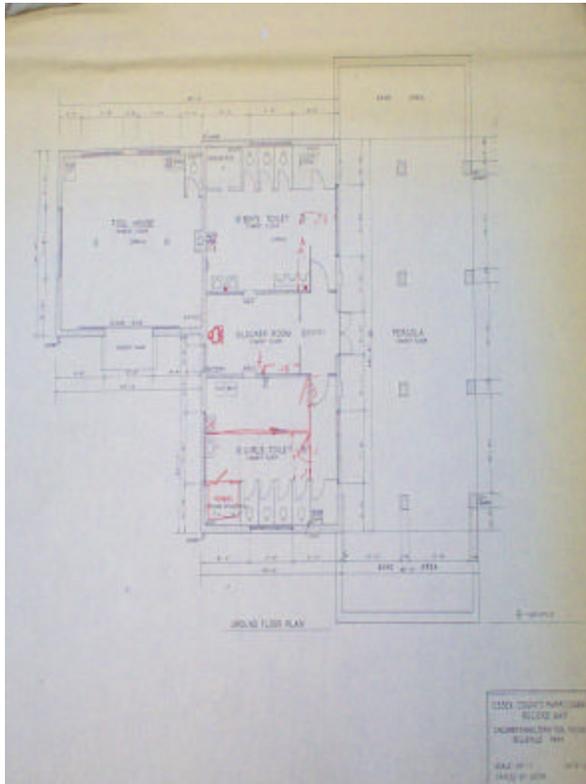
- 9.1 Patch existing historic stucco with restoration mortar to match historic conditions.
- 9.1 Provide new paint over stucco to match historic paint colors, based on scientific sampling and archival research.
- 9.2 Provide stain to match existing on all existing and new exposed wood members.
- 9.3 Clean all stucco, including the removal of all organic growth.

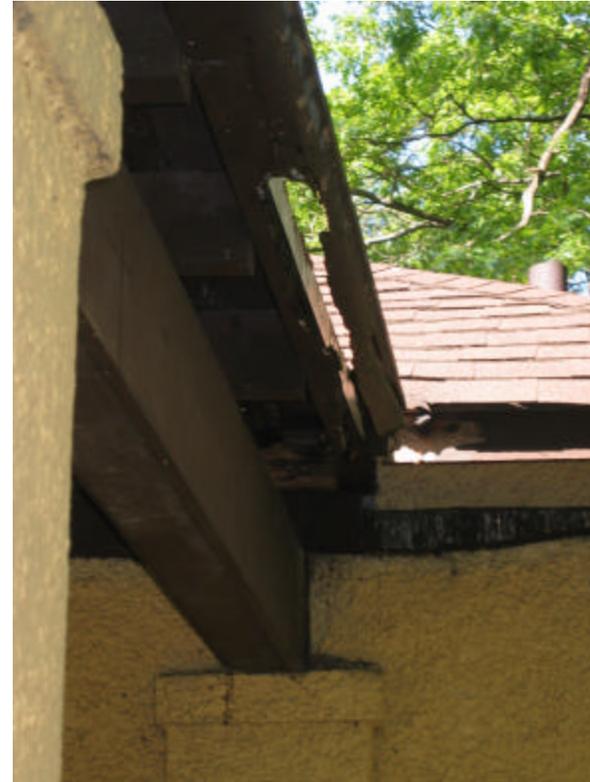
Photo 432  
One of the severely rotted wood gutters on the east side of the veranda; note the water damage to the sheathing.

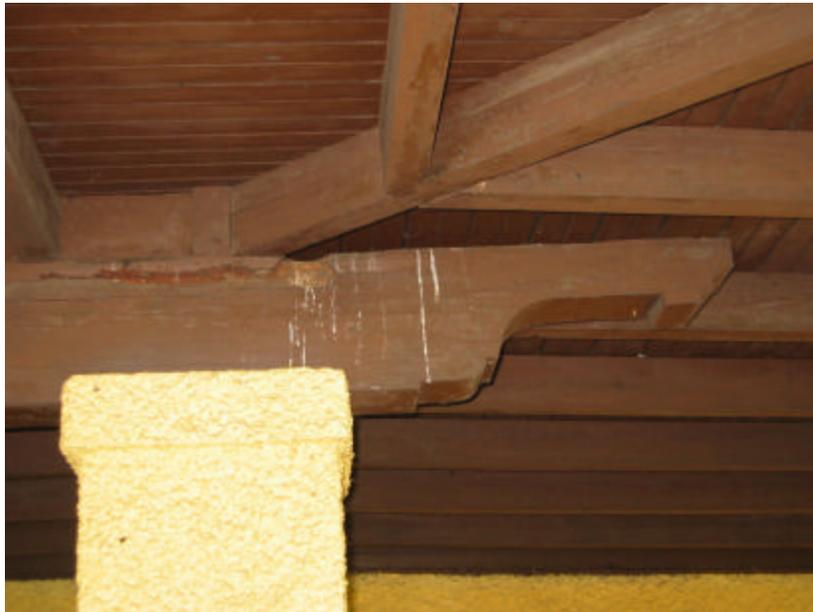
Photo 433  
A beam spanning between two of the square columns in the center of the veranda; note that a section of the beam is cracked and rotted.

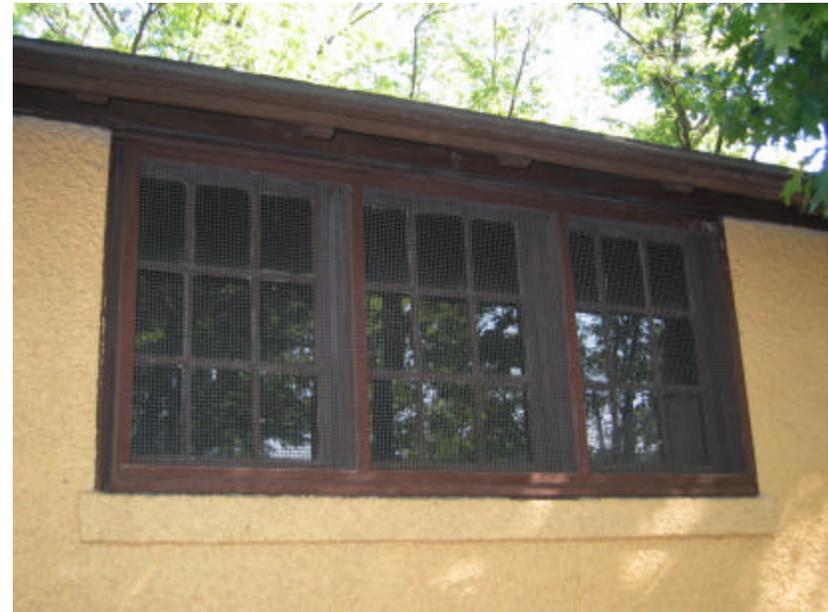
Photo 434  
Three of the original wood sash hopper windows; note that they are covered by a metal screen.

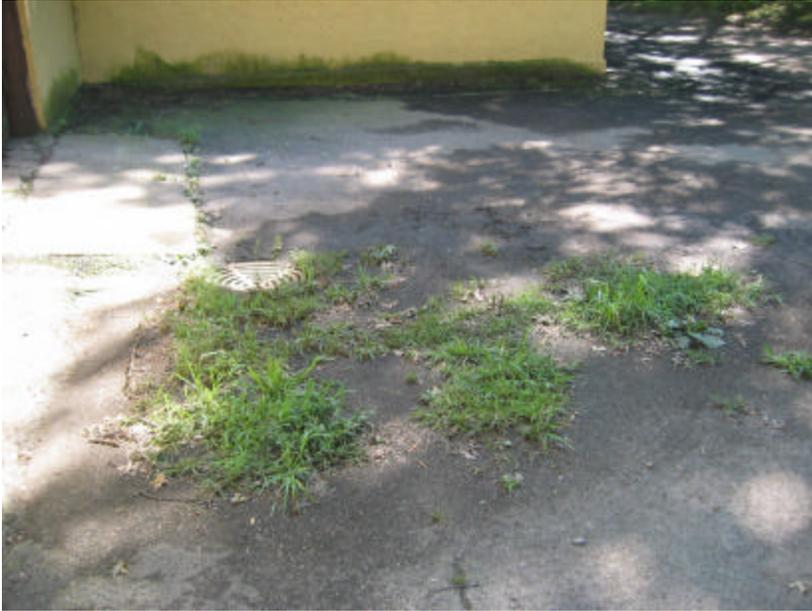
Photo 435  
An area of paving in front of the garage door; note that this section is cracked, buckled and covered with grass and weeds.
