## 37. FOOTBRIDGE 1931

### INTRODUCTION

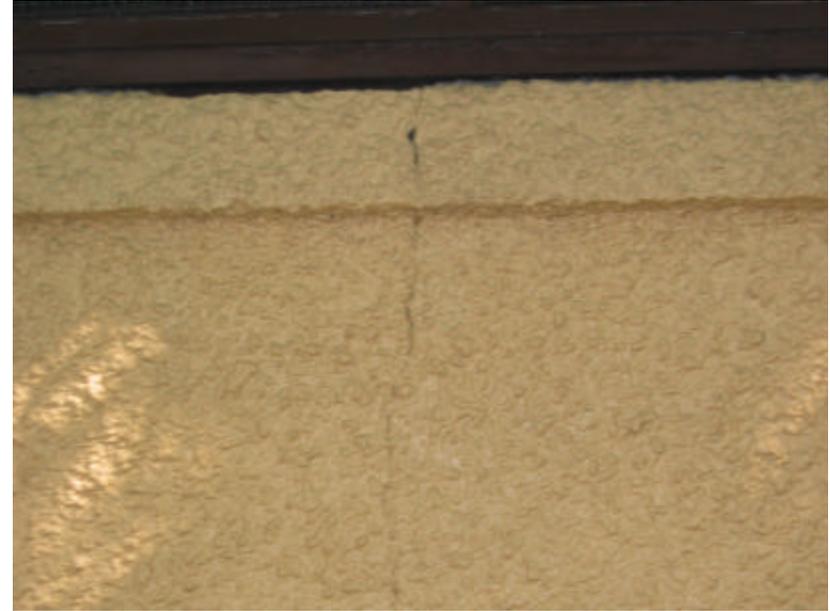
Photo 436  
A large vertical crack below one of the windows.

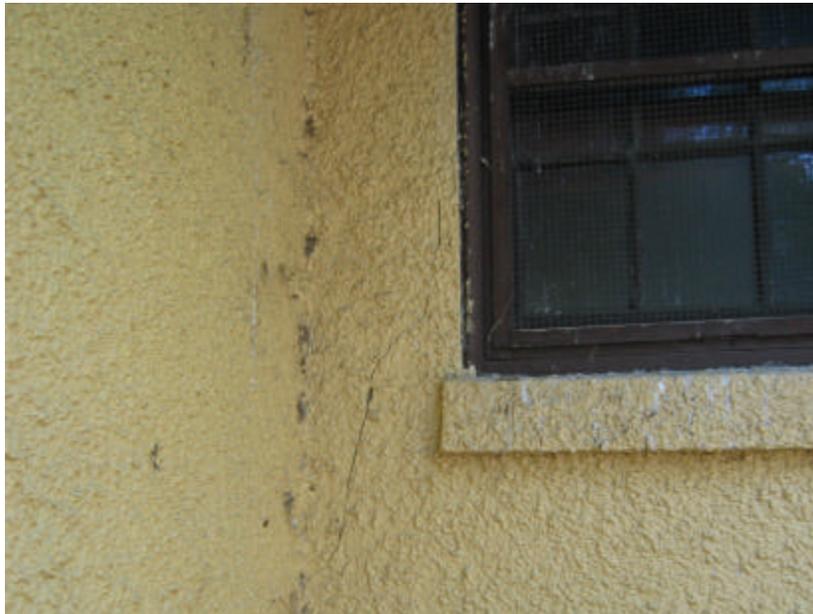
Photo 437  
A crack that runs parallel to a window; note the staining on the stucco's surface.

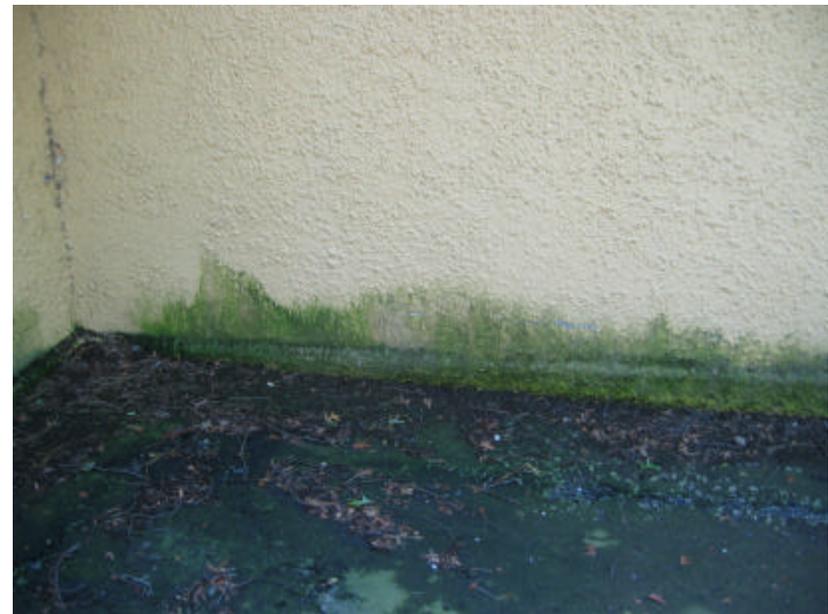
Photo 438  
Organic growth and debris at the base of a wall; note that the site has poor drainage in many locations.

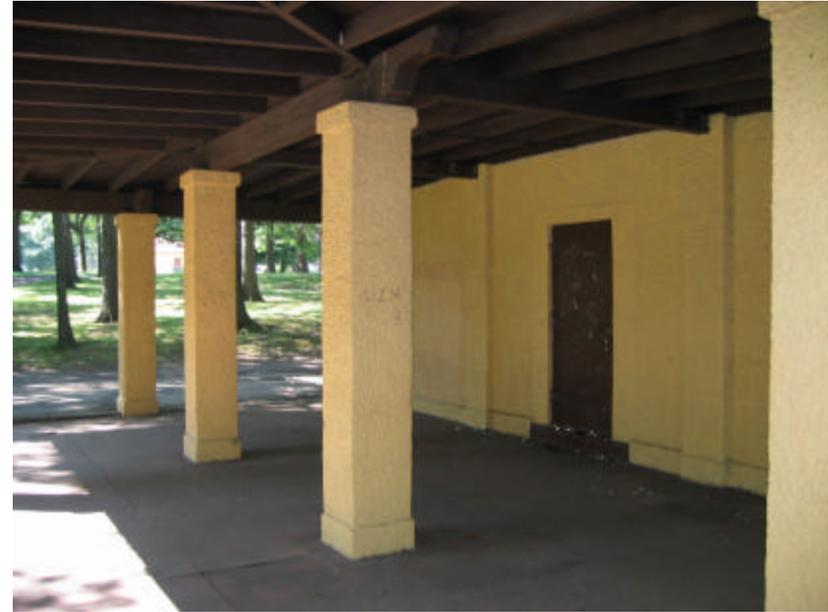
Photo 440  
The wood framing of the veranda's roof; note that the columns are in good condition overall.

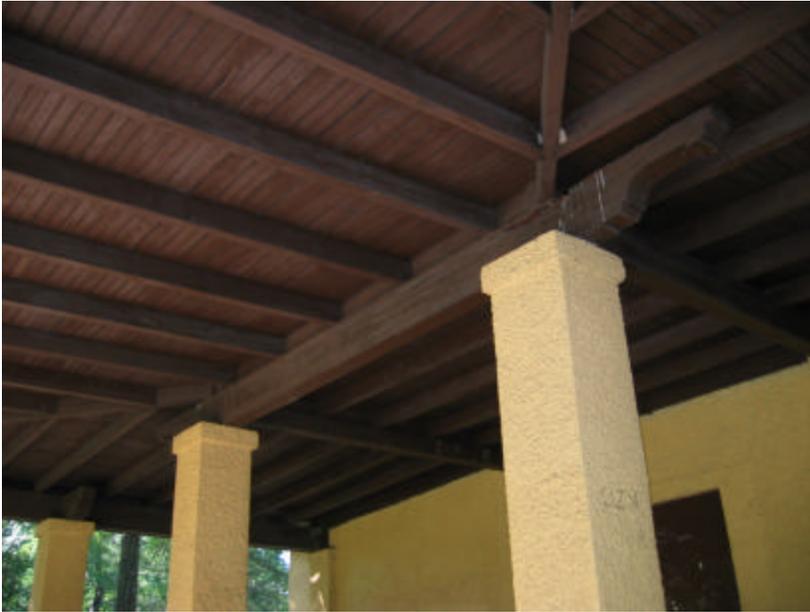
Photo 441  
The rafters and beaded board sheathing; note that the beam is rotted above the right column.

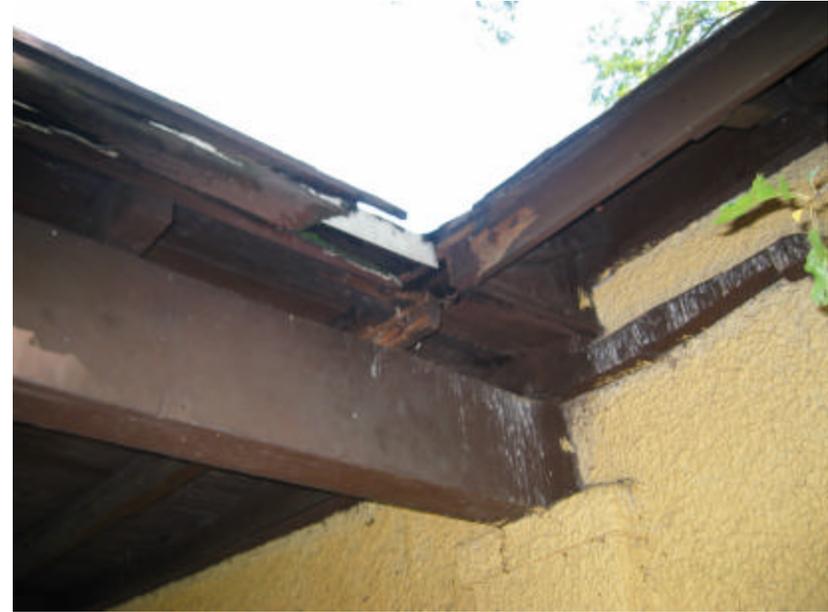
Photo 442  
Rotted wood gutter, eaves, sheathing and rafters caused by severe water penetration and lack of maintenance.

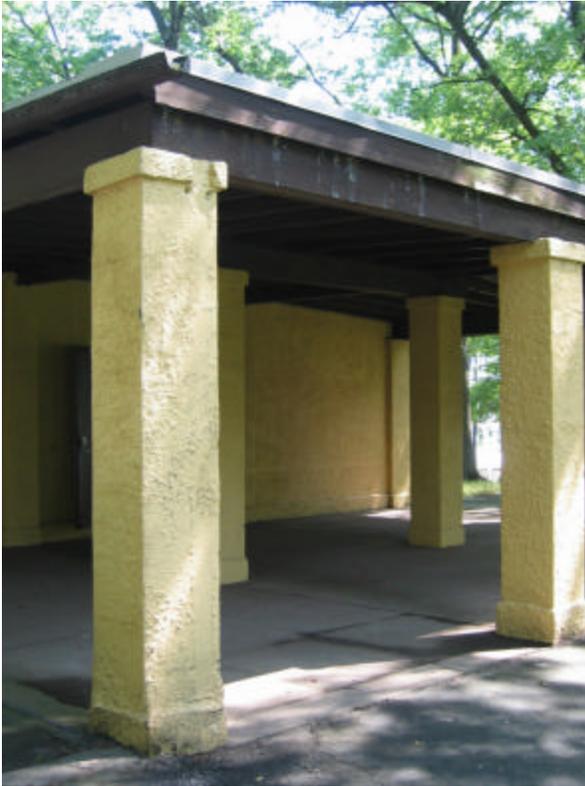
Photo 443  
An original wood gutter is visible above the left column; note the staining on the perimeter beam and the damage to the capital.

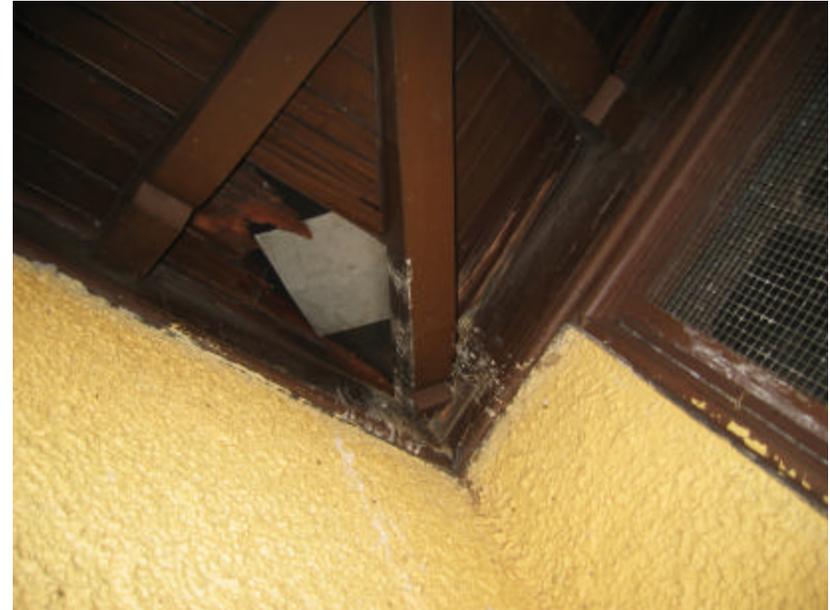
Photo 444  
Rotted rafters and sheathing on the west side of the building; note the staining on the wood.

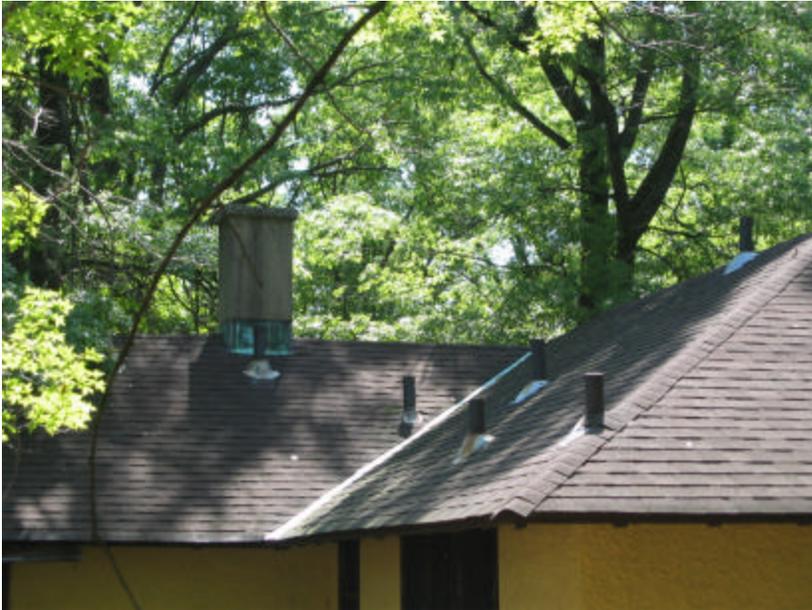
Photo 445  
The asphalt-shingled hip roof; note all the steel pipe penetration and the masonry chimney.

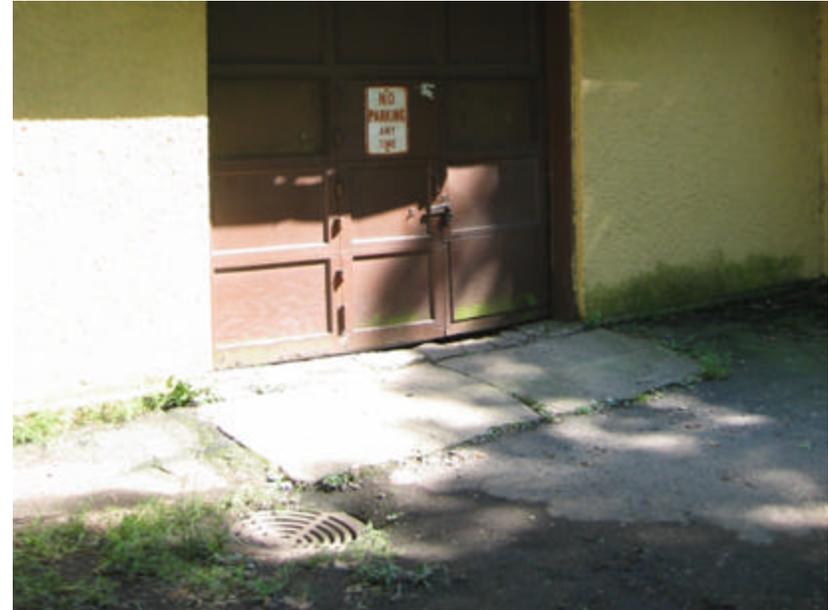
Photo 446  
The wood garage door at the rear of the building; note that the concrete apron is severely cracked.

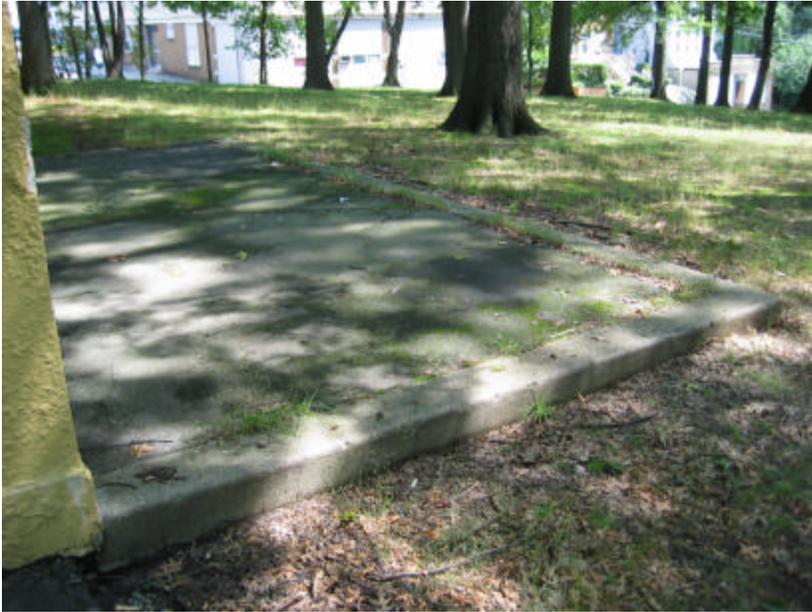
Photo 447  
One of the original sand courts that has been covered with asphalt; note that the paving is now cracked and buckled.

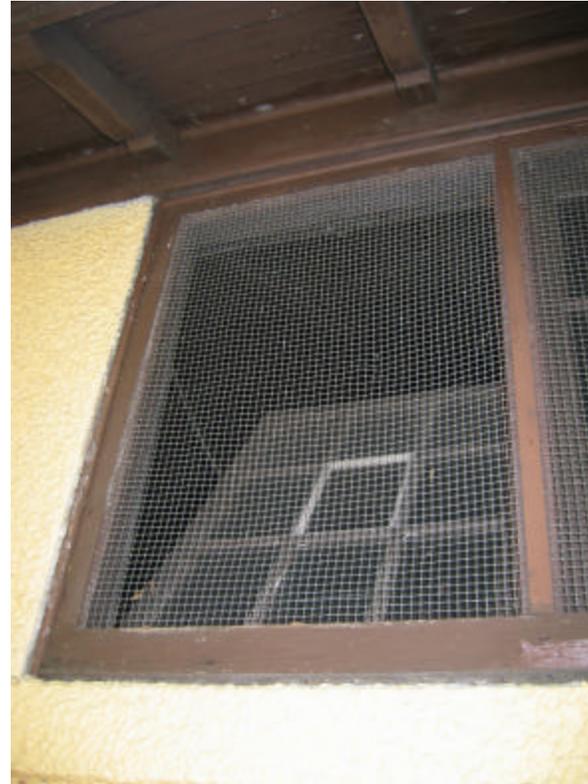
Photo 448  
One of the original hopper windows in the open position; note the heavy metal screen covering the window opening.

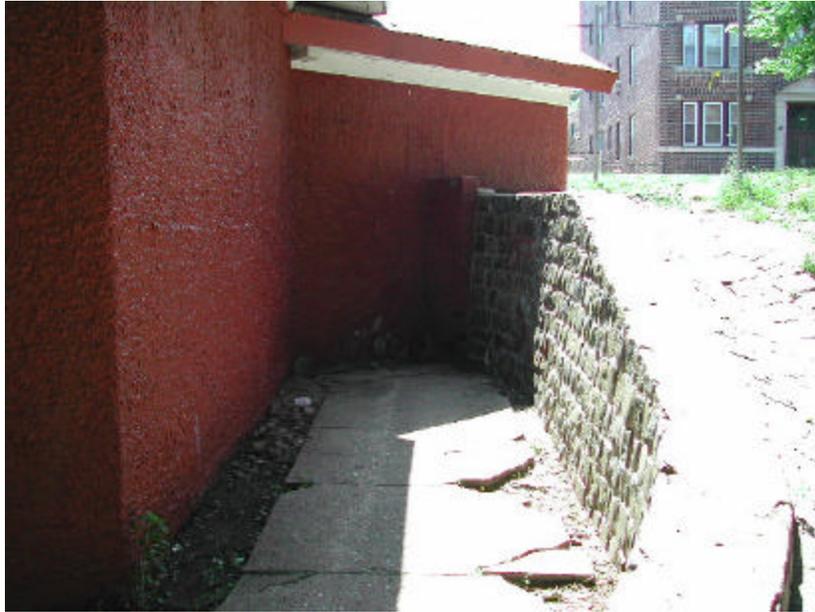
Photo 452  
Detail of stone retaining wall, granite-paved gutter and poor-condition concrete paving.

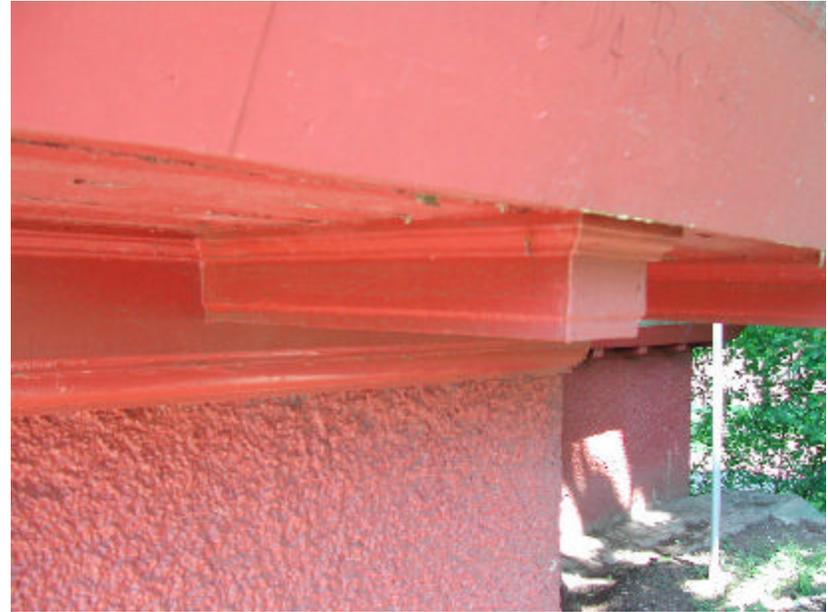
Photo 453  
Detail showing Field House painted, "pebble dash" cement plaster and typical eave brackets.

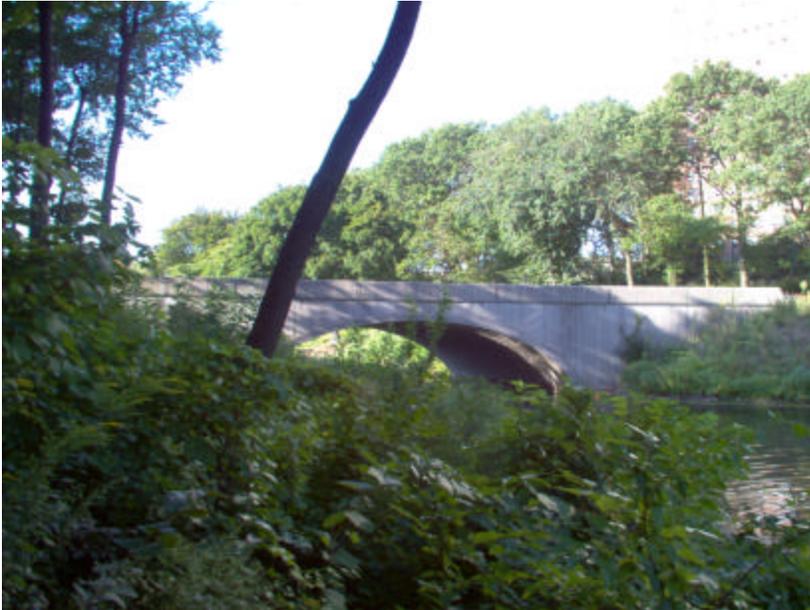
Photo 455  
View of South Branch Brook Drive Bridge from the south; note the heavy vegetation growth on the embankment.

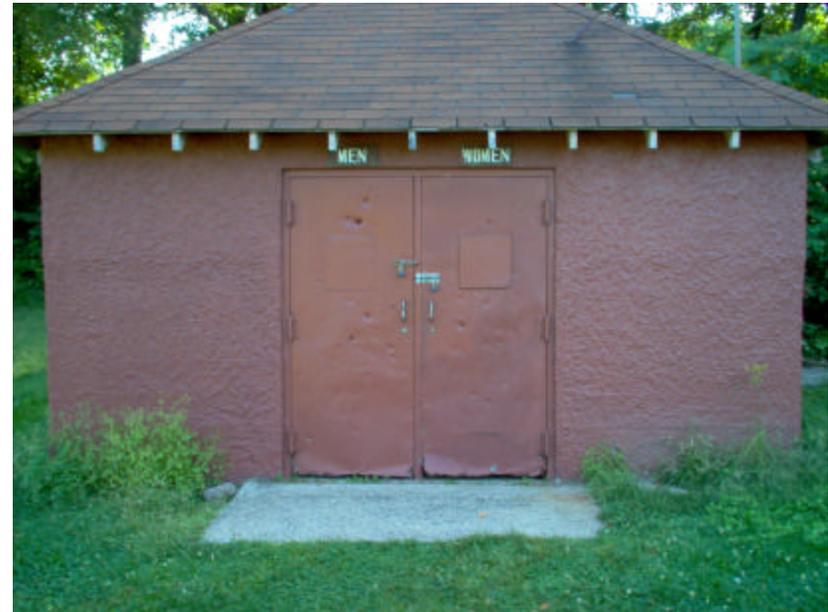
Photo 462  
Detail of the south entry elevation showing painted pebble-texture finish; note the poor condition of door and shingles.

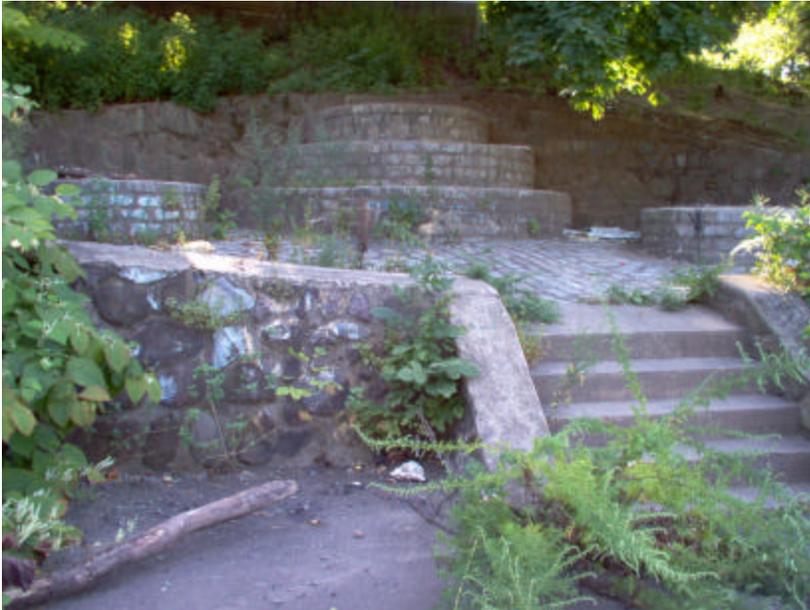
Photo 463  
View of the Rock Structure from the east Branch Brook Lake walking path, showing the 3 stone structures which provide access to the sewer system.

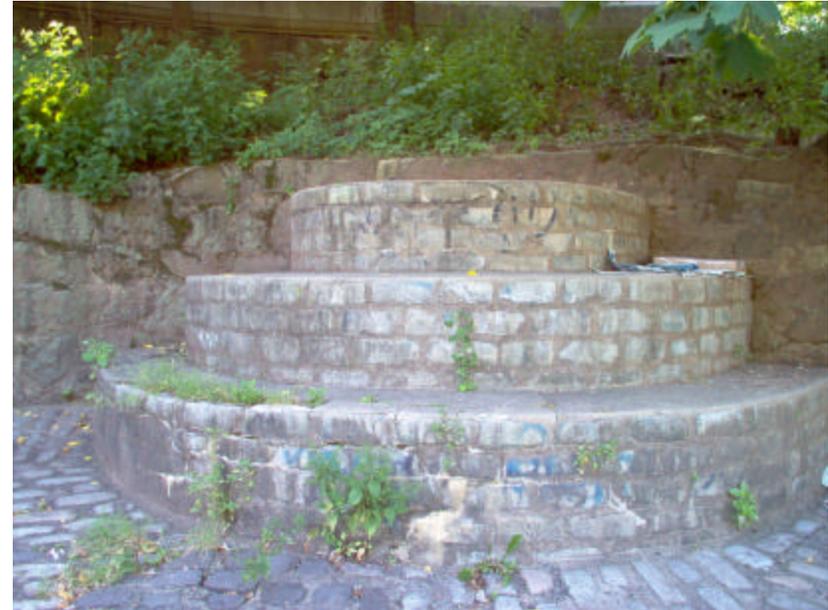
Photo 464  
Detail of the center, 3-tiered structure showing some open and failed joints; note the poorly installed, non-matching pavers at patched area. The fieldstone retaining wall rises beyond and encircles the site.

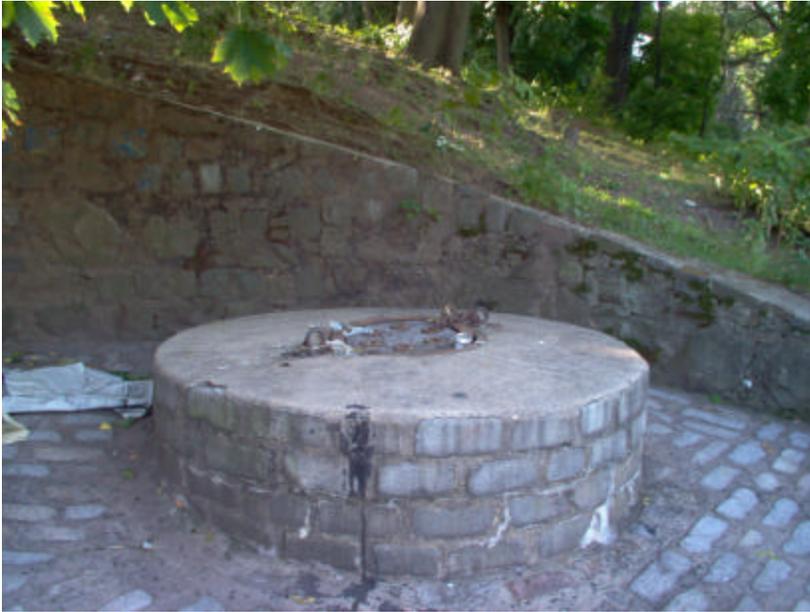
Photo 465  
Detail of the southern structure showing the granite-block walls and the cement mortar cap; note the field stone site retaining wall and eroded terrain beyond.

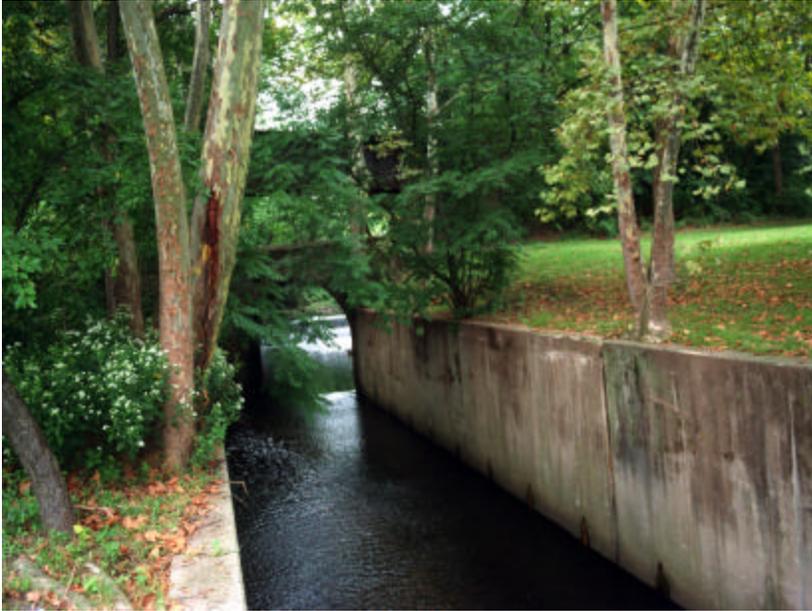
Photo 466  
View of the River Channel at its western terminus east of Franklin Avenue.

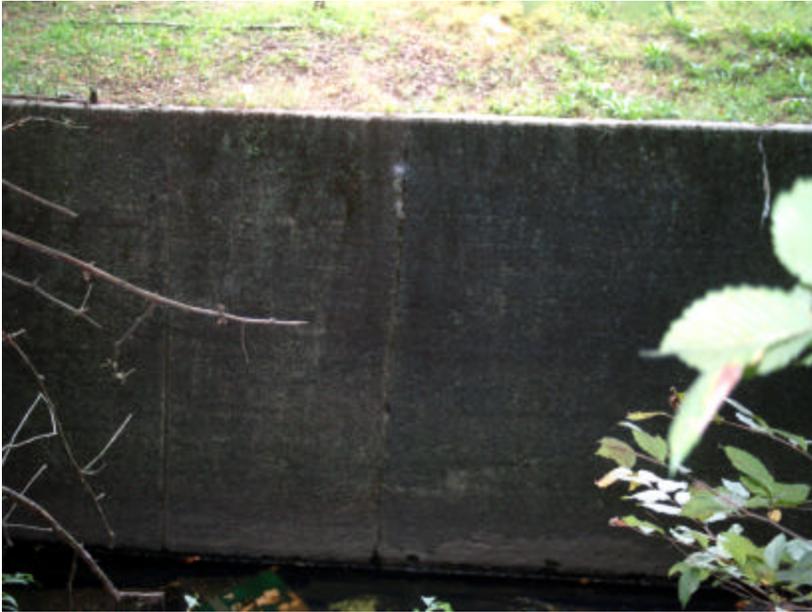
Photo 470  
Detail of full-height, thru-wall crack at the south revetment east of Franklin Avenue.

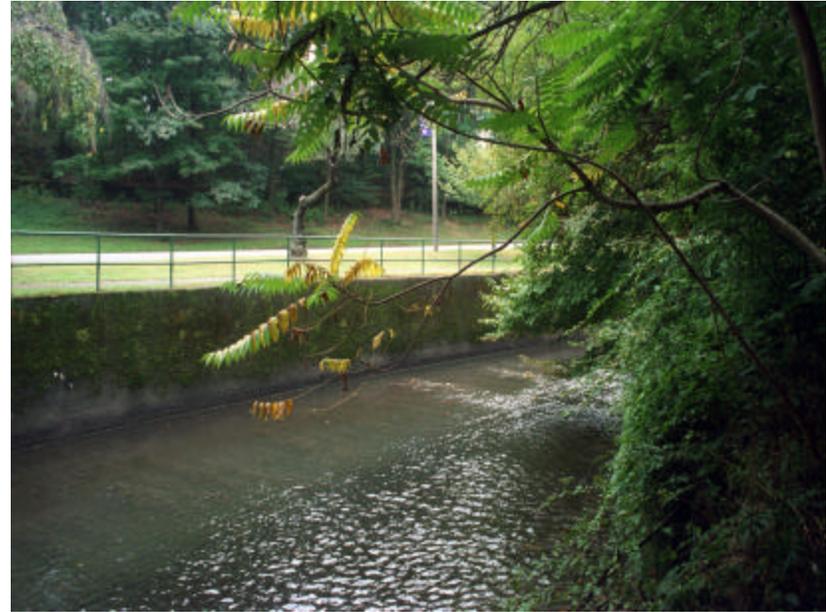
Photo 471  
View west of The Erie Railroad Bridge, looking to the south revetment wall and with North Branch Brook Drive beyond, showing continuous and massive moss growth on channel walls; note the pattern at the channel bed created by the granite pavers.

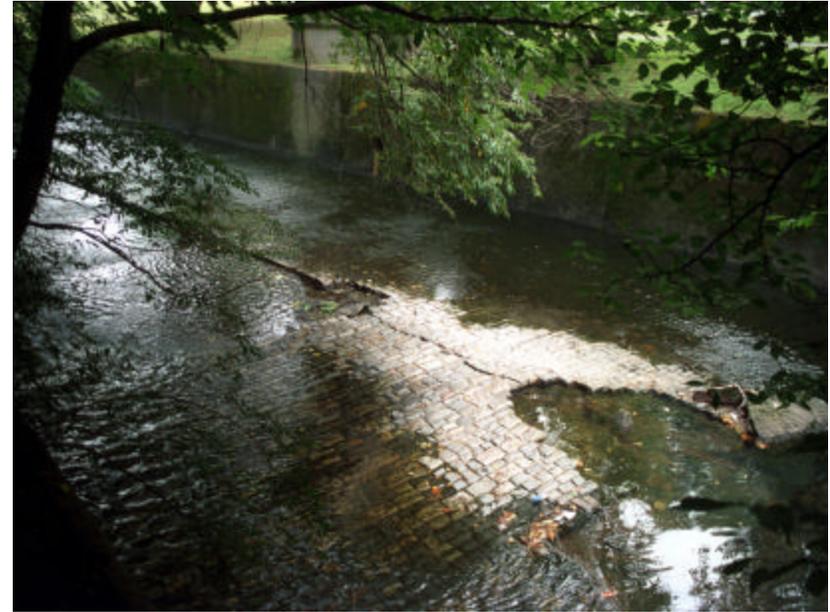
Photo 473  
Detail of the channel bed west of the North Branch Brook Drive Bridge showing destroyed sections and the failure of the adjacent downstream bed (to the east).

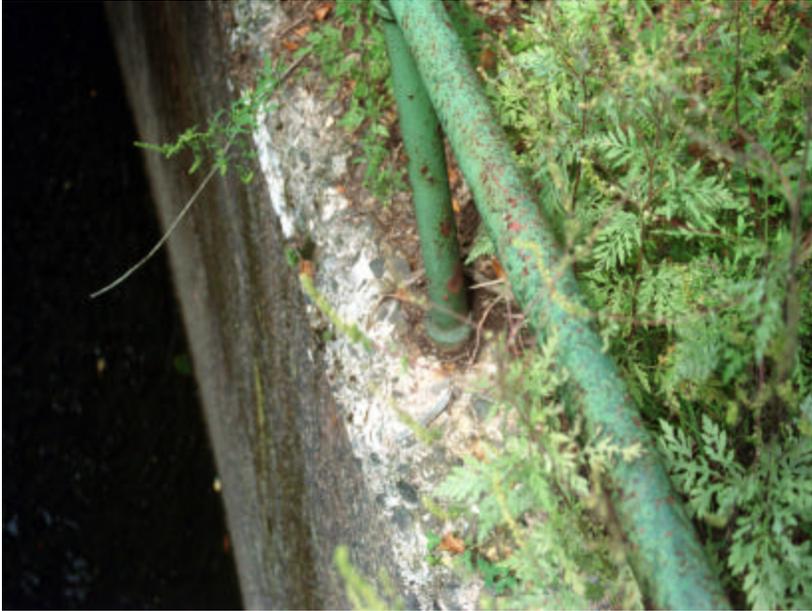
Photo 474  
Detail of the top corner of the channel wall showing erosion that is typical at many locations.

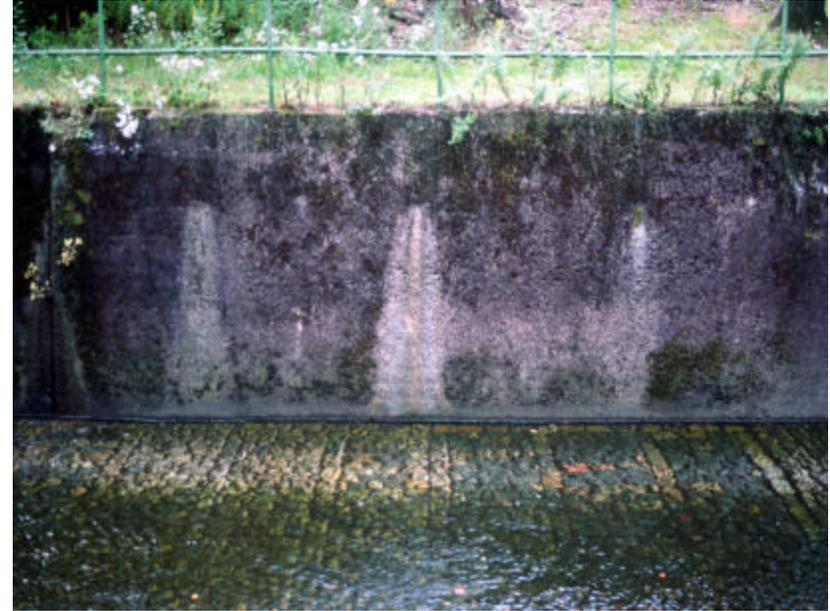
Photo 475  
Detail of South revetment and stone-paved channel bed immediately west of the North Branch Brook Drive Bridge; note the moss growth, erosion and the modest spalling of concrete walls.

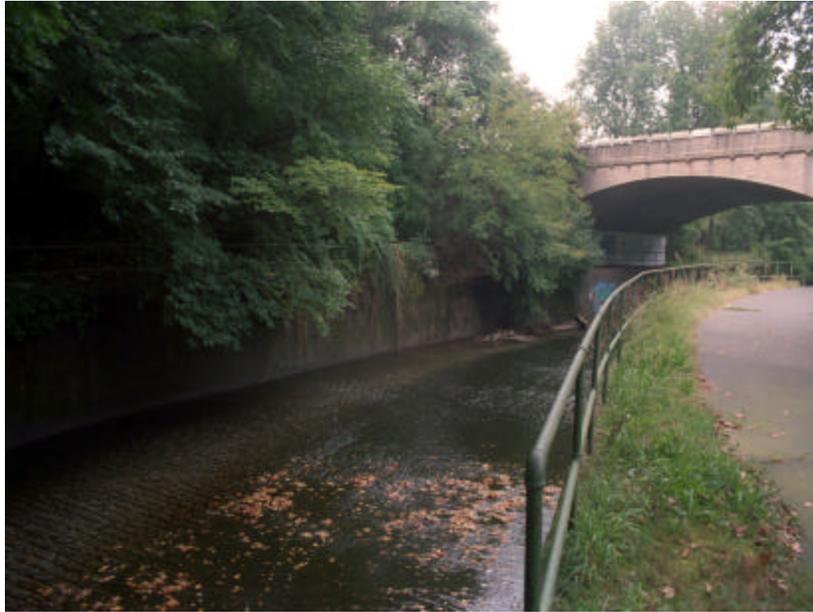
Photo 476  
View looking west toward North Branch Brook Drive Bridge; note the dense plant and tree growth on the south embankment that is typical eastward.

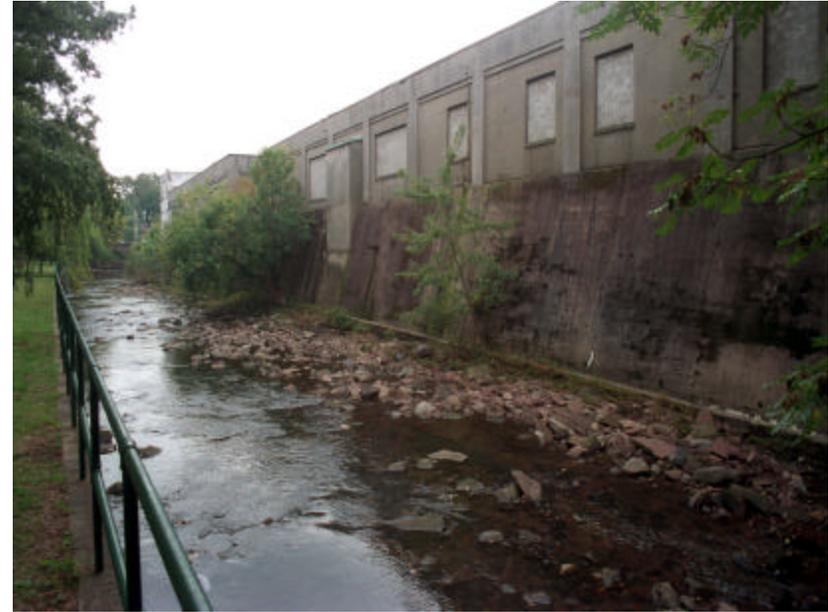
Photo 489  
Detail of the south revetment retaining wall showing spalled concrete and significant natural debris accumulation.

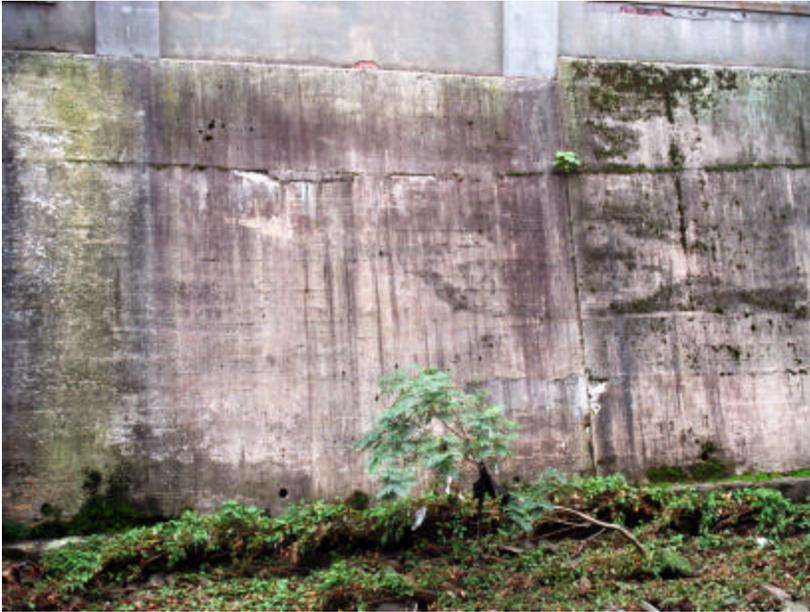
Photo 490  
View looking east showing the grassy park area to the north and the large concrete retaining wall to the south.

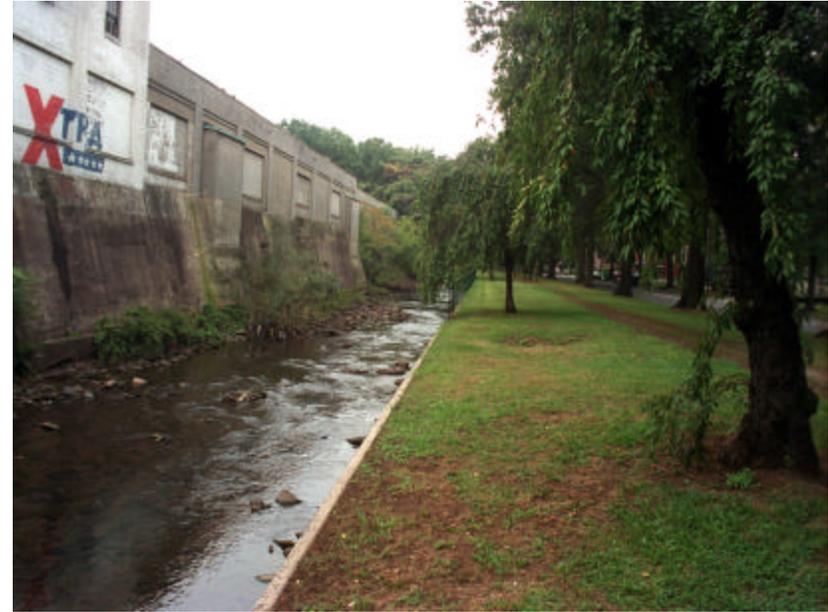
Photo 491  
Detail of the massive debris pile at the west side of the Washington Street Bridge, which obstructs water flow and causes additional debris accumulation.

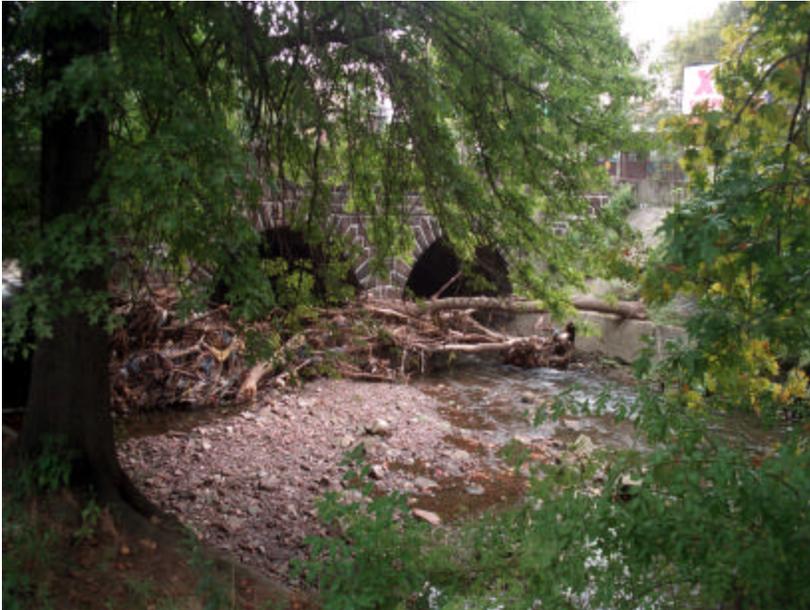
Photo 492  
Debris build-up along the commercial site walls immediately to the west.
