## Part II - Analysis of Hydrology, Utilities, Circulation, and Park Use

## INTRODUCTION TO CHAPTERS 5 THROUGH 9

# BRANCH BROOK PARK

Cultural Landscape Report  
Newark, New Jersey

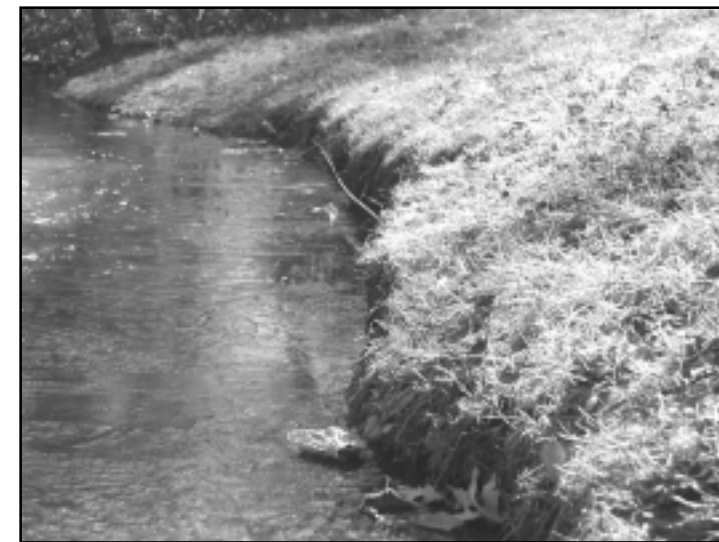
*Example of effectiveness of different plant types in stabilizing the shore. The woody plant material in the background (with roots extending into the lawn area) is more effective than grass.*

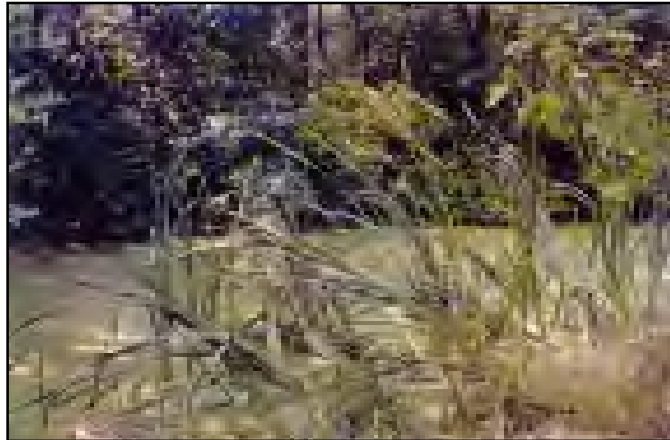
*Cattails and duckweed - two invasive plant species found within Branch Brook Park.*

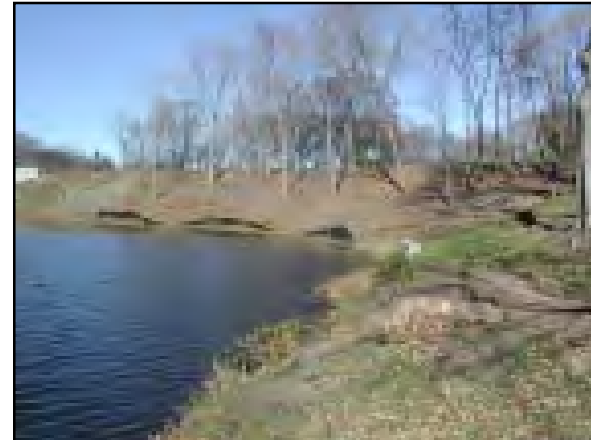
*Example of cleared riparian buffer in the Southern Division. Areas of little or no riparian buffer exist throughout Branch Brook Park.*

- Cleared Riparian Buffers/ Turf Grass – Cleared areas allow sun tolerant, invasive successional growth species to proliferate along the waters edge. Examples of such species include cattails, phragmites, reed canary grass, and tickseed sunflower that are found within the park. In addition upland invasive successional growth species, such as Knotweed and Ailanthus, can end up proliferating within the riparian buffers that do exist and drive out the more beneficial native upland species.

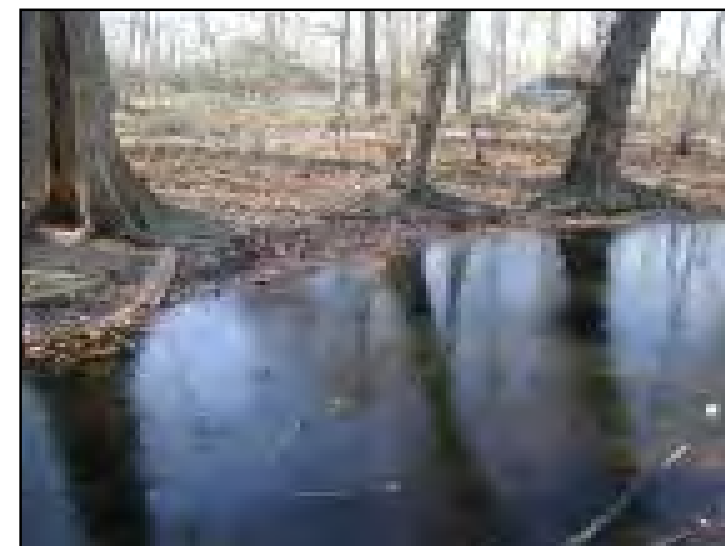
*Minor Erosion Areas:* Minor erosion areas showed signs of bank undercutting, had shallow slopes and had groundcover (either turf grass or understory vegetation).

*Example of minor erosion.*

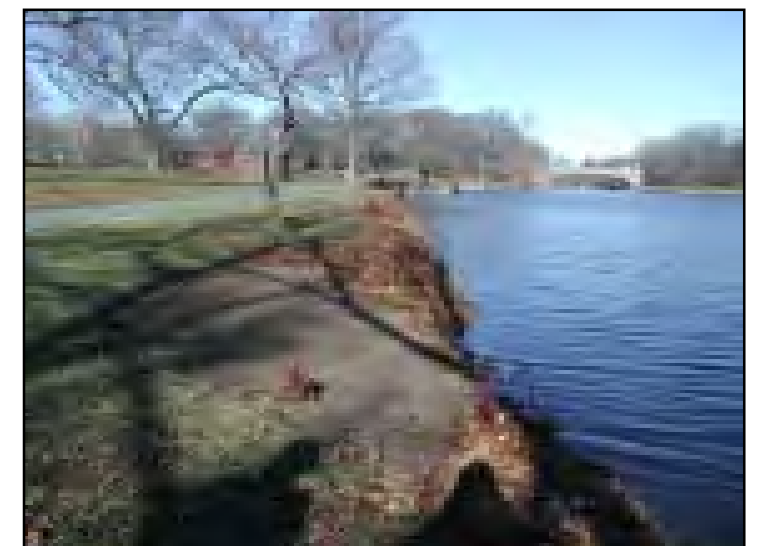
*Moderate Erosion Areas:* Moderate erosion areas include areas of steep slopes with intact geoblock reinforcing, moderate slopes with some or no understory, areas where surface runoff is contributing to the erosion, erosion of the shorelines and minor pedestrian foot traffic.

*Example of moderate erosion.*

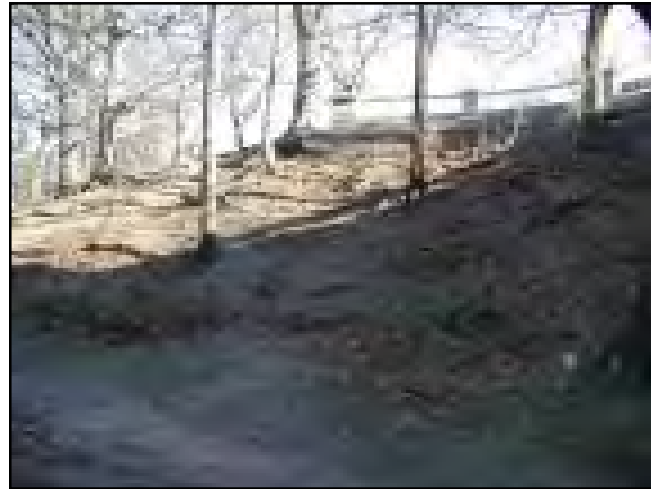
*Major Erosion Areas:* Major erosion areas include steep slopes with no reinforcing (geoblock or understory vegetation) areas of a high concentration of foot traffic and evidence of significant amounts of surface runoff. An exception to that is in the Southern Division where the area south of the internal park drive was all considered major erosion even though some areas of geoblock are present.

*Example of major erosion.*

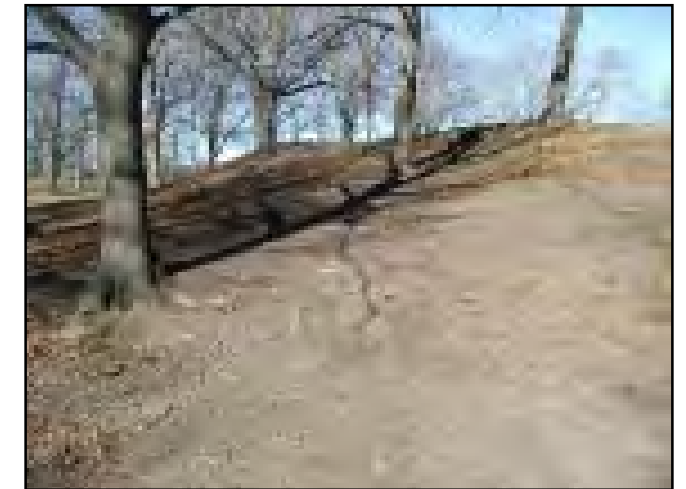
*General area of erosion at the basketball court in Branch Brook Park. Heavy foot traffic in this area has trampled any vegetation that previously existed.*

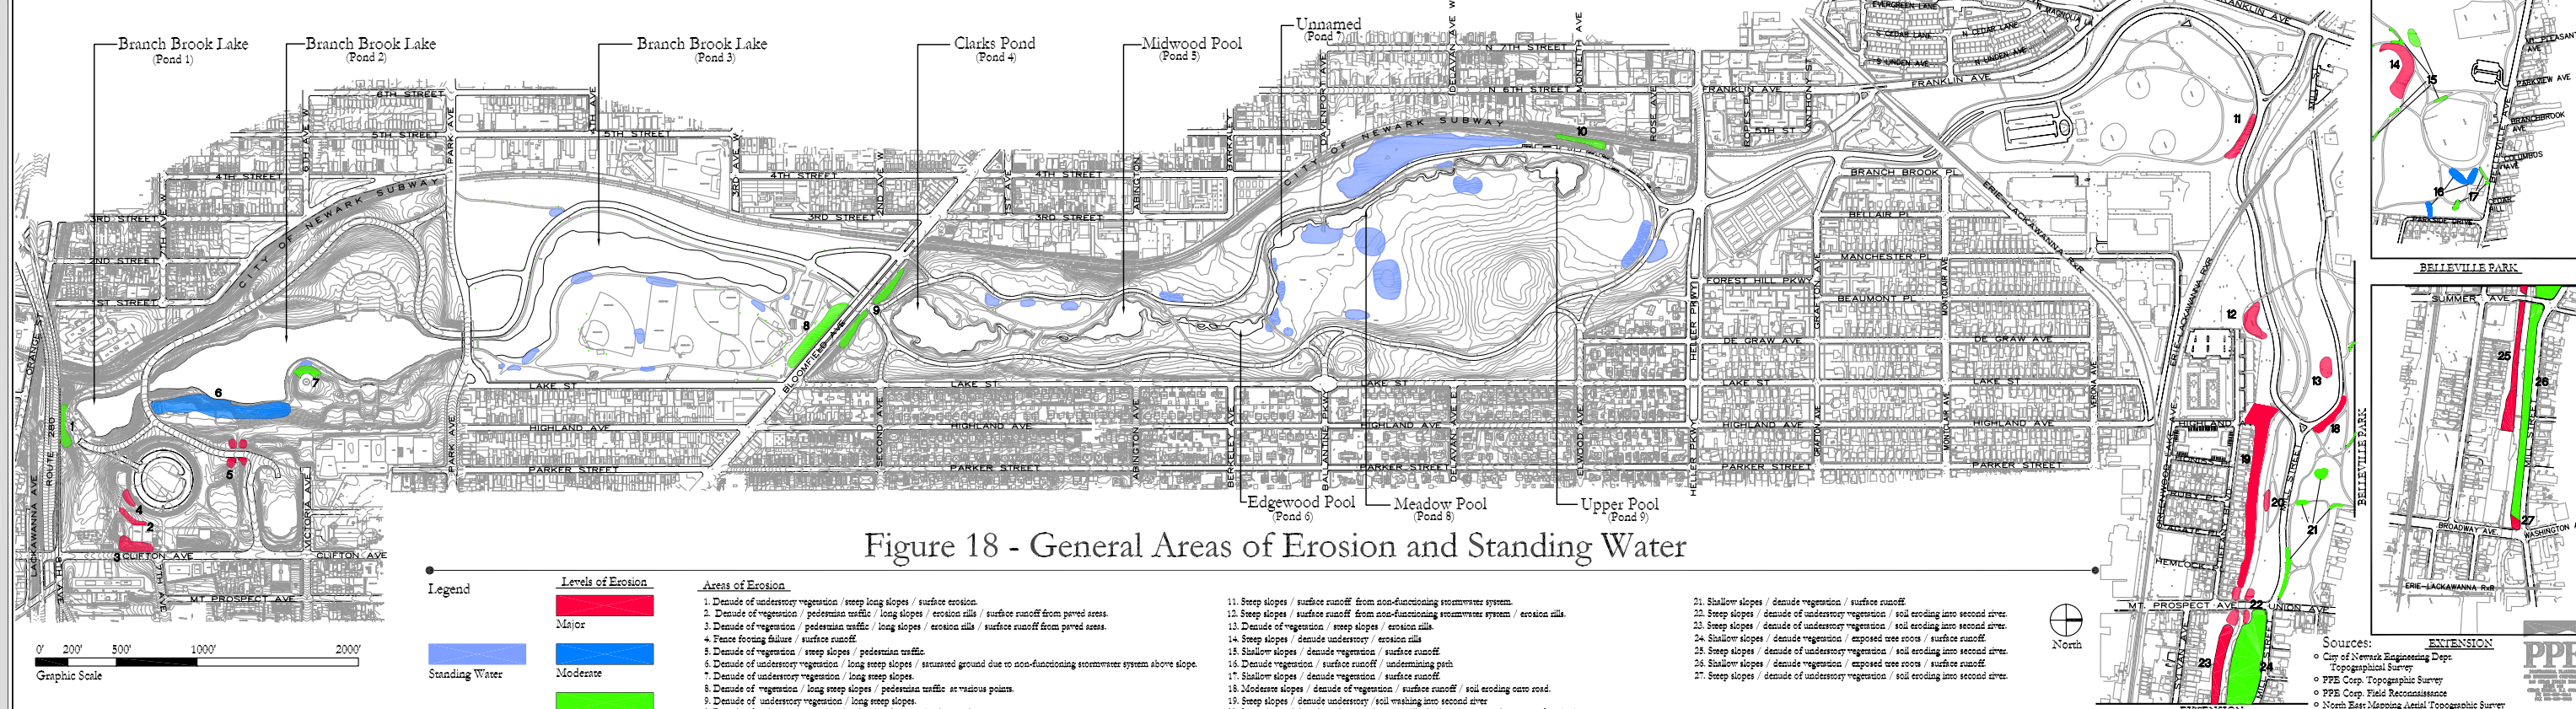
Figure 18 - General Areas of Erosion and Standing Water

- Denude of understorey vegetation / steep long slopes / surface erosion.
- Denude of vegetation / pedestrian traffic / long slopes / erosion sills / surface runoff from paved areas.
- Denude of vegetation / pedestrian traffic / long slopes / erosion sills / surface runoff from paved areas.
- Fence footing failure / surface runoff.
- Denude of vegetation / steep slopes / pedestrian traffic.
- Denude of understorey vegetation / long steep slopes / saturated ground due to non-functioning stormwater system above slope.
- Denude of understorey vegetation / long steep slopes.
- Denude of vegetation / long steep slopes / pedestrian traffic at various points.
- Denude of understorey vegetation / long steep slopes.
- Denude of understorey vegetation / pedestrian desire paths / steep slopes.
