# BRANCH BROOK PARK

TREATMENT AND MANAGEMENT PLAN: A VISION FOR THE FUTURE

**VOLUME 6** | CULTURAL LANDSCAPE REPORT

Prepared for: Branch Brook Park Alliance and the Essex County Department of Parks, Recreation, and Cultural Affairs

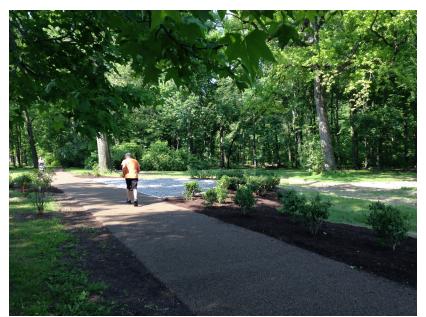
A portion of the newly-installed Two-Mile Loop. The node just off the path is awaiting the forthcoming exercise equipment, Source: RHI, 2014

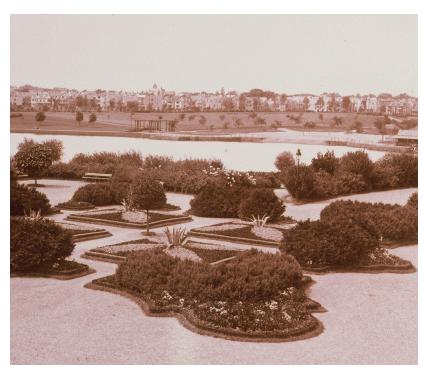
Above: Historic photograph of the elaborate floral garden terraces as planted in the Southern Division, Source: Photograph #137, National Park Service Frederick Law Olmsted National Historic Site (hereinafter "ONHS").

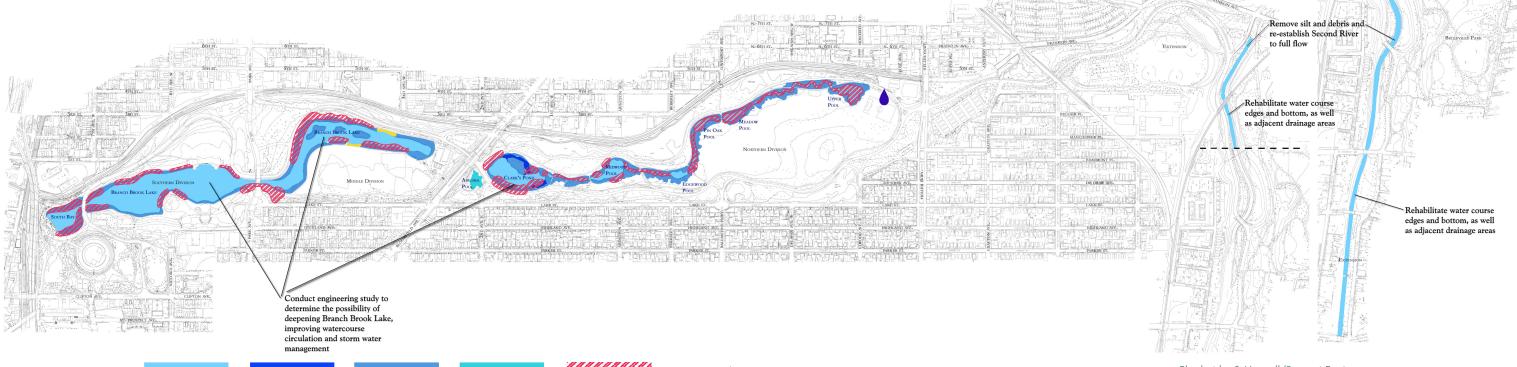
BELOW: The framework plan for the water systems in Branch Brook Park

A framework plan for the park's water system was created to guide future restoration. The map (below) is the integration of the Olmsted Brothers' historic design, existing conditions, and general recommendations from the earlier volumes of the Cultural Landscape

- The 75' riparian buffer zone (which plays an important part in controlling sediment, pollution, and erosion)
- Areas of erosion along the shoreline
  Historic locations of the beaches intended to provide access to the water in selected locations
- Restoring the well to full productivity in the Northern Division to establish water flow through the pools and streams.

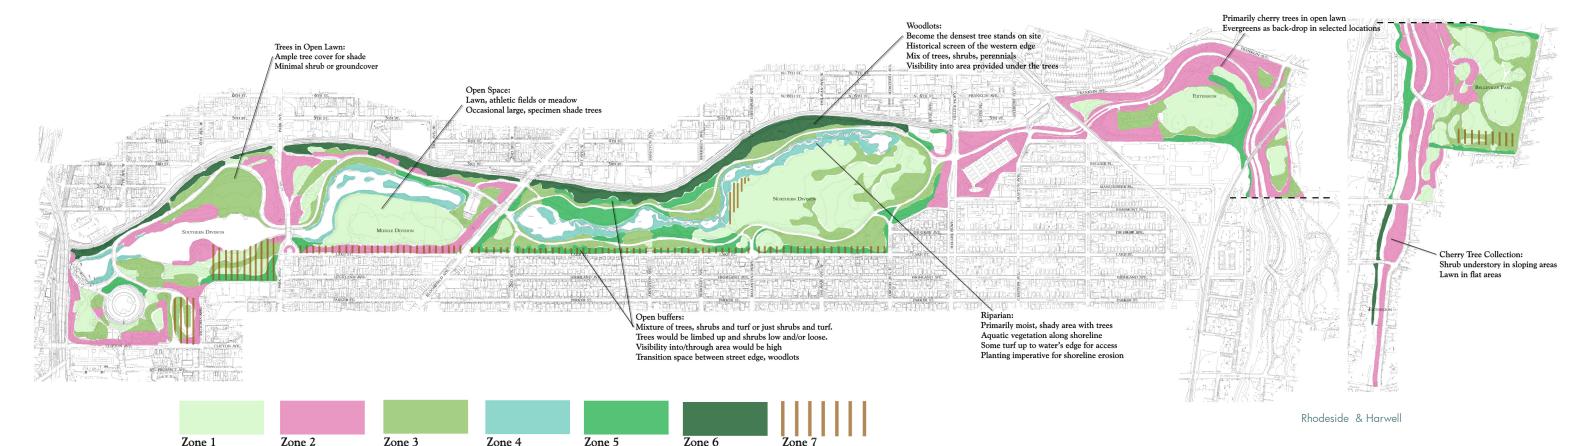
BELOW: The framework plan for the vegetation in Branch Brook Park

spaces. Specifically, the zones illustrate the goal to regain much of the historic vegetative diversity, denseness or permeability that once existed. The zones—open space, cherry trees, trees in open lawn, riparian plantings, semi-transparent screens, and woodlots—range from simple greensward to thickly layered plantings. The framework map integrates historic Olmsted treatments, current schematic treatment plans and what exists in Branch Brook Park today. A more detailed explanation of the vegetation zones follows.

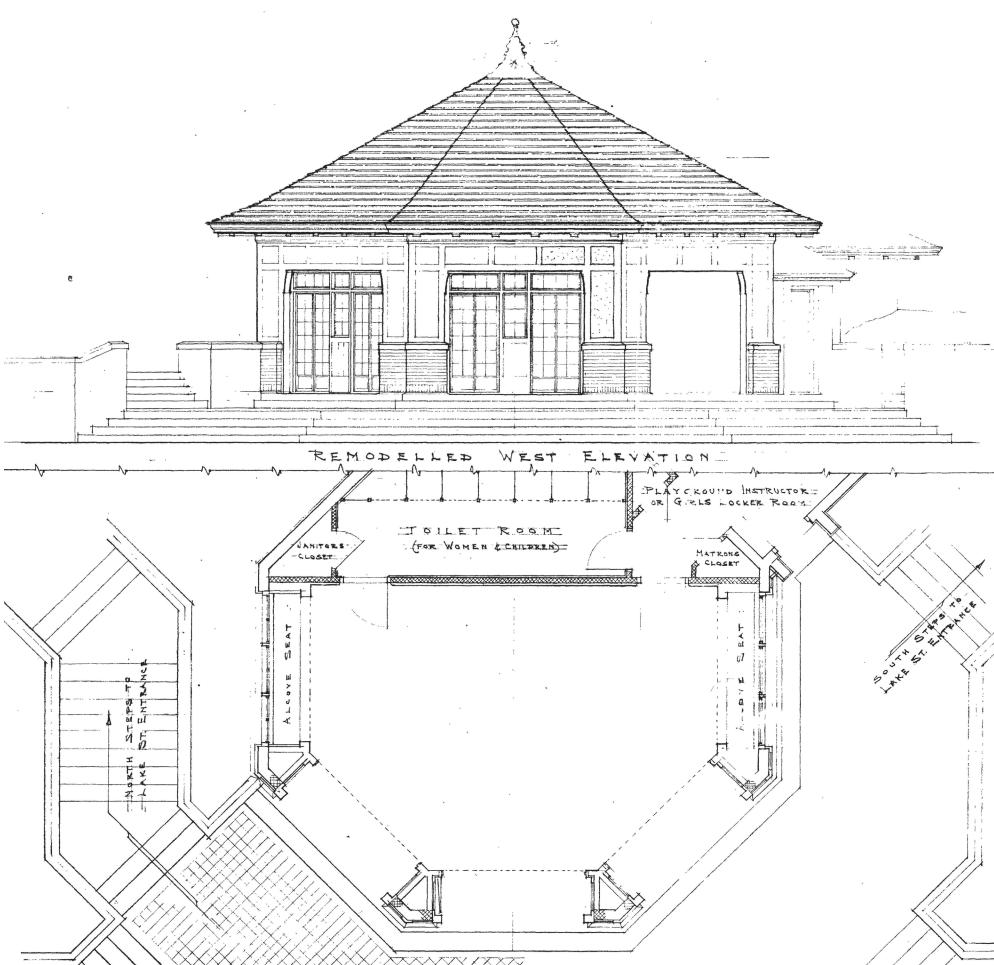
RIGHT: A plan and west elevation for the Octagon Shelter in the Middle Division, originally designed to be used exclusively by women and children using a nearby wading pool. Today, it's an overlook for the lake. Source: ONHS

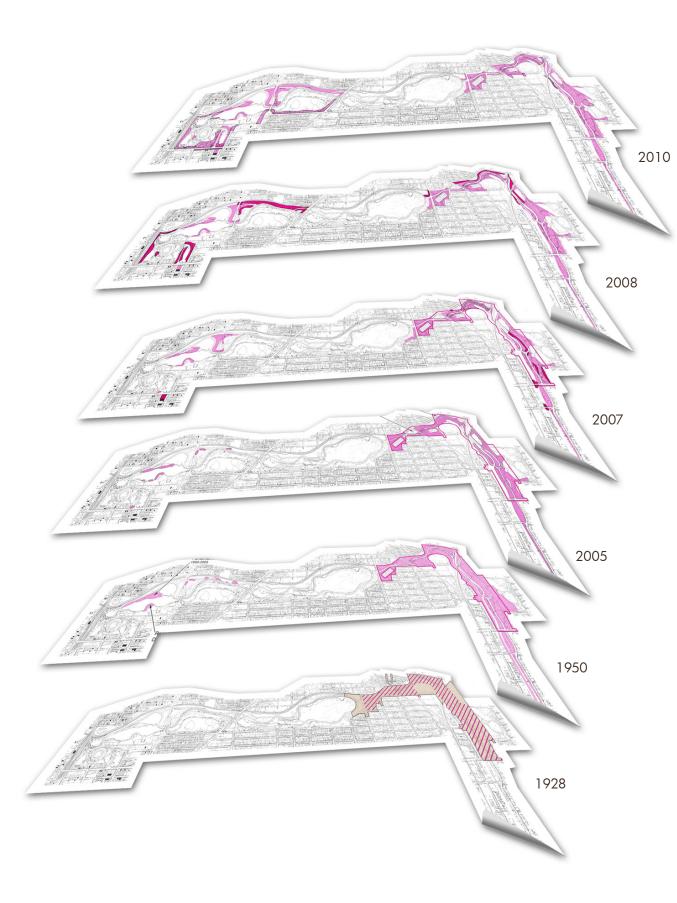
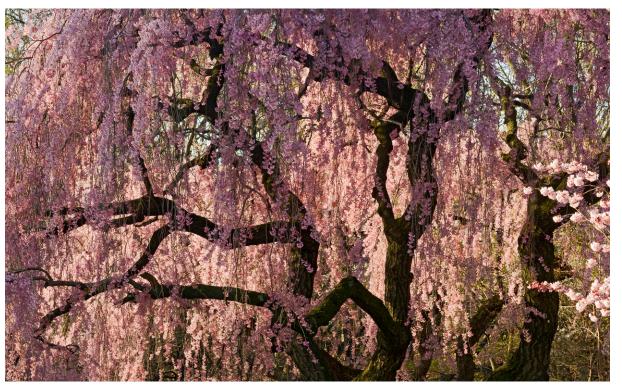
LEFT: These planting/analysis maps by RHI show where cherry trees were first planted for the Fuld collection (1928), areas of cherry trees that had expanded by 1950, and their subsequent demise, shown on the 2005 map, when the areas planted with cherry trees—shown by light pink—had greatly diminished. New areas of cherry tree planting—shown by hot pink—were added from 2006 to 2010, bringing the total cherry trees to 4,300 as of 2013.

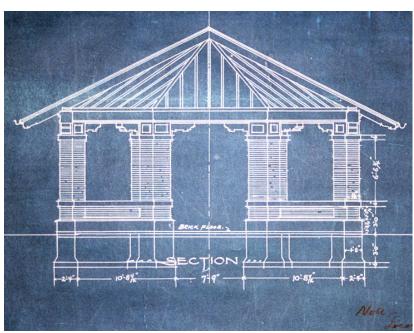
ABOVE: Historic Olmsted drawings of Shelter No. 1, 1899, Source: OHNS

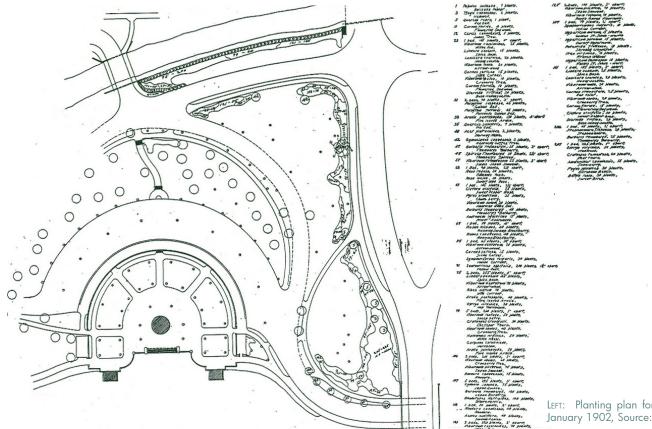
LEFT: Planting plan for the Concert Grove, Plan #2121-576, January 1902, Source: ONHS.

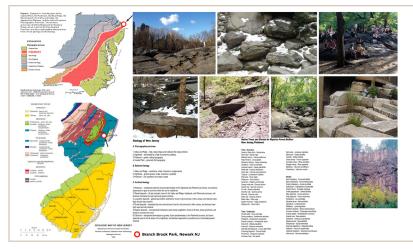
ABOVE: An illustration of the geology of the piedmont area of New Jersey. Much of the inspiration of the design is based on area geology, Source: RHI RIGHT: An enlargement of the Quarry Playground illustrative plan, Source: RHI

The design for a new children's area called 'The Quarry Playground' in the Southern Division, the theme of which is based on the historical usage of parts of the park as a quarry prior to Branch Brook Park's development, features areas for active and passive play, overlooks, climbing, water spray, and informal play and gatherings. A significant component of the project is education, focusing on the geology and urban

ecology. The new playground, designed for ages 6-12, would be constructed of natural stone, with equipment integrated into the slope against which the rockwork will be set. Interpretive signage and interactive elements such as child operated water jets and mist will also be included. To date this project is not implemented.

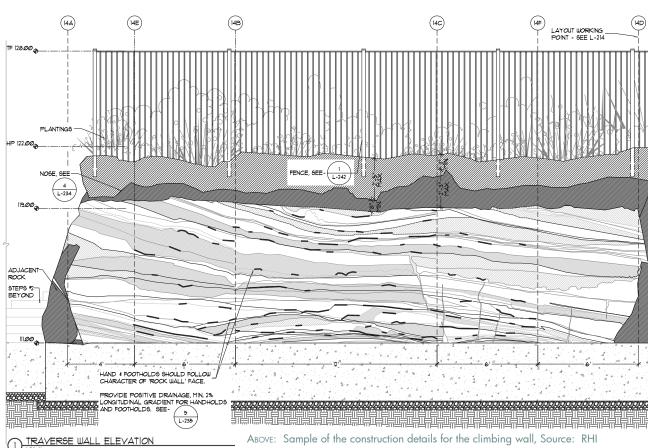
ABOVE: Sample of the construction details for the climbing wall, Source: RHI

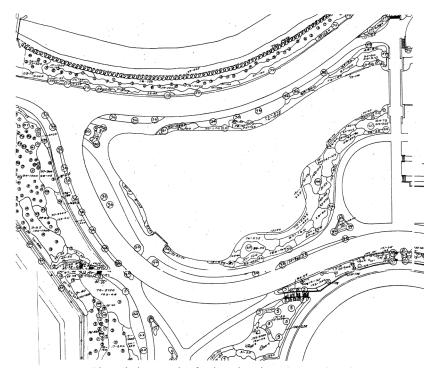
ABOVE: Historic Olmsted planting plan for the Lake Edges, Source: ONHS.

#### F. Lake Edges Restoration

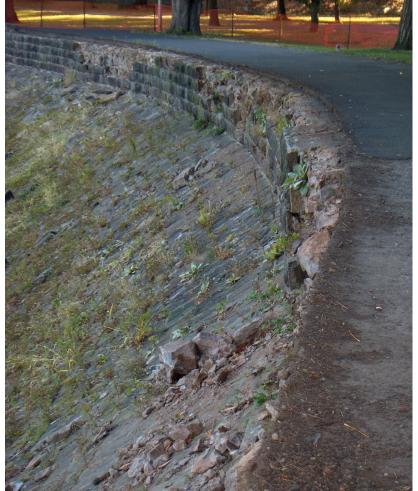
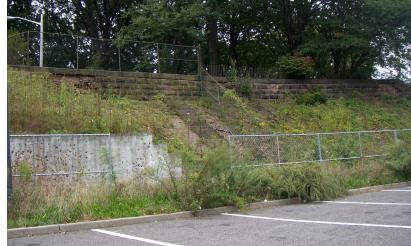
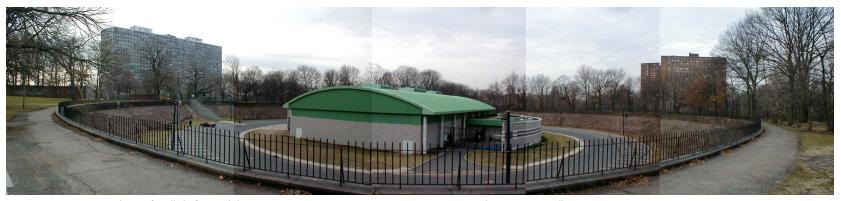
ABOVE TOP: Existing condition of walls before stabilization, Source: RHI, 2008
ABOVE BOTTOM: Panorama of the Reservoir, Source: RHI, 2002

ABOVE TOP: The Reservoir walls in 2009, Source: RHI
ABOVE MIDDLE: Detail from the construction documents prepared for the site's restoration,
Source: CTS Group

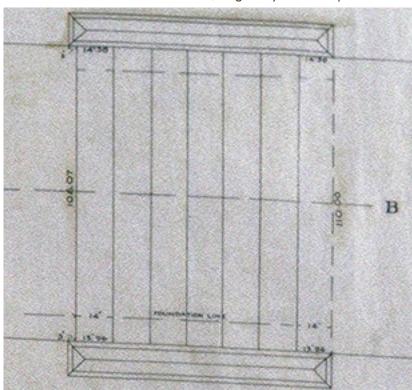
$\label{eq:Above:original} \textit{Above: Original details for the steps at Bloomfield Avenue and Lake Street, Source: ONHS}$

To provide access to the Middle Division from the east, four entrances into the park were reconstructed along Lake Street. As the elevation of Lake Street and the adjacent neighborhood is higher than most of the Middle Division, these entrances were originally built as small graceful staircases, often at a gentle curve to merge with the park pathways. However, by the turn of the century, and like many parts of the park, the existing stairs and adjacent paths had fallen into disrepair or had been replaced in a manner less refined than the original. The entrances were therefore reconstructed, during the Middle Division Ballfields renovation, to grandly welcome park visitors.

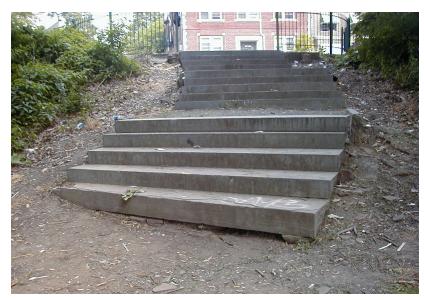
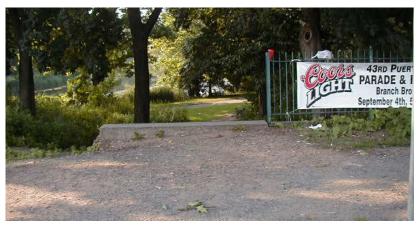
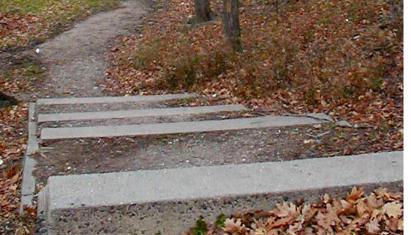
LEFT (ALL THREE PHOTOS): Conditions of the entrances before reconstruction, Source: RHI

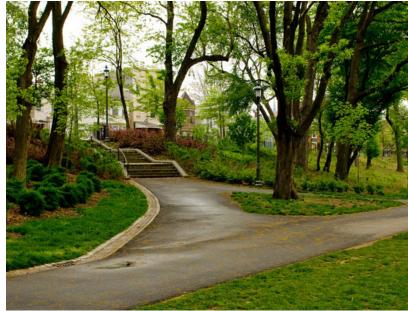
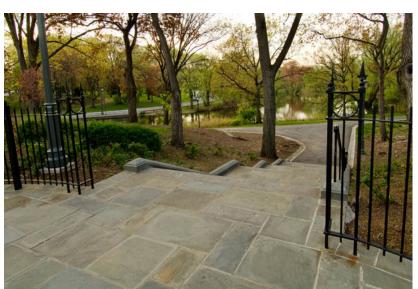
ABOVE: Post reconstruction photos of Middlefield and Midlake Crescent entrances, Source: Patrick O'Brien, May 2008

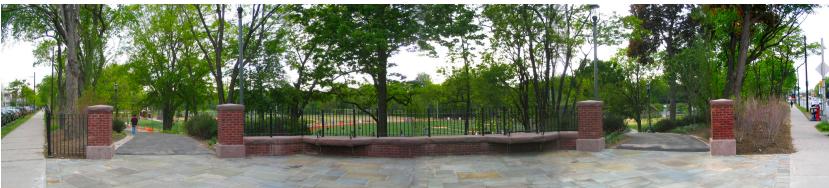
Above Top Panorama: The Bloomfield Avenue entrance before reconstruction in 2003, Source: RHI  $\,$

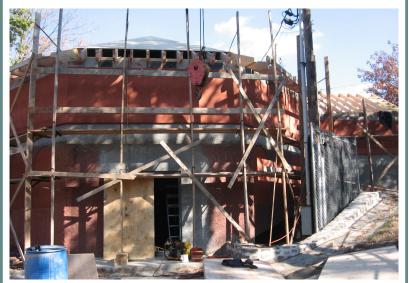
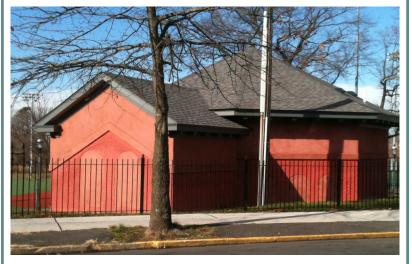
The Octagon Field House being rehabilitated (top) and completed, as viewed from Lake Street (bottom), Source: RHI

The Octagon Field House was constructed around 1920 with showers and lockers for the children that were playing in the nearby wading pool. The structure was built partially tucked into the slope along Lake Street. Having fallen into disrepair, with the surrounding landscape severely eroded, the site was rehabilitated in 2010/2011. In order to avoid easy access (and possible vandalism or injury) to the roof from Lake Street, the building's roof was raised during rehabilitation. New restroom facilities were also installed.

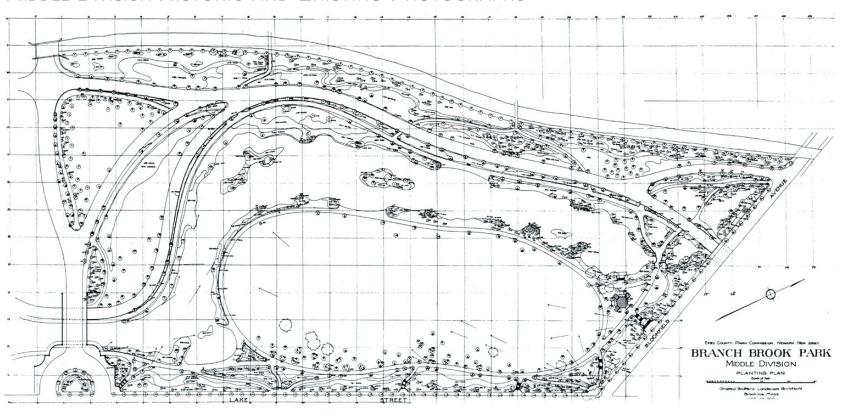
ABOVE TOP: The Olmsted Middle Division planting plan, plan#2121-454, Source: ONHS
ABOVE BOTTOM: Aerial photo of the Middle Division in 2007, before the installation of an artificial turf soccer field, Source: Steve Uzzell

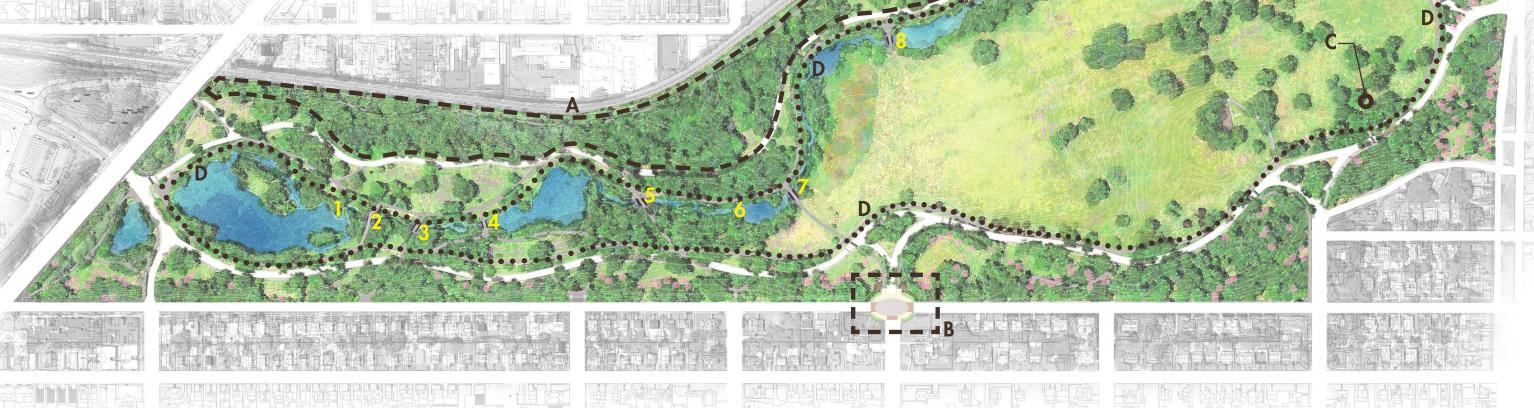
- A. Northern Division Woodland Management
- B. The Ballentine Gates
- C. Supplemental Well
  D. The Lenape Trail/Two-Mile Loop ••••••
- E. The Urban Farm Greenhouses

- 1. Weir 1
- 2. Laurel Wood Boulder Bridge
- 3. Crossover Drive Bridge
- 4. Midwood Pool Bridge
- 5. Midwood Drive Bridge
- 6. Weir 2
- 7. Brownstone Bench Bridge
- 8. Crossover Bridge
- 9. Brookside Meadow Bridge
- 10. Brownstone Lintel Bridge

The Northern Division is home to the Branch Brook stream system with its meandering channels and wide pools. Crossing this system are eight custom-designed footbridges and two stone weirs. The landscape is pastoral in character, turf dotted with large shade trees on gentle topography. Branch Brook Drive provides a one-way driving loop through this part of the park.

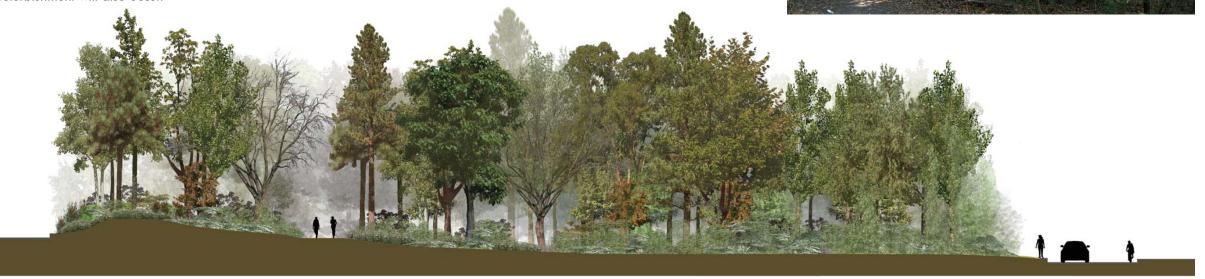
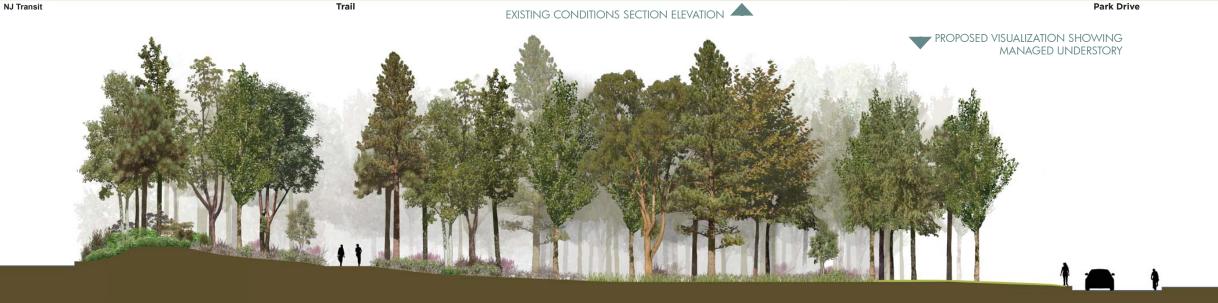
BELOW: Section elevations to illustrate existing conditions (top) and how the woodland should look post restoration, Source: RHI

The woodlands along the western edge of the Northern Division have grown dense, impassable, are choked with invasive plant species, and are a perceived security hazard. Restoring the woodland will require carefully balancing the existing conditions with historical planting plans to come up with an action plan that will involve a mixture of clearing, pruning, large tree removal, as well as the preservation of some existing conditions, and possible new plantings. Pathway refurbishment will also occur.

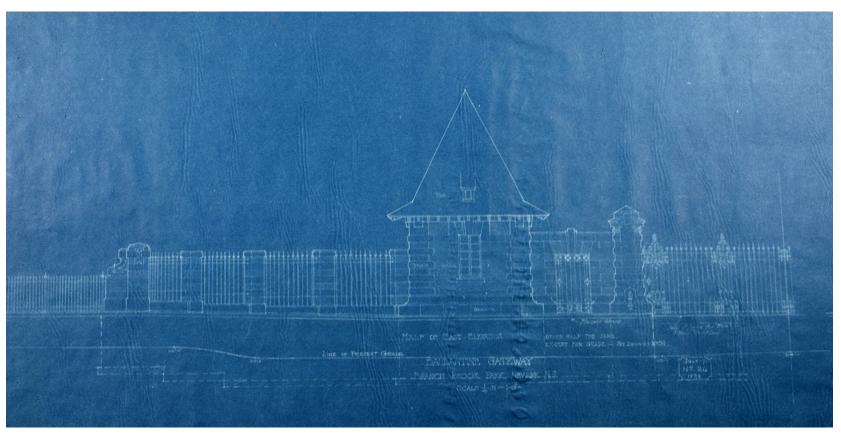
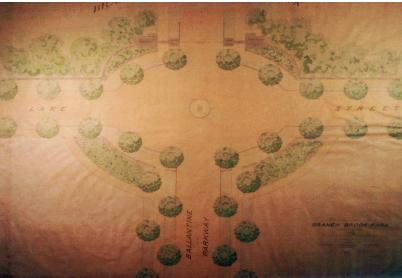
ABOVE: Front elevation of Ballentine Gateway blueprint, drawing E048, Source: ONHS
LEFT: Preliminary plan for Ballentine Gate, 1899, plan #2121-119, Source: ONHS

The Ballentine Gates serve as one of the primary entrances into the Northern Division, and certainly the most iconic. The Olmsted Brothers conceived of the Northern Division as the more natural of the park's divisions. The planting design in the area was only to use native trees and shrubs so the scenery was rural and simple. Few architectural features were to be in the Northern Division. However, along the perimeter, and at the terminus of the formal Ballentine Parkway, an exception was made. The design for the Ballentine Gateway, done by Carrere and Hastings (with guidance from John C. Olmsted) was completed by 1899. The buildings, columns, fencing as well as the adjacent paths, plaza, and plantings were all finalized by the spring of 1901.

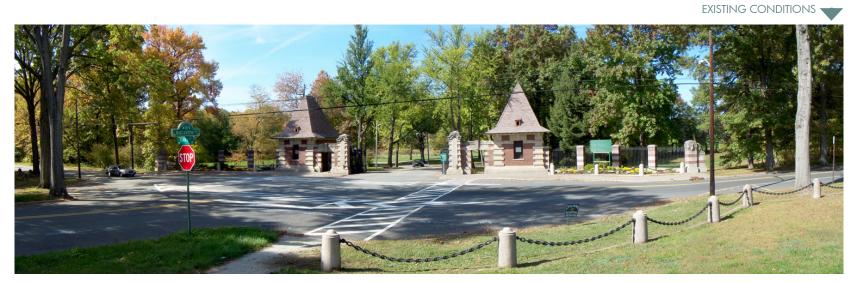
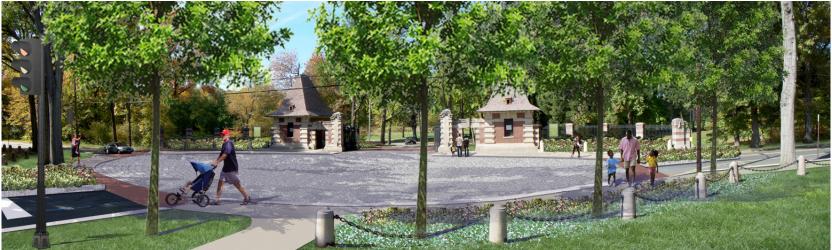
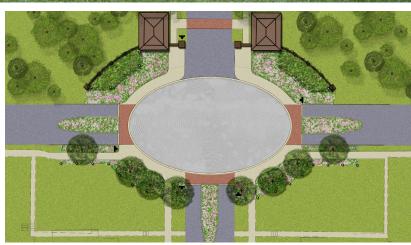
ABOVE TOP: Panorama of the current Ballentine Gateway, Source: RHI

Above Bottom and Right: Proposed visualization and plan for the Ballentine Gate restoration, Source:  $\mbox{RHI}$

- Repair brick masonry on walls
- Repair damaged, settled brownstone/restore damaged stones
- Repair/selectively replace copper gutters, downspouts, and roof (shingles and beadboard support)
- Replace non-historic windows, doors, and trim, based on historic research
- Illuminate structure as appropriate
- Remove vegetation and roots impacting the structure (within 5' of the building), and repair structure accordingly
- Recreate historic paving and plantings based on historic documents, including drainage around the building
- Refinish/repair fence as required

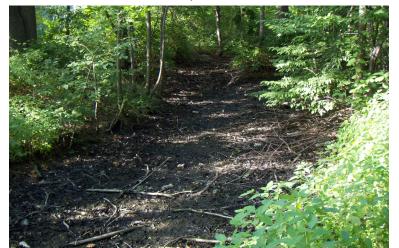
ABOVE TOP: Stream in the Northern Division. The bottom is moist, but no surface water is present, August 2008, Source: RHI
ABOVE BOTTOM: Algal bloom in one of the pools, June 2010, Source: RHI

Until 2014, many of the brooks were dry (or only moist), the pools suffered from algae bloom, and the whole system barely functioned with built-up silt and debris. The park's waterways were carefully studied. As a result of recommendations from the study, to begin bringing this system back to health, a supplemental well is under construction at the time of this report.

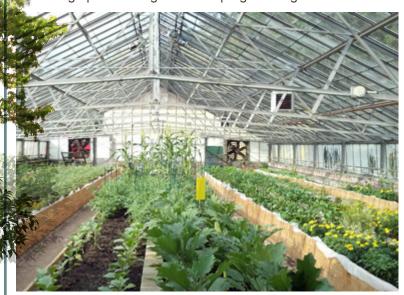
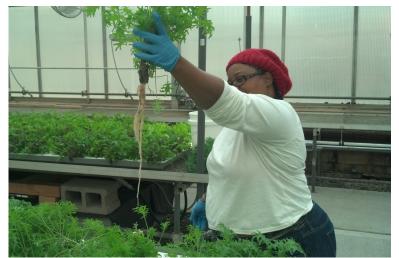
The restored Urban Farm greenhouses, Source: photos courtesy of the Branch Brook

The Essex County Urban Farm was launched as an effort to help encourage and to provide for the community access to more fresh, affordable produce. Recognizing the need for increased awareness for public health, the greenhouses were renovated in 2012 and now regularly grow food in hydroponic and soil-based systems. Programs involving area school children and teachers are also a large part of the greenhouse programming.

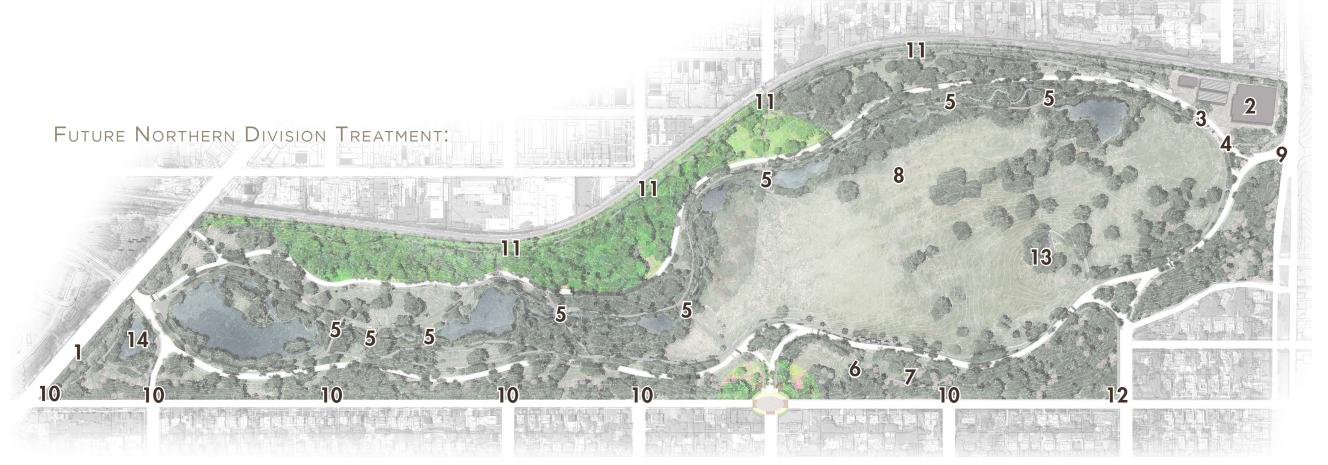
- 1. Reintroduce historic Bloomfield field house entrance, an important visual park connection across Bloomfield Avenue at street level
- 2. Renovate existing maintenance facility building in a style appropriate to the park design, including: Replace windows, replace fencing, replace alarm system and electric gate

- 3. Remove angle parking along south Branch Brook Drive near maintenance facility to improve safety and allow parallel parking along both sides of drive to maintain current parking count

- 4. Retain small portion of access drive to maintenance facility twoway for ease of access to facility
- 5. Rehabilitate 6 pedestrian bridges and 2 historic road bridges over Branch Brook per structural recommendations

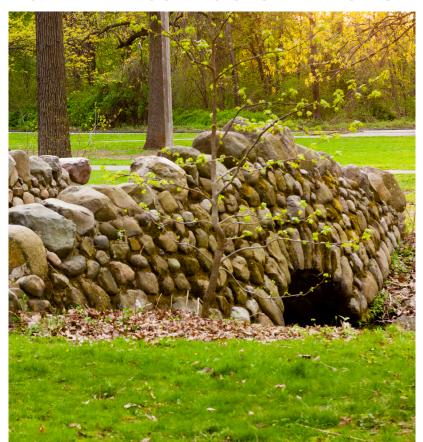
ABOVE TOP: Laurel Wood Boulder Bridge, Source: Patrick O'Brien, May 2008

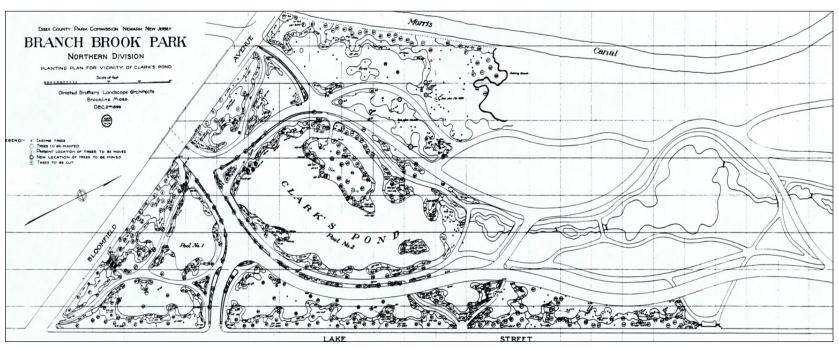
ABOVE TOP: An Olmsted planting plan of the area adjacent to Bloomfield Avenue and Clark's Pond, plan #2121-383, Source: ONHS

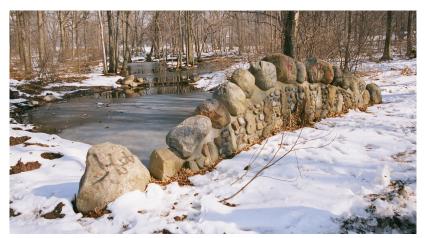
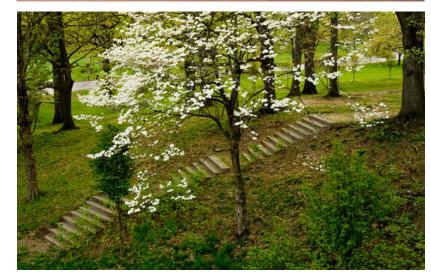
Above Top: Midwood Drive Bridge, Source: RHI
ABOVE MIDDLE: Detailed sketch of the Midwood Drive Bridge, Source ONHS
ABOVE BOTTOM: Steps in the Northern Division, Source: Patrick O'Brien, May 2008

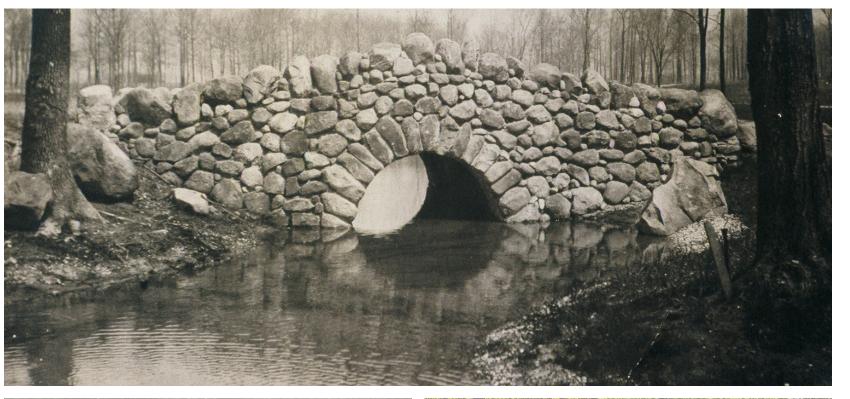
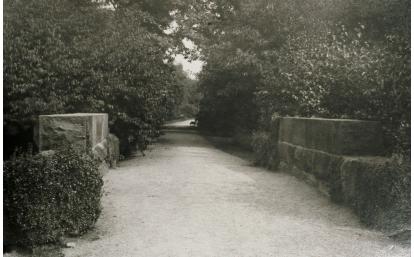
ABOVE TOP: View of the Midwood Pool Bridge at the outlet of Abington Pool, Source: ABOVE: Historic postcard of a pool and weir in Northern Division. photograph #2121-77, ONHS
ABOVE BOTTOM: Path at the Brownstone Lintel Bridge, Source: photo #2121-176, ONHS

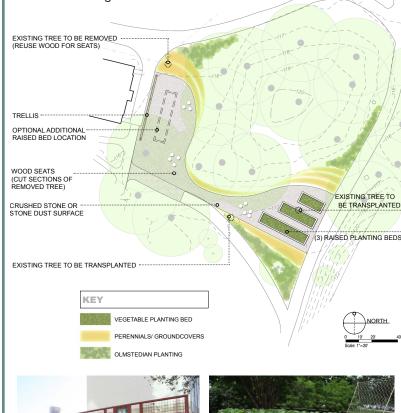
A plan of the design concept, as well as "inspiration" photos that the Children's Garden is based upon, Source: RHI

At the edge of a small mossy mound covered with canopy trees, a Children's Garden was envisioned. Adjacent to the Essex County Cherry Blossom Center and behind an elementary school, this area will become a space for active learning, planting, and cultivating.
Under construction at the time of this report, the garden will be
used by local children for them to become better acquainted with plants and their benefits, as well as for junior Master Gardener's training. An "art trellis" with panels created from children's/ paintings, raised planting beds, along with wood log and boulder seats provide elements for children and small groups to feel welcome in this garden.

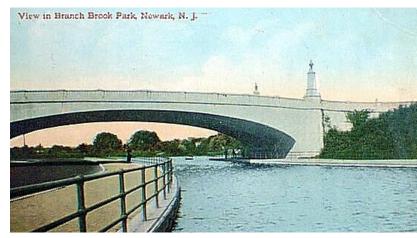
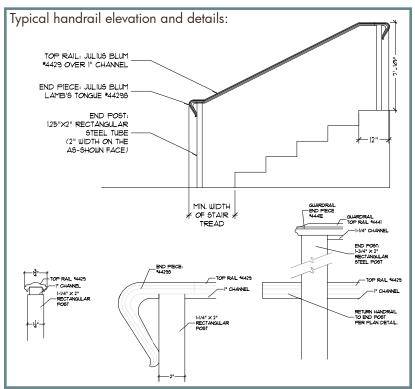
Typical guardrail elevation (with and without handrails) and handrail return to guardrail plan

The handrails and guardrails chosen for Branch Brook Park were designed by considering and interpreting the historic design (see below for post card from 1915 of the guardrail along Branch Brook Lake), while complying with the current Americans with Disabilities Act (ADA) specifications. Cost and ease of maintenance were also factors in the design.

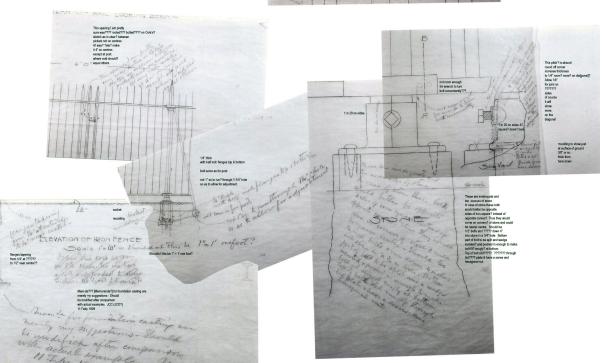
When restoration began in the park, much of the perimeter fencing was in disrepair. Before new fencing was installed, careful analysis of the historic drawings as well as of the existing perimeter fence was conducted. From that investigation (see far right for a sample of the

study), a prototype for the new fence, including the more ornate end post, was designed. All railings and fence elements are to be semi-gloss black.

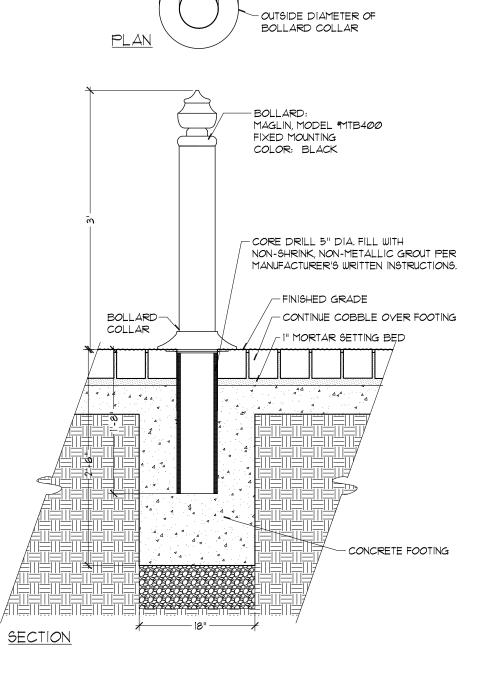
## **Bollard:**

Typical spacing: On 10' path, minimize number of bollards by placing bollards at 3' from edges of path (rather than bollards at very edge of path). On 8' path, place bollards 2' from edges of path.

OUTSIDE DIAMETER OF BOLLARD POST

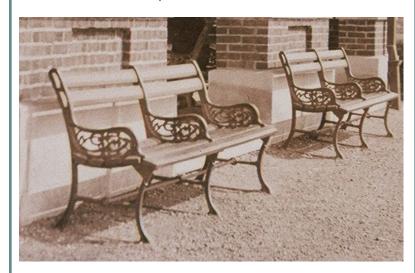
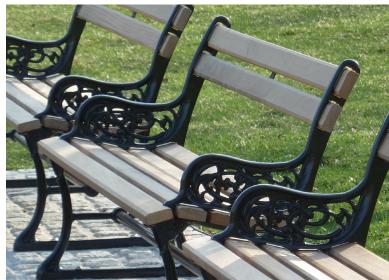
## **Bench**

The standard bench for Branch Brook Park is a custom fabricated (by Maglin) bench that is based on the original park bench design. An original bench was available to provide measurements for the metal work. The standard bench length is 6' long, the decorative end pieces are semi-gloss black cast aluminum metal and the wood slats are ipe.

The above, top image is an historic photo showing Branch Brook Park's original benches. The bottom photo offers a close-up of the new installed bench, source: Bob Hartman 2012.

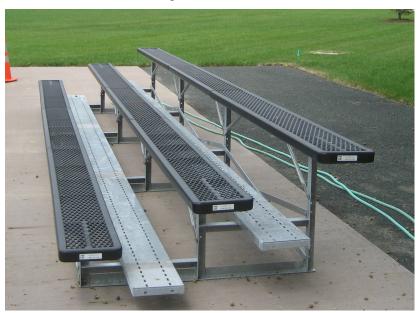
## **Bleachers:**

Galvanized frame; vinyl-coated black seats. Height set to avoid the use of guardrail, at the time of this writing International Building Code allows a maximum height of 30" and 3 rows of seats.

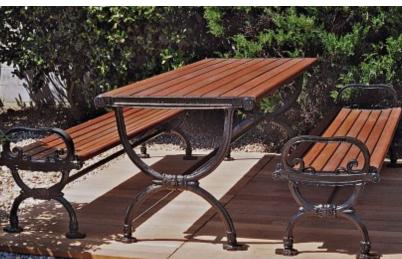
## **Picnic Tables:**

By Victor Stanley (model C-7 from the Classic Series) semi-gloss black cast ductile iron frames with slats made of ipe.

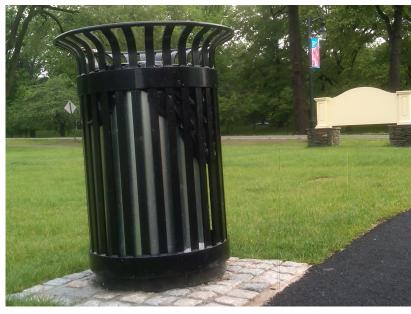
## Trash Receptacles:

Fabricated by Maglin, the standard trashcan is galvanized semigloss black steel with a 32 gallon capacity (model MLWR200-32).

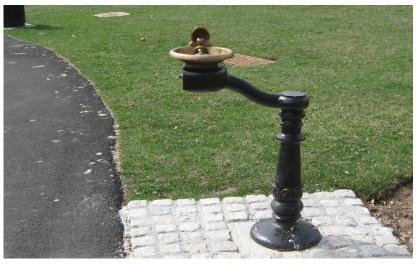
## **Drinking Fountains:**

Single-bowl drinking fountain with wheelchair arm by Murdock Fountains (model mc-76-1). Solid brass bowl, color: black, frost-proof.

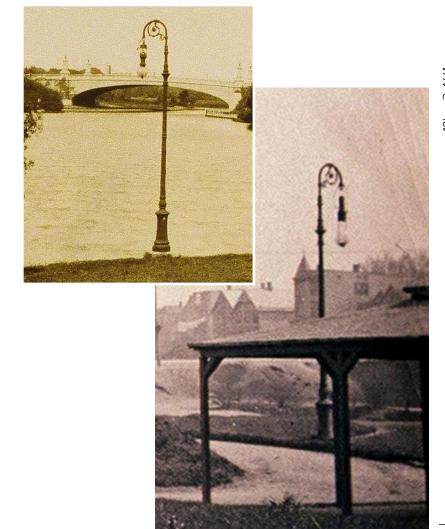
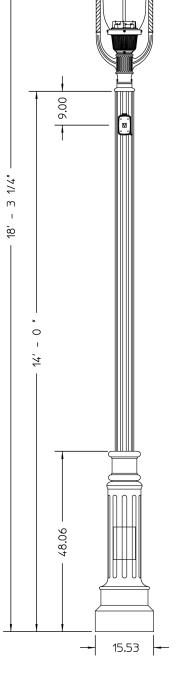
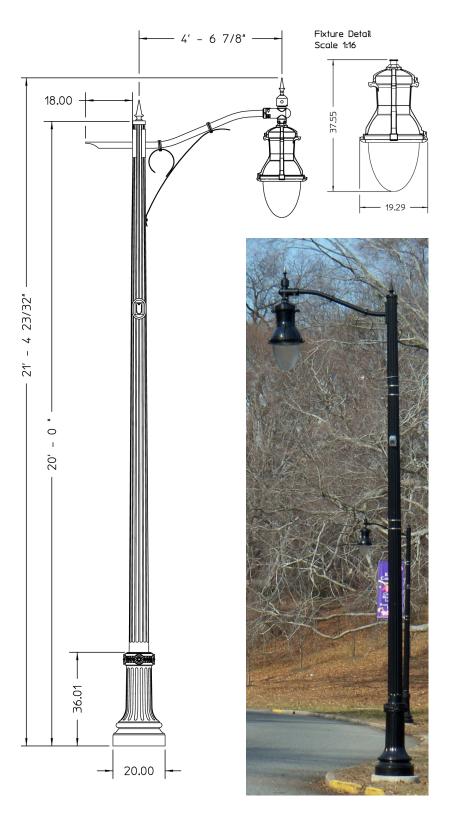
## LIGHTING

Two different types of light fixtures were selected, both semi-gloss black in color. One fixture should be used when lighting pathways in the park, and is slightly shorter, offering a more pedestrian scale (near right). The second light, with a drop-down teardrop fixture, is taller with an extended arm and should be used to light roadways (far right). Both of the fixtures are manufactured by HADCO, and approved by Public Service Electric and Gas Company (PSE&G).

Historic photos and postcards (some of which are seen below) were studied for guidance in determining the appropriate lighting for Branch Brook Park.

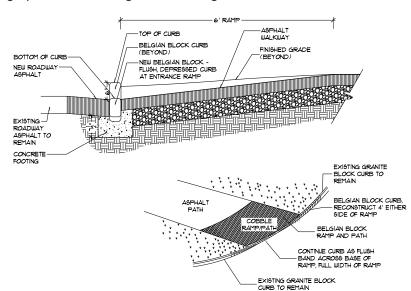
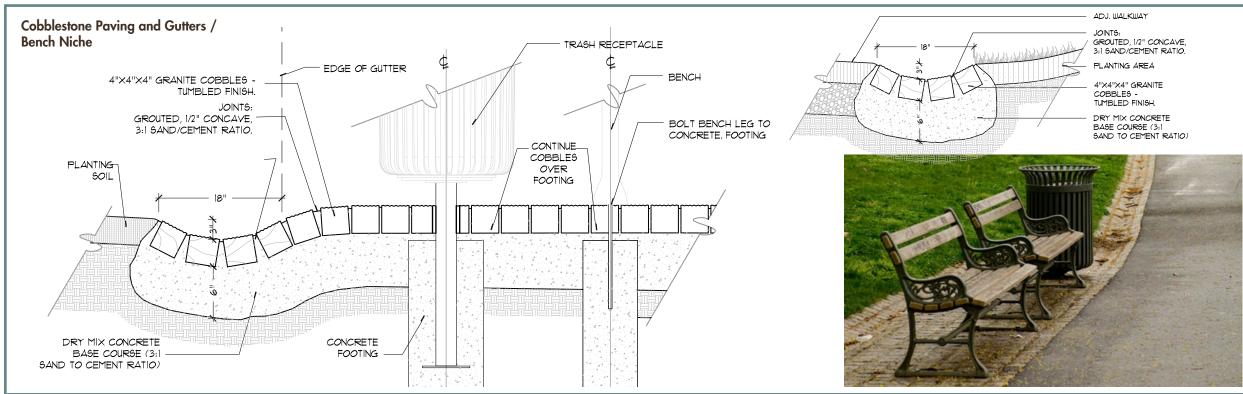
## Curb Ramps: Asphalt and Cobble (with depressed cobble curbs)

Granite "Belgian block" cobble is 4" wide, the color should be light gray to match existing cobbles along Branch Brook Drive.

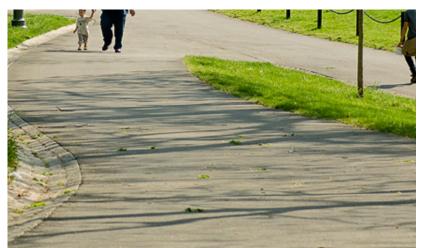
## **Asphalt Paving/Block Pavers**

Top: Asphalt paving for pathways: standard primary path is 10' wide, standard secondary path is 8' wide. Cross slope path (do not crown) to allow for snow removal. Use standard NJDOT asphalt mix. Bottom: Asphalt block paving is Hanover asphalt block pavers, color matrix A80012, finish "Heavy Tudor"; size: 12" x 5" rectangle or 12" x 6" rectangle. Border paving areas with 12" wide rowlock course, while the field of pavers should be set in running-bond pattern.

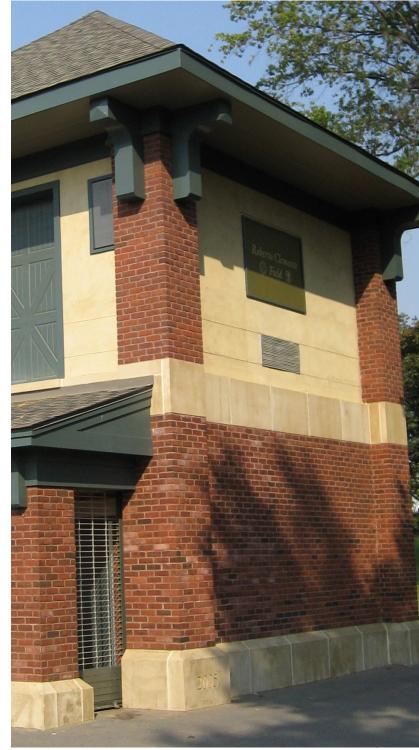
The finish for stucco should be a light stippled pattern; the color, beige color to match the Cerone Building (see photo right). Note that for the Middle Division, the color "Travertine" by the Lehigh Cement company was selected; future projects may require a slightly darker color.

Cast stone should be 'limestone' color, fabricated to match the historic cast stone at the Ballentine Gates, or the new Cerone Building press box in the Middle Division. A light sandblast texture should be applied and the color of the mortar joints should match the cast stone (for the Middle Division the color "Ivory" 12B by Lehigh Cement company was selected).

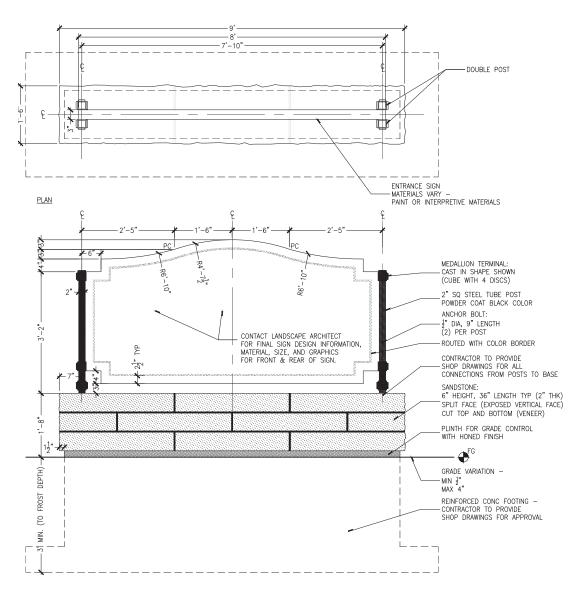
## **Primary Entry Signage**

The sign detailed below is based on the design of other Essex County park's signs, but has been slightly modified to better fit within the family of furnishings in Branch Brook Park. The base of the sign has been modified to be large, split-face sandstone (bluestone) and the posts that hold the sign have been replaced with black steel posts. The County does have a smaller version of its typical sign. If this version is needed for Branch Brook Park, the smaller sign should mimic the base and the streamlined proportions as shown in this detail.

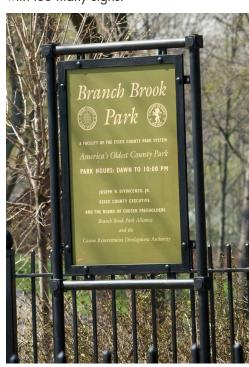
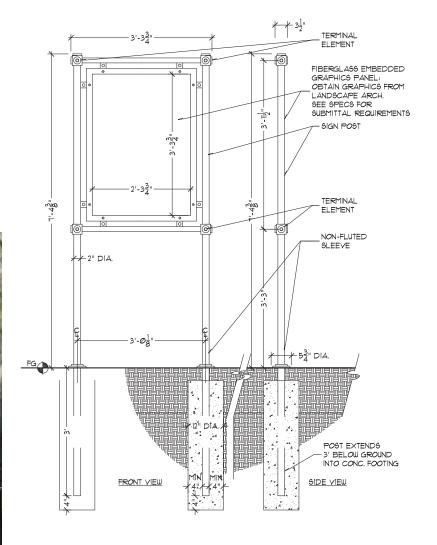
## Permanent signage

The sign shown and detailed below and to the right should be used for permanent signage needs in the park beyond the Primary Entry Signage. The metal frame of this sign should be semi-gloss black to match the other site furnishings within the park. The use of this sign should be limited in order to keep Branch Brook Park from becoming littered with too many signs.

Signage Panel Fonts: Sans Serif: Gill Sans Bold Condensed Serif: ITC Galliard, Roman and Italic

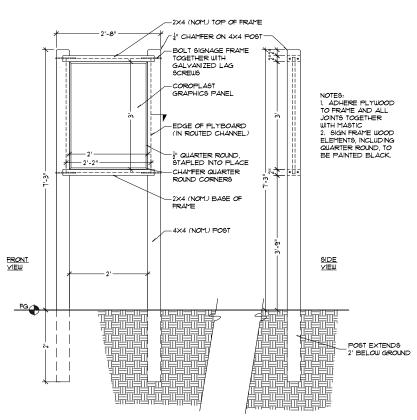
The detail on the far right is provided so even temporary signs can fit in with the park's design standards. This sign is ideal for when temporary signage needs to be more substantial and have a stronger presence in the park.

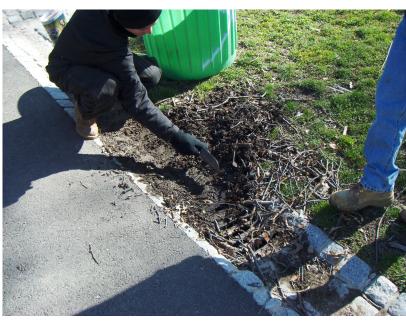
ABOVE: Clearing away accumulated debris blocking a drainage grate, Source: RHI
